**GEOTECHNICAL INVESTIGATION**

STEELE CANYON ROAD AT P.M. 2.00  
NAPA COUNTY, CALIFORNIA

Prepared by:  
Blackburn Consulting

July 27, 2007

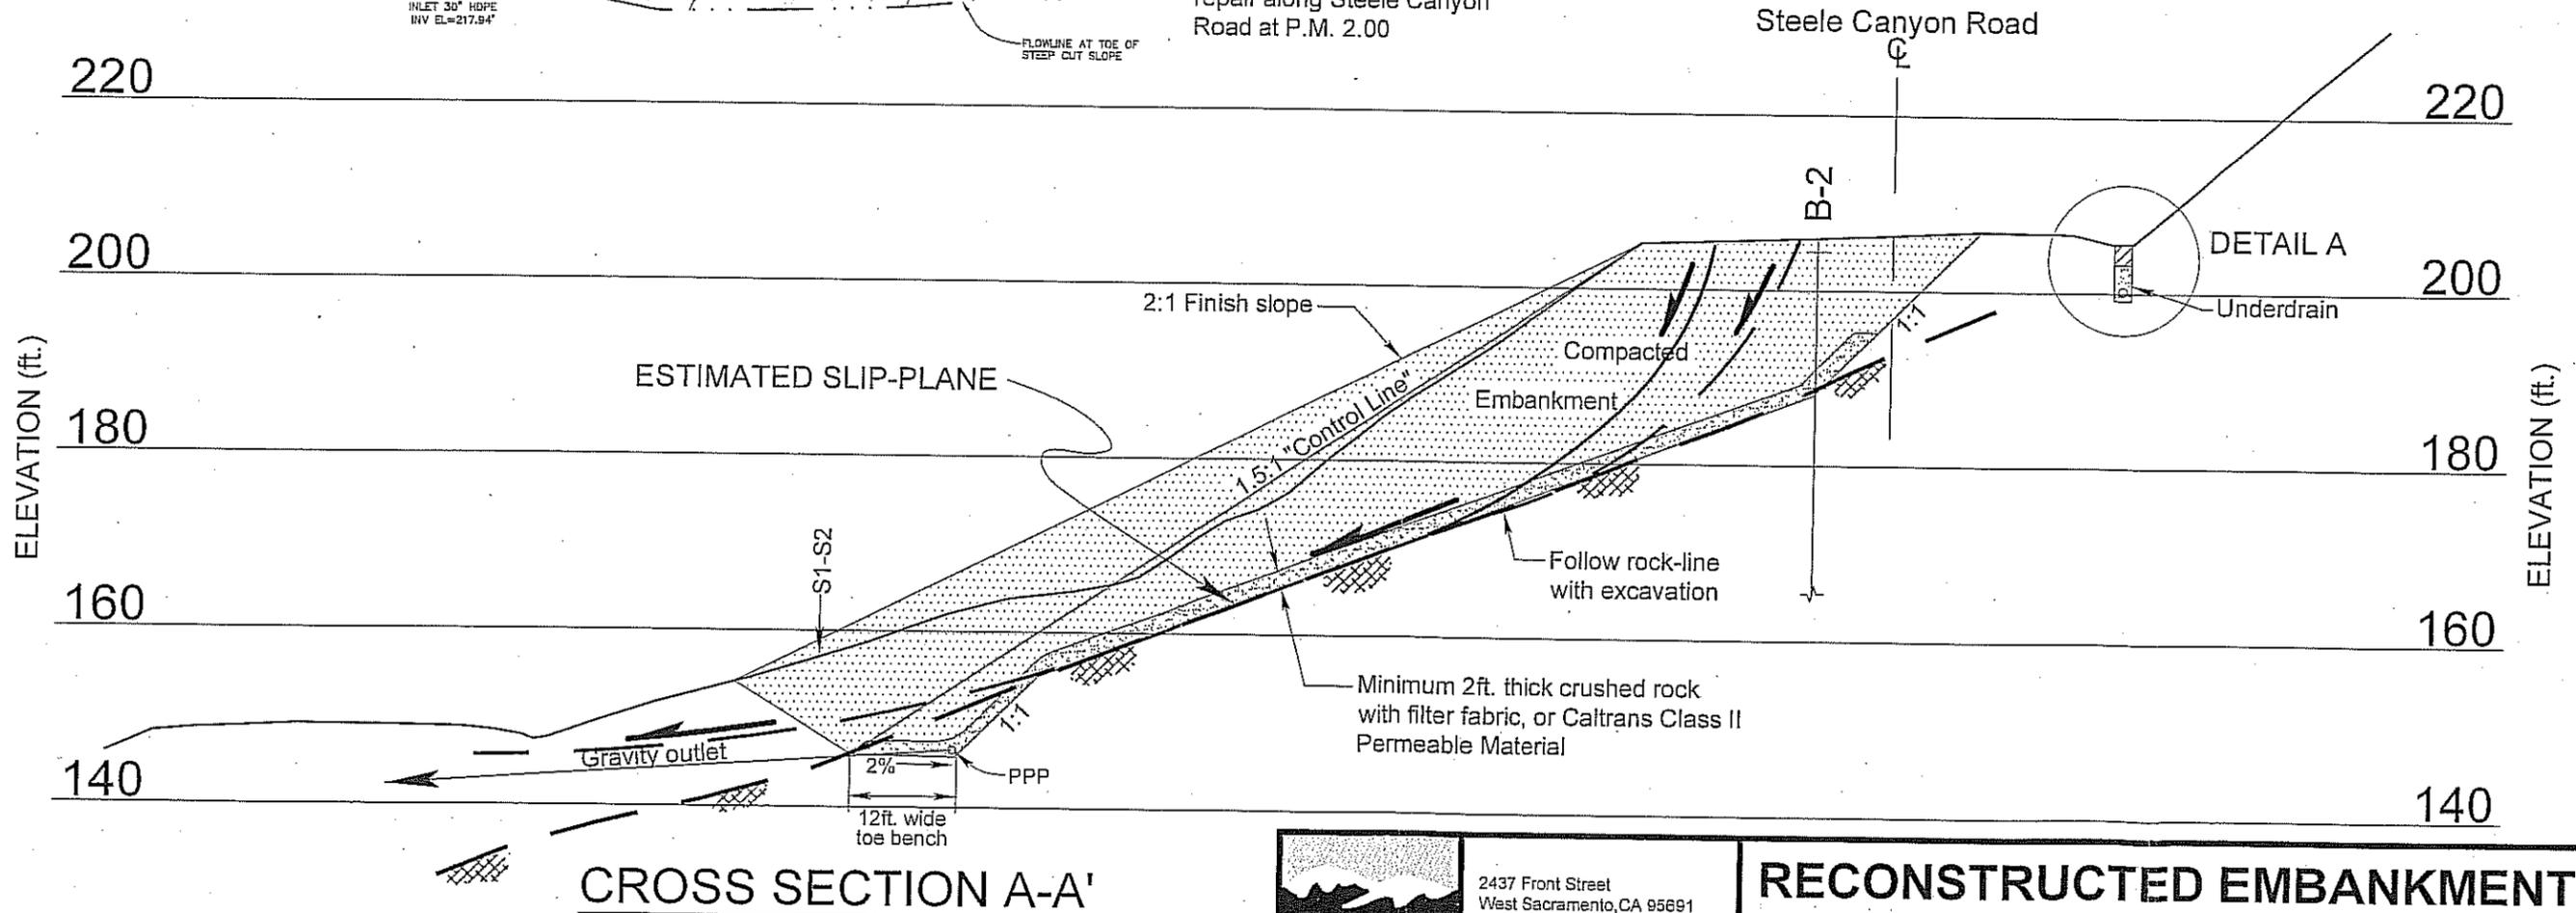
**CROSS SECTION A-A'**  
1"=20'

The slip-plane extends to the rock line in the central portion of the slipout. The Unit 1 fill materials are directly involved with the slipout event and we identified a 5 to 6 foot thick zone of weak Unit 2 soil that remains in-place along the flanks of the slipout. The lowermost Unit 3 rock appears "in-place" and not materially involved with the slipout event. Based on our boring data, the underlying rock is stable, but is intensely weathered, fractured and locally sheared (typical of rock weakened by fracturing, shearing and crushing along/near faults). We show the estimated slip-plane on Figure 3.

The most straight-forward approach to re-establish the roadway at this location is a reconstructed, drained embankment section. The key elements of this work include toe support within Unit 3 rock; internal subdrainage with assured positive relief at the outlet; replacement and reconstruction of the embankment as compacted fill; and an interceptor underdrain along the inside road area to help control seasonally shallow groundwater infiltration/seepage. Below we

provide recommendations for a reconstructed embankment section with a 2:1 (horizontal: vertical) finished slope established from the restored original hinge-line (see Figure 3).

- Reconstruct the embankment section the full length of the distressed area, approximately 140 feet along Steele Canyon Road.

- Construct a minimum 12 foot wide toe bench (keyway), established within “in-place” Unit 3 weathered rock as identified by BCI.
- Establish the toe bench level to slope from elev. 149 at the south end to elev. 143 at the north end, defined by a 1.5H:1V (horizontal;vertical) “control-line” from the re-established outer-roadway hinge. The actual toe bench elevation may require adjustment during construction to account for local variation of Unit 3 rock materials (particularly at the ends).

- We recommend that the excavation backslope extend at 1:1 from the heel of the toe to the top of Unit 3 rock materials, then follow the rock surface to where a 1:1 backslope can be constructed to maintain one-lane access through the site. Some trimming into the inboard slope may be necessary to maintain a single lane for traffic.

- Drain the buttress section with a 2-foot-thick “blanket” of ¾-inch crushed rock placed along the base of the toe bench and extended up the backslope to within 10 feet of road level to intercept/relieve subsurface water infiltration. Wrap the crushed rock with filter fabric (such as Mirafi 140N or equivalent) to prevent mobilization of fines into the drain.

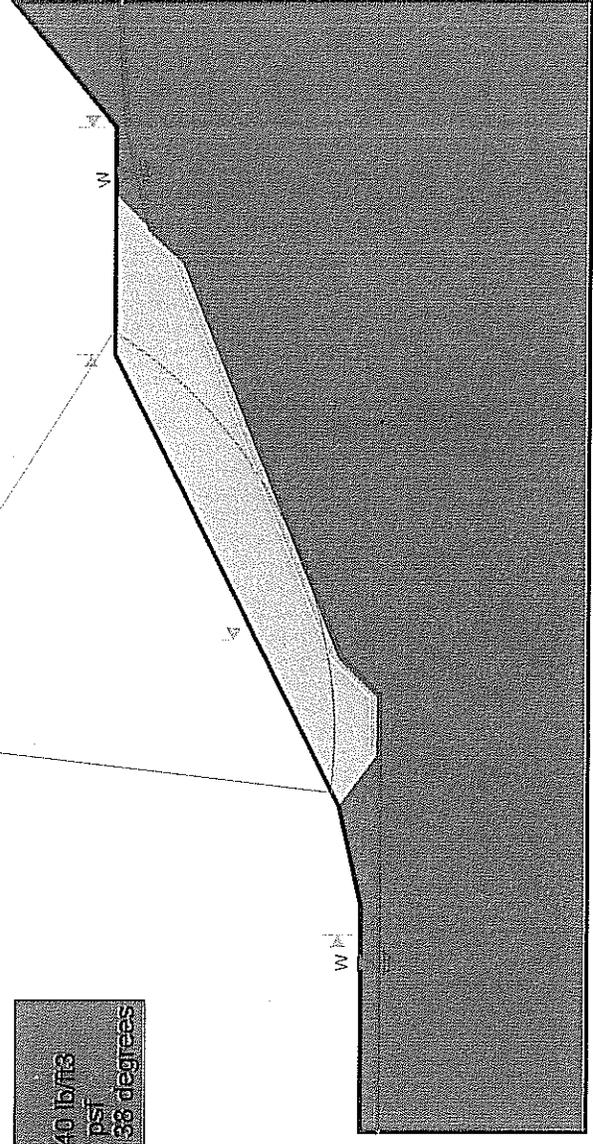
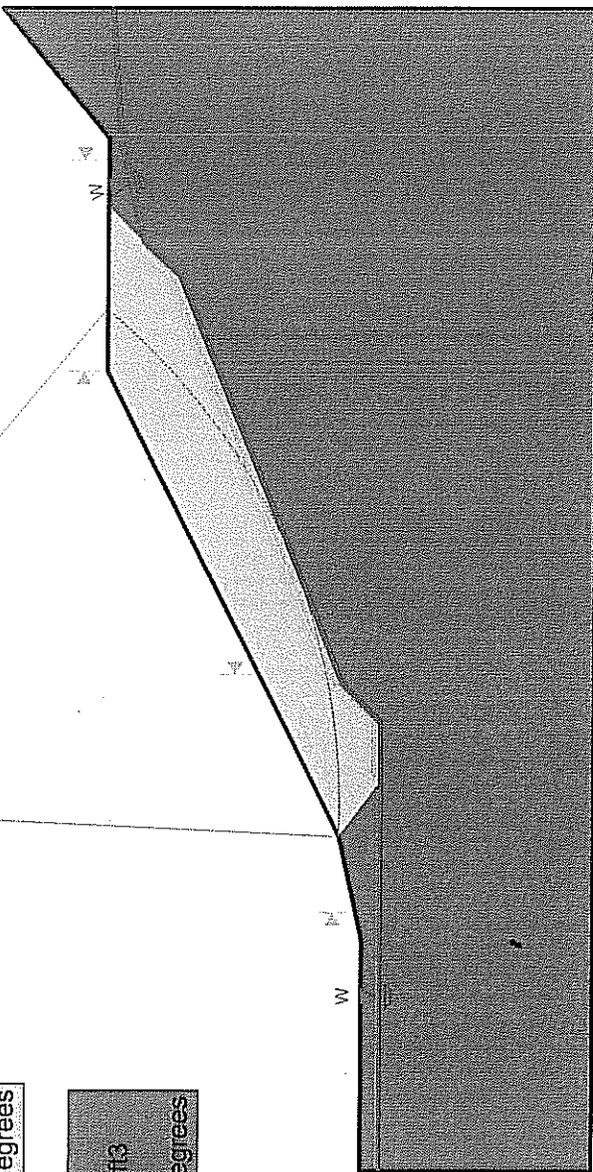
We used the SLIDE program to evaluate slope stability of the reconstructed, drained embankment section recommended below. The results of our analysis indicate a Factor of Safety (FS) of about 1.4 for static conditions, and a FS of about 1.1 for pseudostatic (earthquake) conditions.

We used conservative soil parameters to model the backslope of the reconstructed embankment section within the zone between the drain "blanket" and rock surface (i.e.,  $\phi$  angle =  $20^\circ$  and cohesion = 50 psf). For pseudostatic conditions, we used a seismic coefficient of 0.125.

Based on our analysis we expect that the recommended reconstructed, drained embankment section will be appropriately stable. We show the graphical output from the slope stability analysis (including soil parameters) in the Appendix.
