## **Napa County Stream Maintenance Manual**

*Prepared for:*

Napa County Flood Control and Water Conservation District  
804 First Street  
Napa, CA 94559  
Contact: Michael Gordon, Watershed and Flood Control Resource Specialist  
707/259- 8684

January 2019

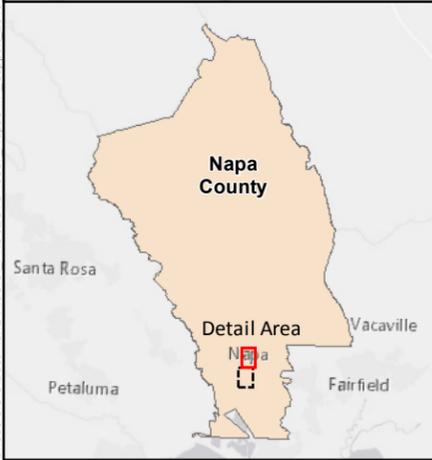
**Figure 1-7**  
**Napa Flood**  
**Protection**  
**Project Features**  
**Page 1 of 2**

Flood Protection Features	
Flap Gate	Rootwad revetment
In-stream woody structures	South Closure Gate
North Closure Gate	Stoplog Structure
Rock Riffle	Stoplog Structure (Dry Bypass)
Floodwall	Joint Planted Rock
Levee	New Train Bridge
Non Planted Rock	Vegetation & Reinforced Matting (HPTRM)
Training Dike	Marshplain Terrace
Vegetated Reinforced Soil Slopes	Vineyard Dike
Bypass	Bypass low flow channel
Floodplain Terrace	Gabion wall

Specific vegetation management activities include monitoring and replanting vegetation on the marshplain terrace, removing invasive vegetation and debris in the southern portion of the project area (between Imola Avenue and the Highway 29 crossing), maintaining vegetation at the dry bypass inlet and outlet, and monitoring grazing activities in the southern portion of the Flood Protection Project. As noted previously, maintenance activities associated with the Flood Protection Project and that are consistent with maintenance activities currently conducted by the District are described in more detail in the USACE authorized O&M Manual and thus incorporated by reference in this Manual (Appendix M).

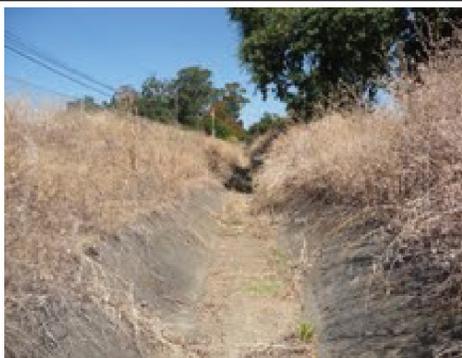
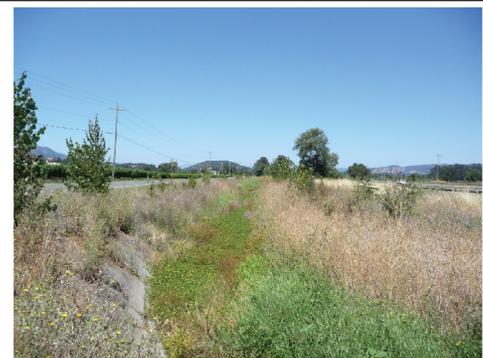
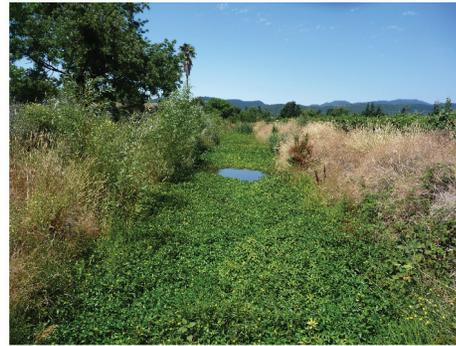
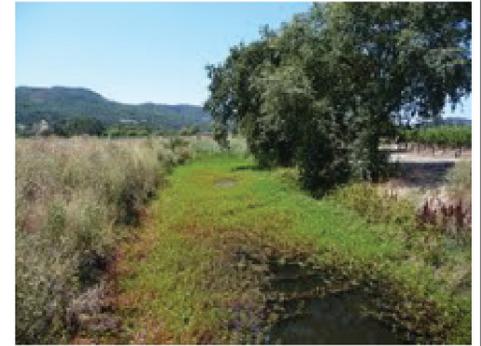
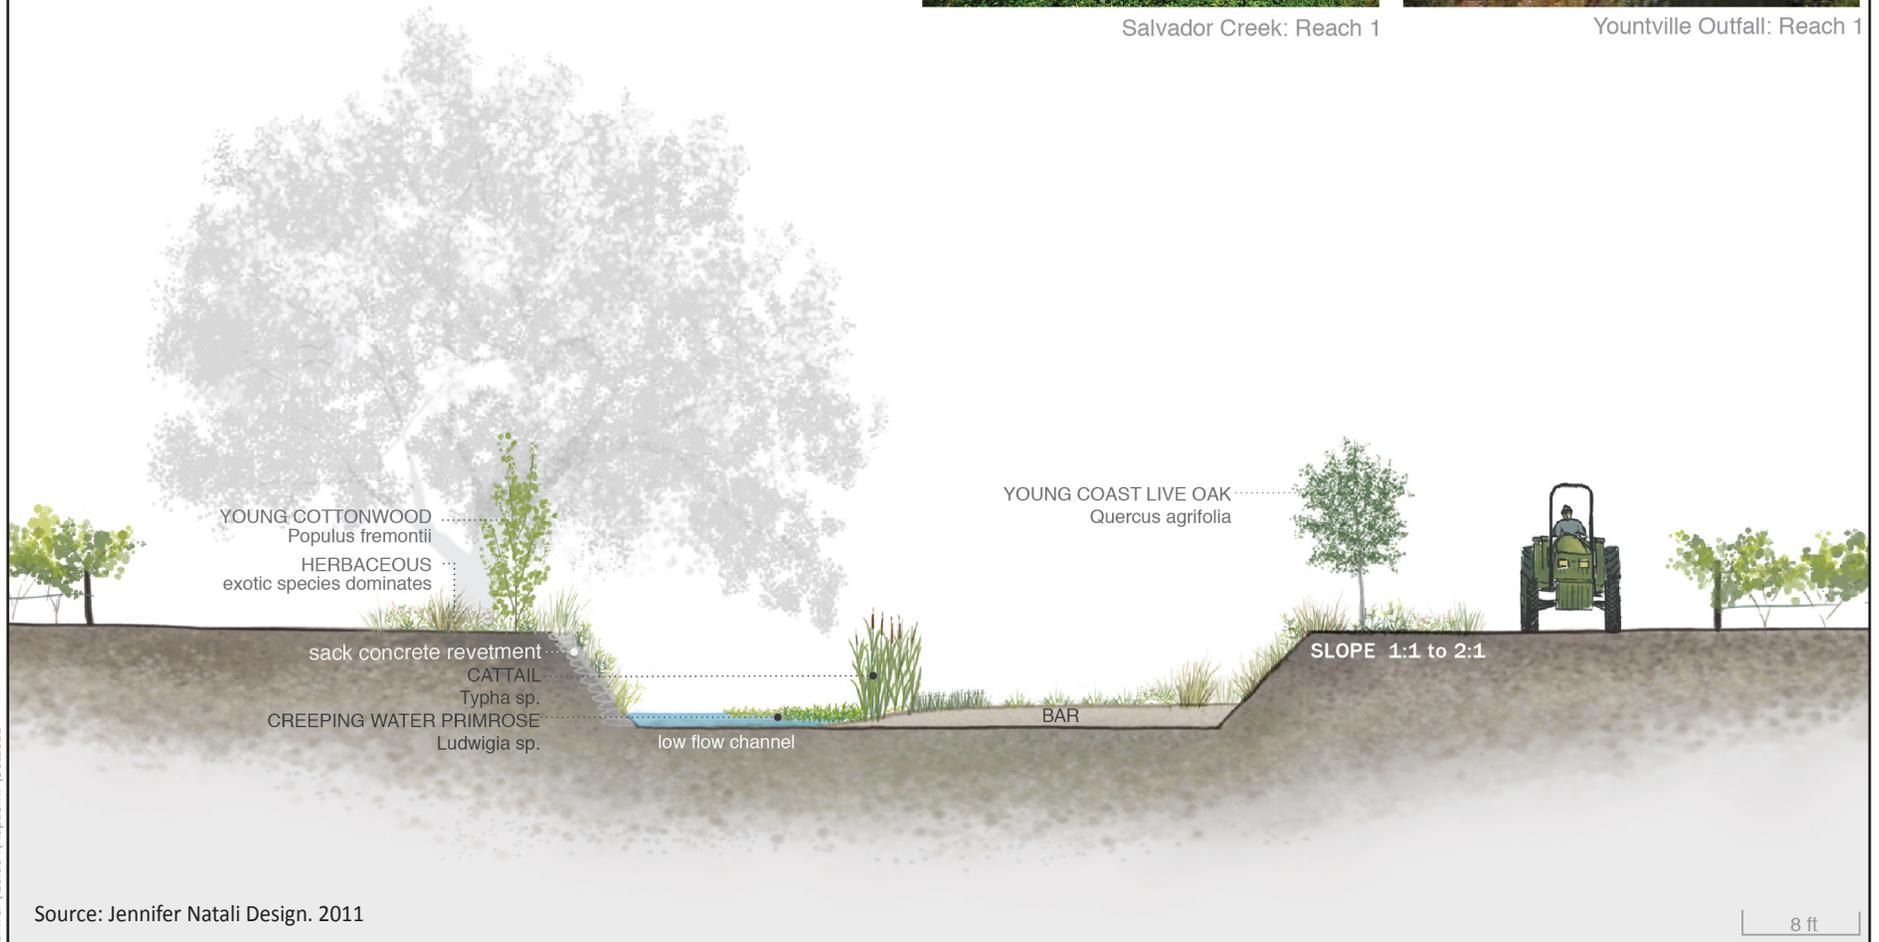
**Figure 1-10**  
**Typical Channel Cross Section - Semi-modified and Natural**

Semi-modified channels maintained by the District are illustrated in **Figure 1-10**. Examples of these channel types are found at Conn Creek and Tulocay Creek. In comparison to modified channels, semi-modified channels typically have natural, un-modified stream beds and support a higher percentage of native vegetation to non-native vegetation, and a moderate to mature riparian corridor. The banks of these channels may have been modified to prevent flooding or bank erosion.

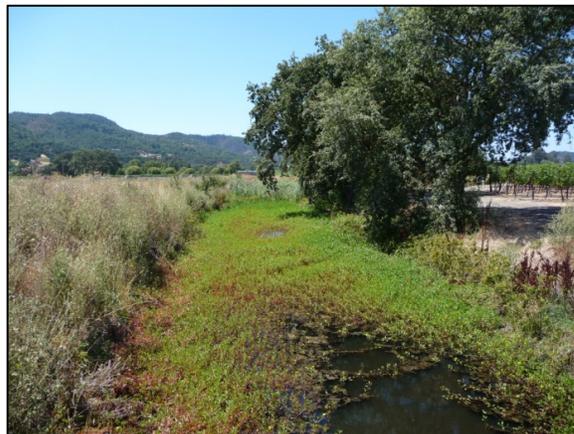
**Aquatic vegetation, primarily *Ludwigia*, in the Yountville Outfall.**

Only a few species of vascular plants typically grow within fast-flowing streams. Species that may be found in or adjacent to such streams in the program area include torrent sedge (*Carex nudata*), giant chain fern (*Woodwardia fimbriata*), spicebush (*Calycanthus occidentalis*), and small-fruited bulrush (*Scirpus microcarpus*). Certain non-vascular plants, such as aquatic mosses and filamentous algae that are tightly attached to rocks by strong holdfasts, can survive the fast current. Low gradient, slow flowing streams and drainages in the program area support dense growth of aquatic vegetation such as *Ludwigia* (see photo), water plantain (*Alisma plantago-aquatica*), and smartweeds (*Polygonum* spp.).

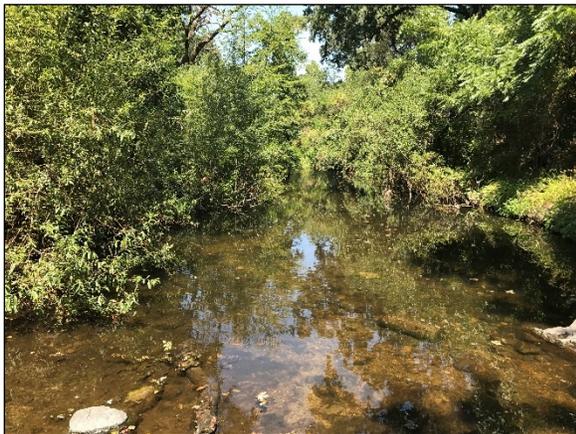
**Photo 1.** Typical conditions of the riparian corridor, looking upstream from Pioneer Park in Calistoga. Bank vegetation and canopy cover is generally very dense with little to no instream emergent vegetation (August 2017).

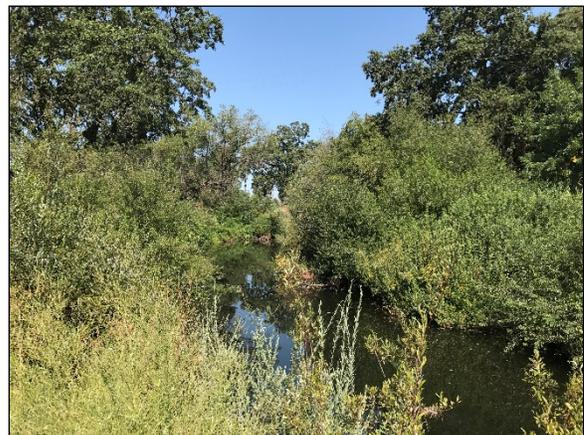
**Photo 2.** Typical conditions of the riparian corridor, near the lower portion of Reach 1 in St. Helena (August 2017).

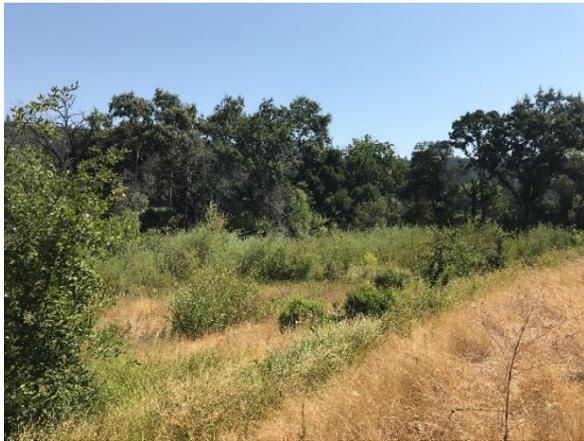
**Photo 3.** Flood terrace restoration site near the confluence of Sulfur Creek in St. Helena. Restoration activities were taken to ensure projects meet performance criteria (August 2017).

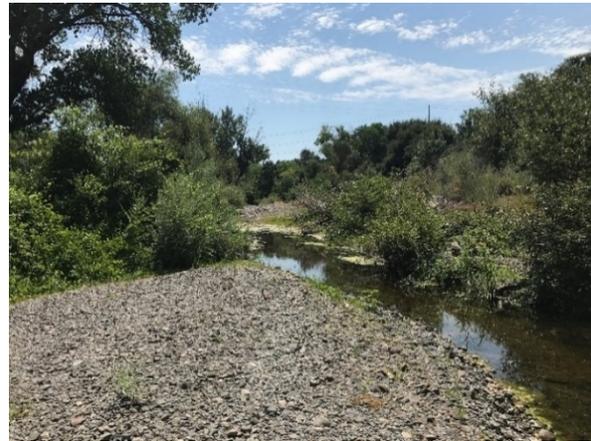
**Photo 4.** Facing downstream near XXXX. The right bank (photo right) was regraded to include a wider setback and gravel/cobble bar (photo foreground) and is typical for Reach 1 (August 2017).

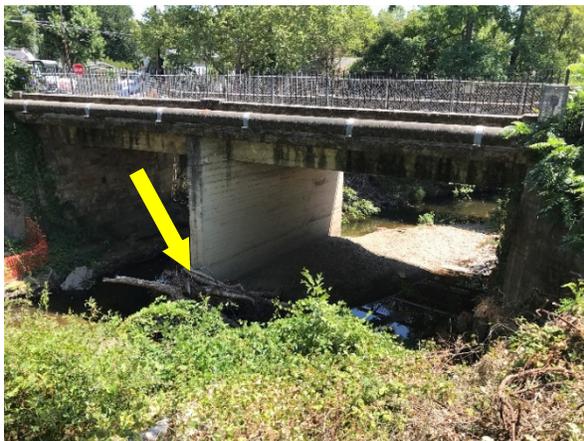
**Photo 5.** Large woody debris jam at the Berry Street bridge pier. Jams such as this have the potential to jeopardize infrastructure integrity, divert flows and thereby cause heightened erosion or result in localized flooding (August 2017).

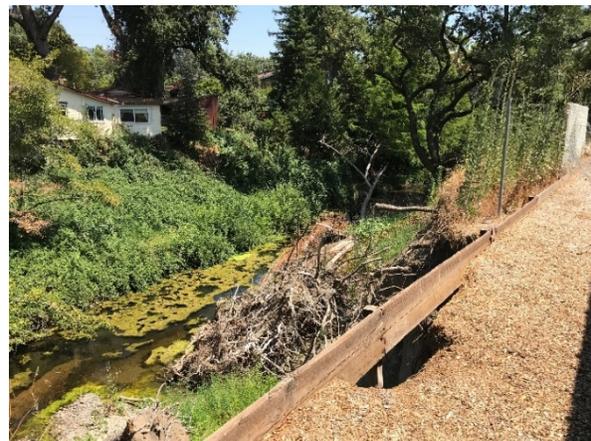
**Photo 6.** Site of a recent severe erosion and bank failure at Calistoga Elementary School. A mostly confined channel and steep banks result in similar bank failures in this reach (August 2017).

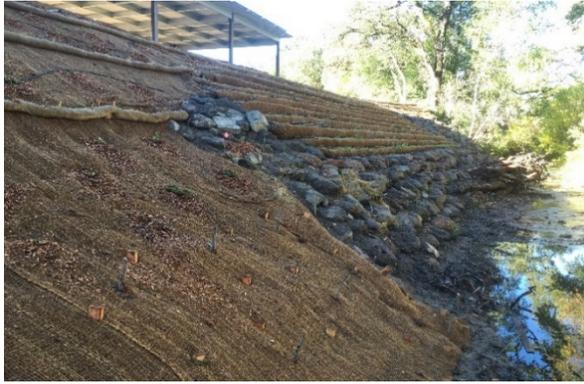
**Photo 7.** (Left) The biotechnical bank stabilization project installed at the Calistoga Elementary School included vegetated soil lifts, extensive native plantings, and habitat log structures (November 2017).

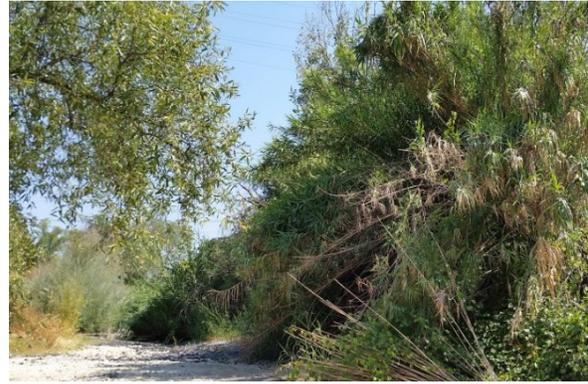
**Photo 8.** Untreated Arundo patch in St. Helena area. Uncontrolled Arundo can produce large amounts of biomass and reduce channel capacity. (June 2016)

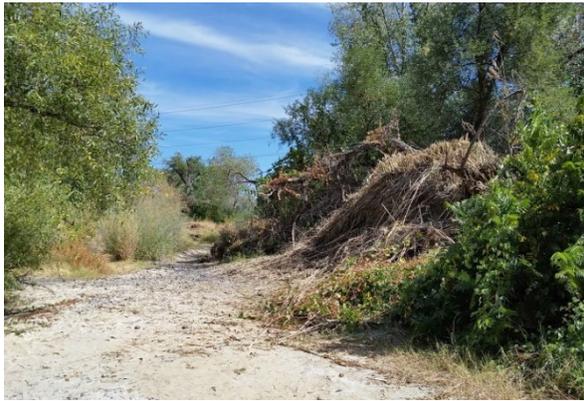
**Photo 9.** The same patch following manual removal of Arundo biomass. Follow-up herbicide treatments have proven to be targeted and effective. Arundo sites between Calistoga and Big Tree Lane are in final phases of eradication and most have had no resprouts for several years. (August 2016)

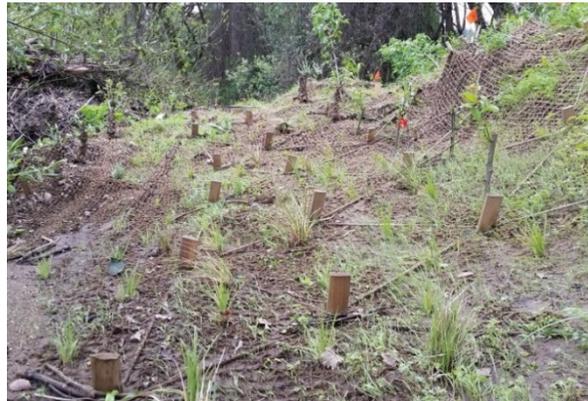
**Photo 10.** An Arundo revegetation site near Lodi Lane planted with Blue elderberry (*Sambucus mexicana*), Santa Barbara sedge (*Carex barbarae*), and Fremont's Cottonwood (*Populus fremontii*) among other species. Erosion control BMP's were also installed with the plants. (November 2016)

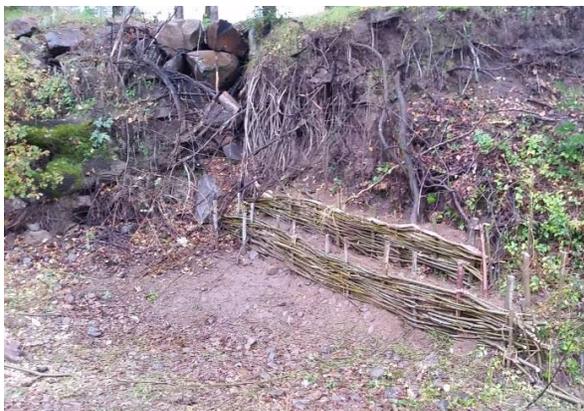
**Photo 11 (left).** Willow fence below eroding bank near Bale Lane. Small scale biotechnical projects in the area are occasionally installed alongside revegetation sites to address incipient erosion problems. (November 2016)

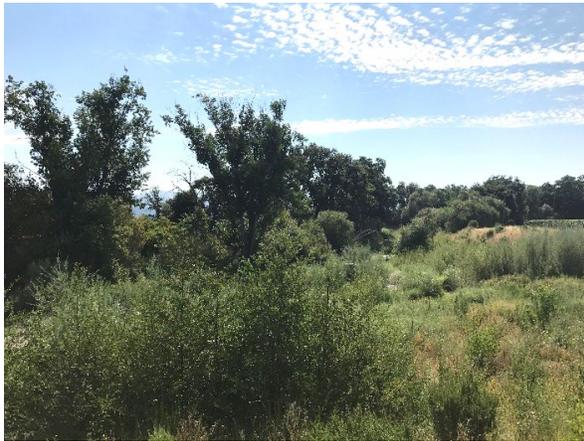
**Photo 3.** Post-restoration vegetative growth after increasing bank setbacks and grading of in-channel floodplain benches (*August 2017*).

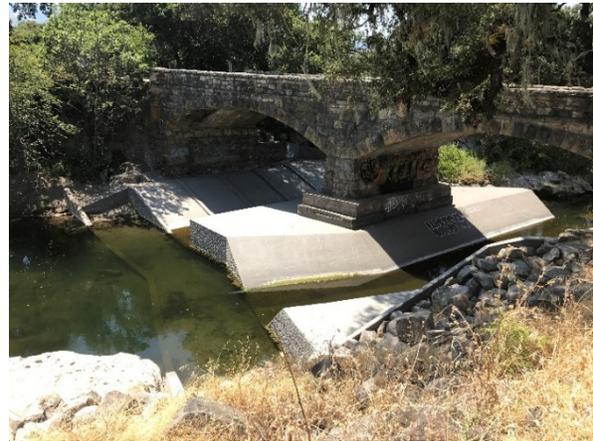
**Photo 4.** Looking at the downstream face of the Zinfandel Lane bridge. This bridge/channel was designed to allow debris and sediment to pass downstream unobstructed thereby requiring less frequent maintenance (*August 2017*).

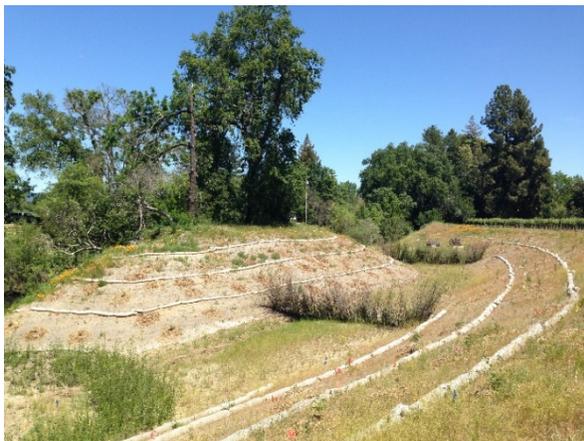
**Photo 5.** Looking upstream at the Bella Oaks restoration site. Restoration efforts at this site included bank setbacks, construction of a high flow side channel. Willow wattles are placed in the side channel to increase roughness and trap sediment (*May 2014*).

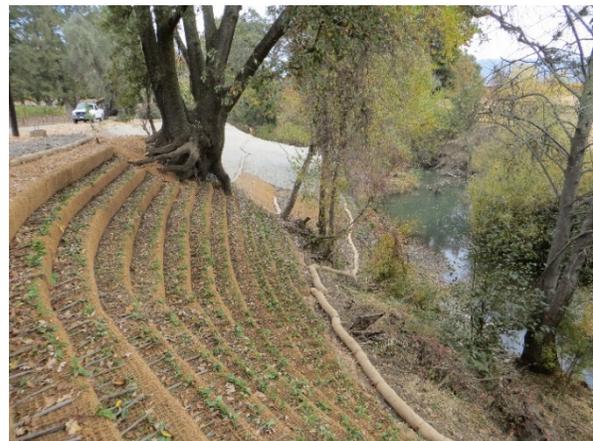
**Photo 6.** Vegetative soil lifts at the Bella Oaks restoration site in the Rutherford Reach (*November 2013*).

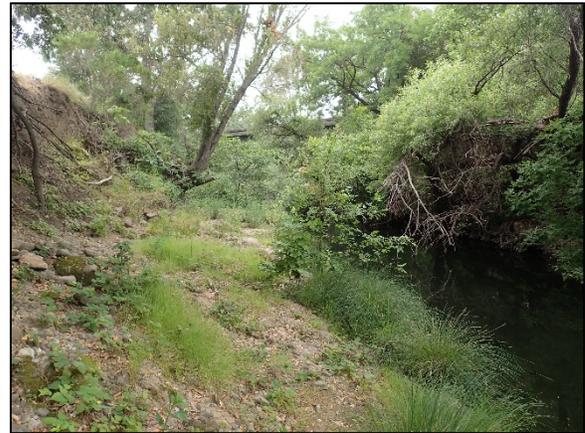
**Photo 2.** Typical channel conditions with steep, eroded banks and dense vegetation on the mid- and upper banks (January 2016).

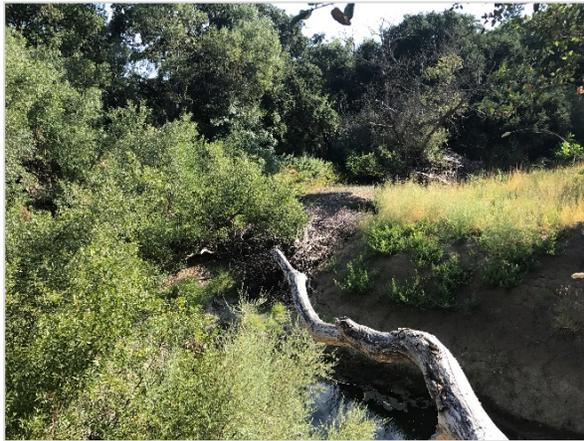
**Photo 3.** Eroding banks near the head of a ~4,300-foot long island where the Napa River splits into two separate channels. Bank sheering have resulted in near vertical sections of bank that continue to erode. This area is part of the Oakville to Oak Knoll – Group D (August 2017).

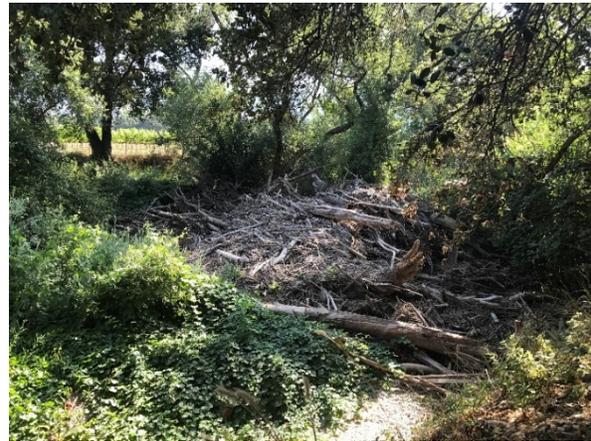
**Photo 4.** LWD jam that formed during one season. Two or three of these LWD jams form every season and can result in localized flooding or redirect high flows and create new areas of erosion and/or destabilize banks (August 2017).

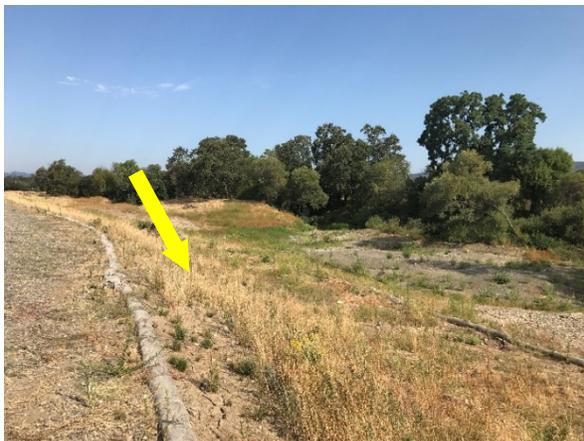
**Photo 5.** Oakville to Oak Knoll – Group C, Site 14. The right (west) bank levee was setback and bank slope decreased to help combat erosion. This managed bank retreat and expanded riparian corridor will help restore natural alluvial process (August 2017).

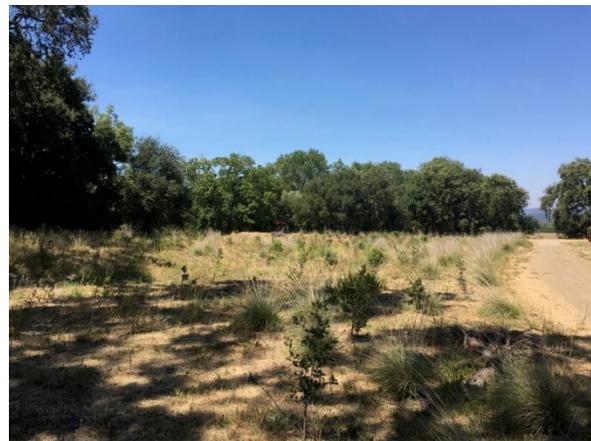
**Photo 6.** Oakville to Oak Knoll – Group A, Site 23. The site features a backwater alcove that was constructed to increase connectivity to the channel. Revegetation efforts enhanced the diversity and abundance of native riparian plant species. (August 2018)

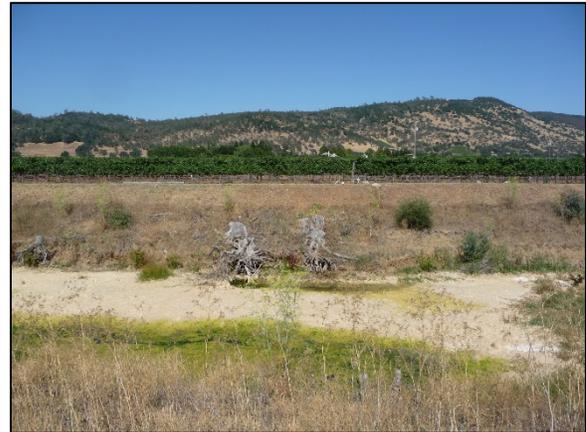
**Photo 2.** In the upstream portion of the reach, the channel has a trapezoidal cross-section with minimal riparian habitat. A thick layer of algae covers the channel bed. Vegetation along the banks is primarily non-native, invasive herbaceous species and eucalyptus. (Looking east from the west bank, August 4, 2010).

Reach 1 of Conn Creek is a modified channel that appears to have been dredged and/or straightened for agricultural land use and/or flood control. The upstream portion of the reach is generally in poor condition with respect to aquatic and riparian habitat (Photos 1 and 2). In the middle and downstream portions of the reach, some mature trees (predominantly eucalyptus) line the banks and the channel has geomorphic features (e.g., low flow channel, floodplain surfaces) that are indicative of recovery of natural channel processes (Photo 4).

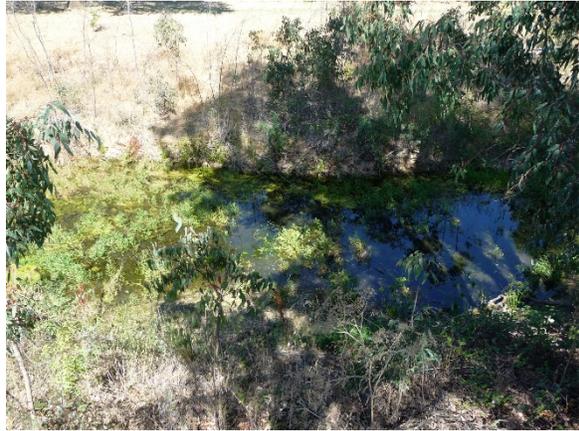
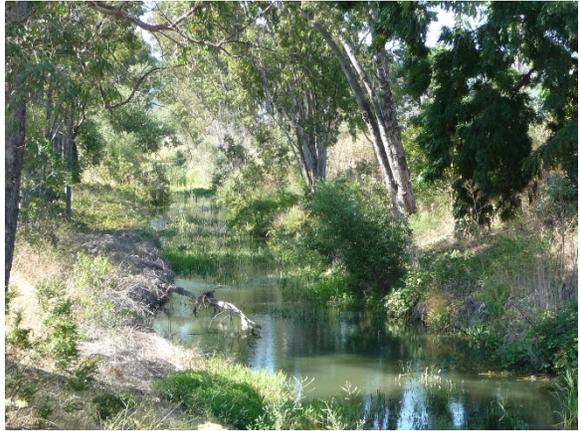
<p><b>Photo 3.</b> In late summer, much of the reach has relatively stagnant water with considerable algae and aquatic vegetation growth (<i>Looking east near the middle portion of the reach, August 4, 2010</i>).</p>	<p><b>Photo 4.</b> In the middle to downstream portion of the reach a bankfull channel has formed within the larger flood conveyance channel; mature trees (predominantly eucalyptus) shade the channel (<i>Looking upstream near Skellenger Lane, August 4, 2010</i>).</p>

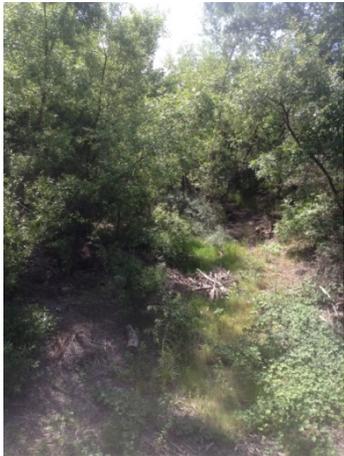
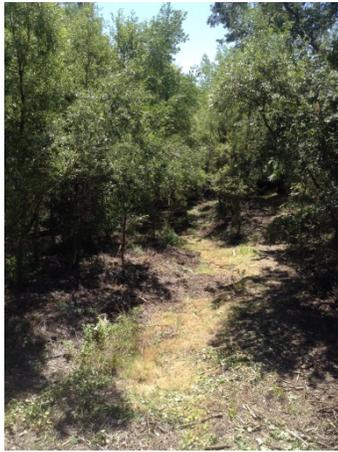
<p><b>Photo 5.</b> Looking downstream at willows (2014).</p>	<p><b>Photo 6.</b> Looking downstream after vegetation pruning and debris removal (2014).</p>

This reach of Conn Creek was a Soil Conservation Service (SCS) flood control project. 2014 maintenance activities included vegetation management (8 cubic yards), invasive removal (16 cubic yards), and blackberry removal (8 cubic yards) at Skellenger Road. In 2016, similar activities took place including vegetation maintenance (50 cubic yards), invasive removal (100 cubic yards), and blackberry removal (25 cubic yards).

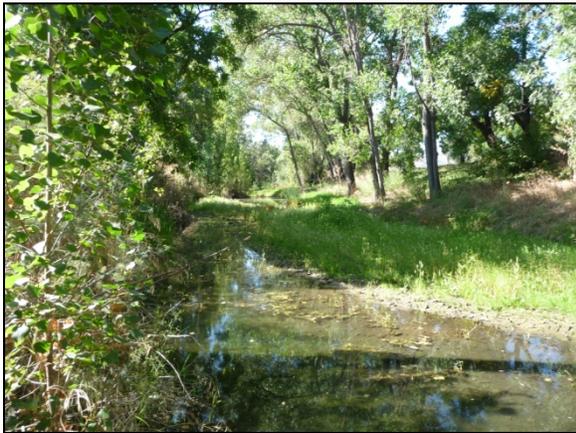
**Photo 1.** Looking upstream near the upstream end of Reach 2 (August 4, 2010).

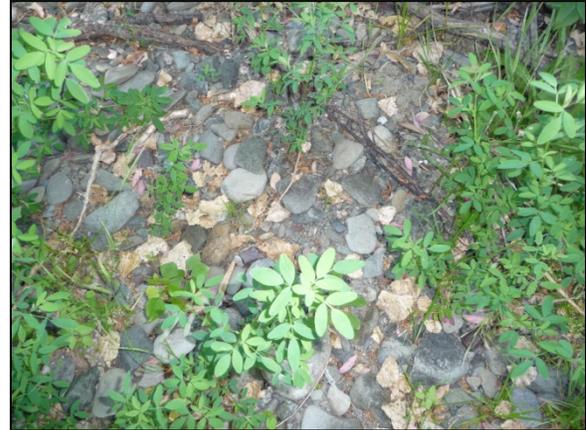
**Photo 2.** Typical streambed substrate, medium sized pebbles in Reach 2 (August 4, 2010).

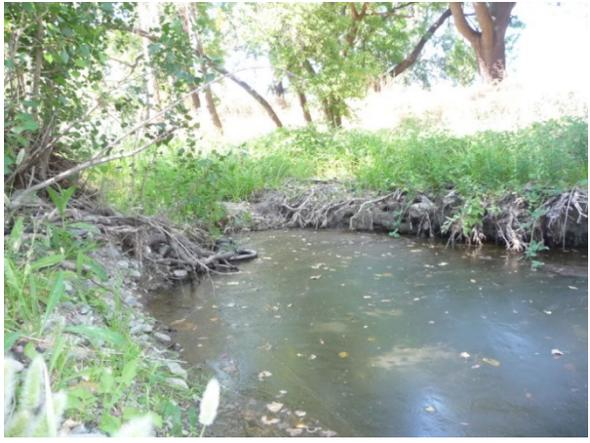
<p><b>Photo 3.</b> 2-3 ft deep headcut is found midway through Reach 2. Tree roots provide bed stability at this location and the rate of headward migration appears slow (<i>Looking upstream near the middle portion of the reach, August 4, 2010</i>).</p>	<p><b>Photo 4.</b> As a result of recent bed incision, the bankfull channel in the downstream portion of the reach is deeper and straighter than in the upstream portion. The riparian corridor remains intact, with mature native riparian trees lining the banks (<i>Looking upstream near Oakville Road, August 4, 2010</i>).</p>

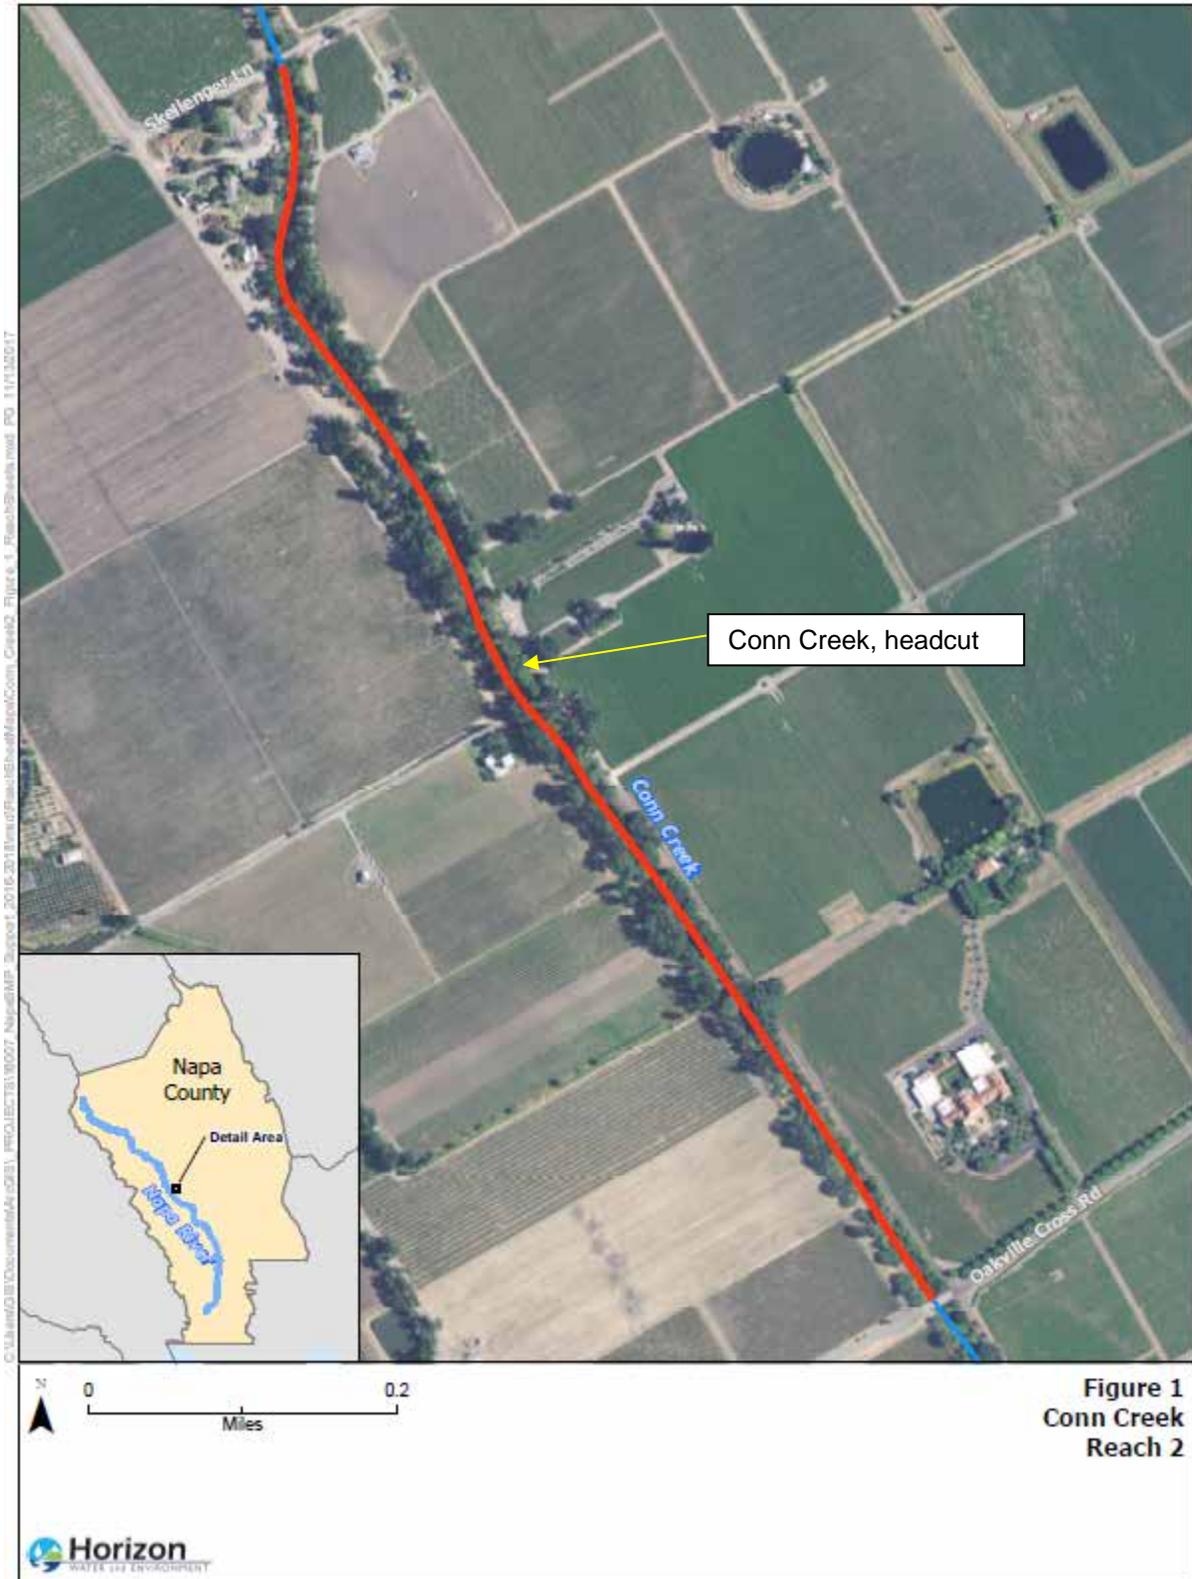
Map A. Approximate location of headcut in Reach 2 of Conn Creek.

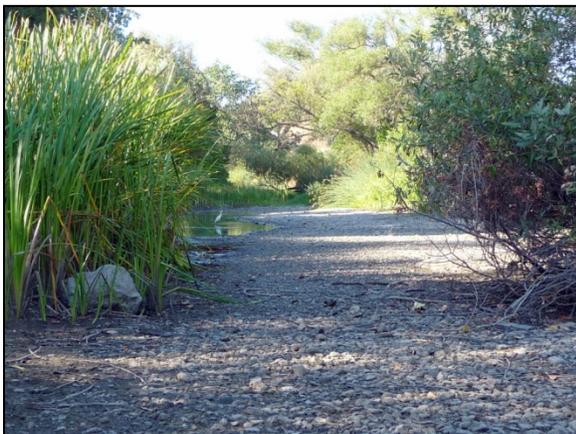
**Photo 2.** Looking upstream in the lower portion of Reach 3 (August 4, 2010).

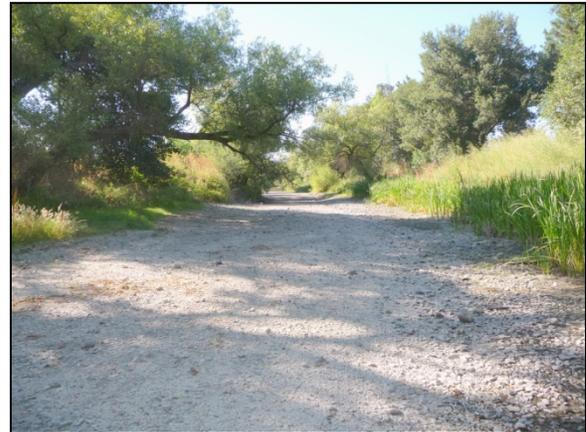
**Photo 1.** Looking upstream near the upstream end of the reach (August 4, 2010).

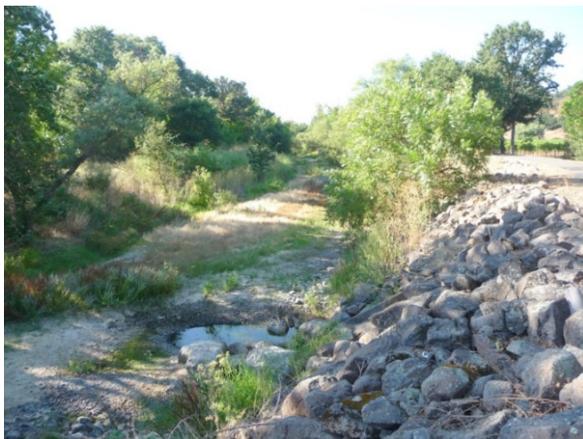
**Photo 3.** Looking upstream at the riprap section where the channel turns towards the west. Erosion-resistant riprap sloughed into the channel has resulted in some local bed scour and pooling (August 4, 2010).

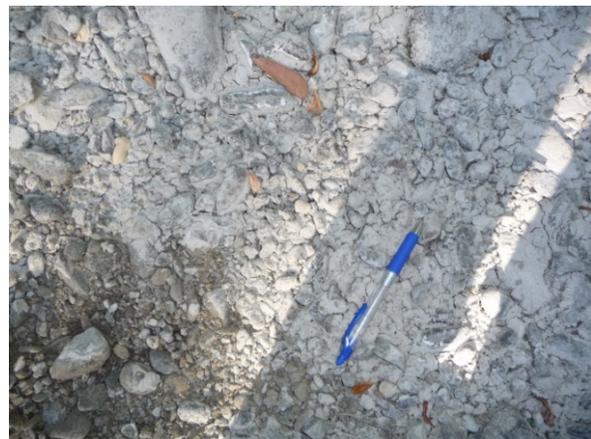
**Photo 4.** Typical streambed substrate in Reach 3. Note the algae cover on substrate (August 4, 2010).

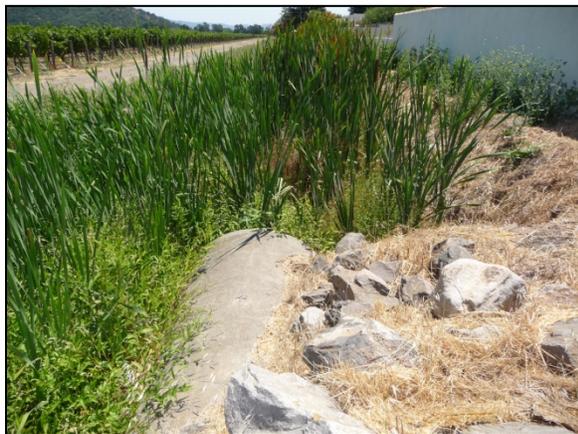
**Photo 1.** Looking downstream from Finnell Road. Dense emergent vegetation occludes the culvert at this crossing (August 4, 2010).

Channel: Vegetation in the channel is dominated by tall flat sedge (*Cyperus eragrostis*). Broad-leaved cattail (*Typha latifolia*) is dominant in the section just downstream of Finnell Road (Photo 1). Other species present include curly dock (*Rumex crispus*), rushes (*Juncus* spp.) and Italian ryegrass (*Lolium* sp.)

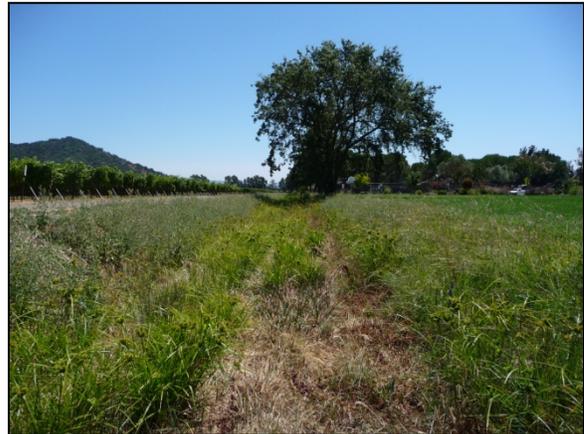
**Photo 2.** Looking downstream from the mid-point of the Beard Ditch (near Oak Circle). Photo depicts typical conditions in the reach. Adjacent land uses include vineyards along the east (left) bank and residential development along the west (right) bank (August 4, 2010).

*Aquatic or instream habitat:* Instream habitat is dominated by hydrophytic vegetation (Photo 2). The low flow channel is not well defined. There is a perennial pool at the downstream end of the reach. This pool had some small fishes present; no bullfrog (*Rana catesbeian*) tadpoles were observed.

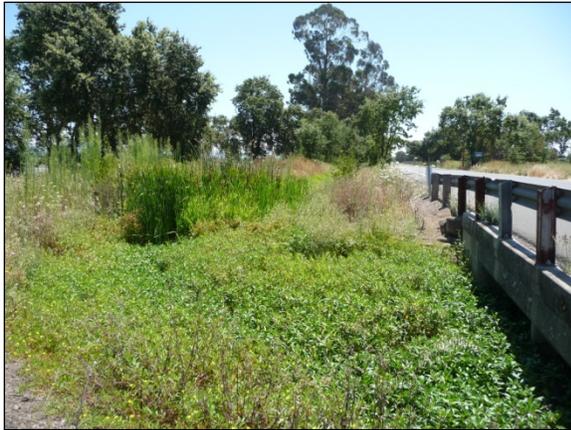
**Photo 1.** Looking downstream from upstream end of the NYC. Two concrete box culverts pass flows from the main upstream tributary into the NYC. Note the dense aquatic and emergent vegetation in the channel (August 4, 2010).

The North Yountville Collector (NYC) is a trapezoidal engineered channel that collects runoff from natural drainages, vineyards and Vintners golf course to the west. The NYC begins at twin concrete box culverts that cross under Solano Ave. (Photo 1). The NYC joins the South Yountville Collector and flows east becoming the Yountville Outfall.

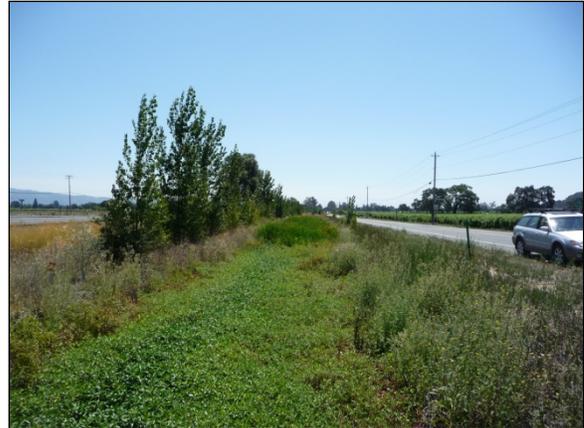
**Photo 2.** Looking downstream near Vineyard View Drive. The channel supports interspersed patches of aquatic vegetation dominated by Ludwigia (foreground) and emergent vegetation dominated by broad-leaved cattail (background). Note cottonwoods planted by District on east (left) bank (August 4, 2010).

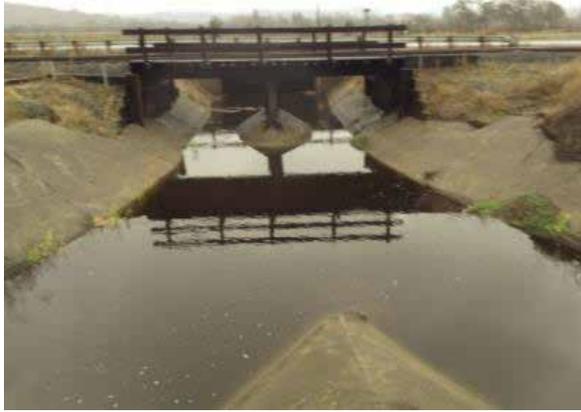
**Photo 3.** Confluence of south and north Yountville collectors Upstream of railroad bridge and Highway 29, first winter after Sediment removal project. (2014)

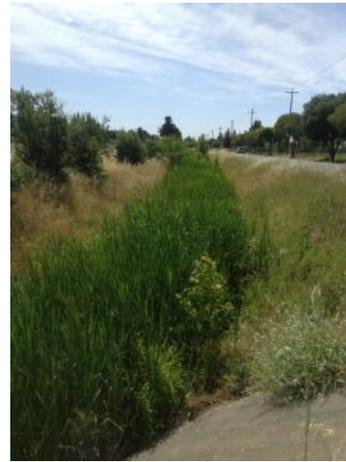
**Photo 4.** Looking downstream from Hoffman Lane (prior to cattail removal work in 2016).

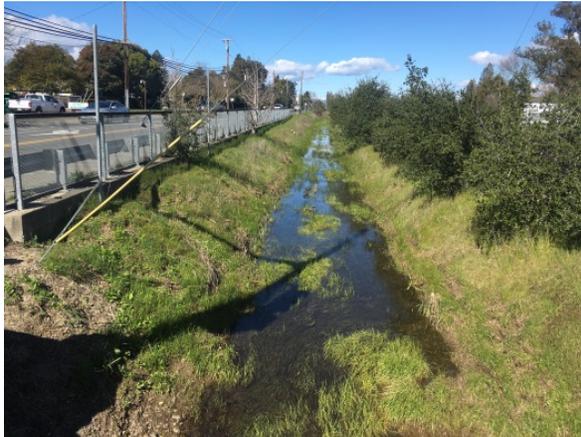
**Photo 5 (left).** Looking downstream from Hoffman Lane after cattail removal work (2016).

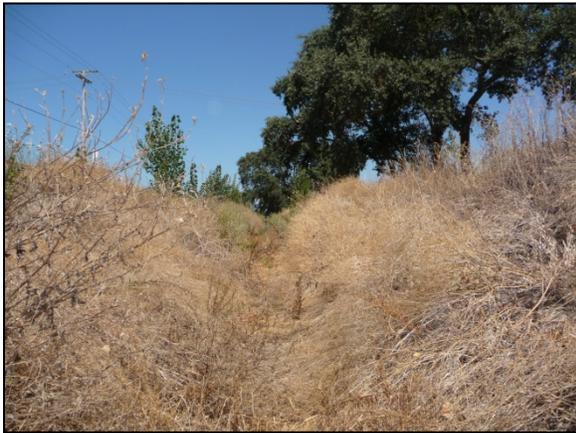
**Photo 2.** Looking downstream in the upper portion of the SYC. The channel is formed in native soils. The channel bottom and banks are dominated by non-native herbaceous vegetation (August 4, 2010).

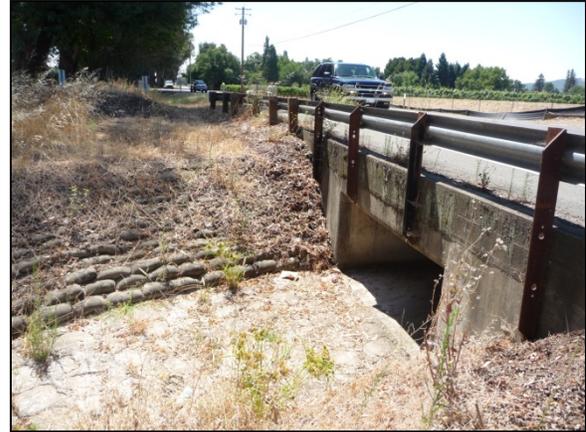
The South Yountville Collector (SYC) is a trapezoidal engineered channel that collects runoff from natural drainages and vineyards to the west. The SYC begins at a concrete box culvert that crosses under Solano Ave. (Photo 1). Reach 1 of the SYC flows for approximately 2,760 ft. before a major tributary enters from the west, which marks the transition to SYC – Reach 2.

**Photo 1.** Upstream end of the SYC. A concrete box culvert passes flows (beneath Solano Ave.) from an unnamed tributary to the west into the SYC (August 4, 2010).

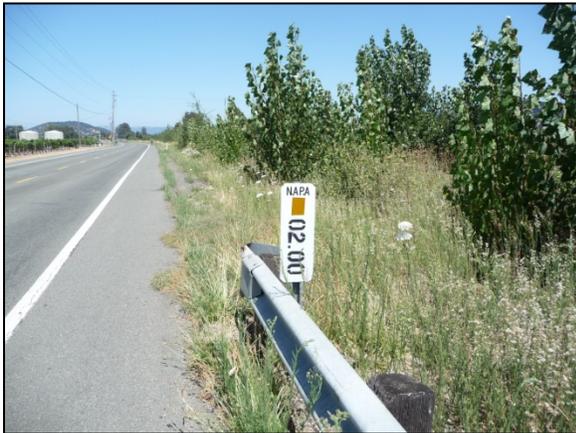
**Photo 1.** Upstream end of the SYC- Reach 2. The culvert at Mile Marker 2.0 marks the upstream end of the reach. Note the cottonwoods planted along the channel (Looking downstream, August 4, 2010).

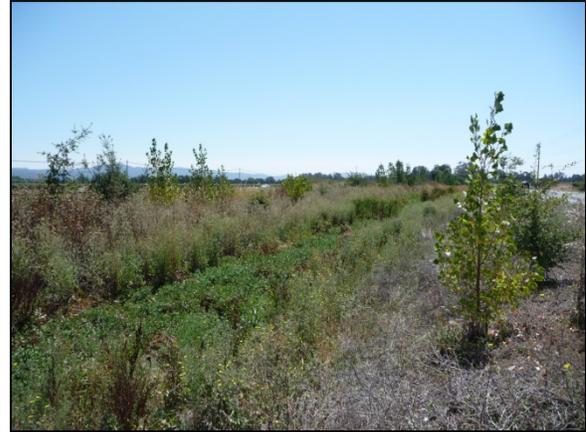
**Photo 2.** Looking upstream in the mid-portion of SYC Reach 2. The channel is formed in native soils. Dense aquatic vegetation, such as *Ludwigia*, grows in the channel (August 4, 2010).

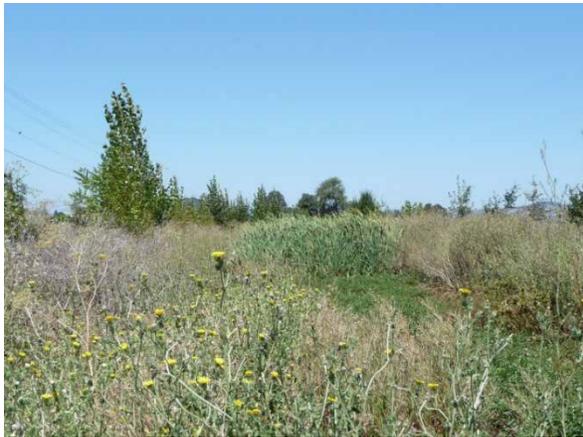
**Photo 3.** Looking upstream from mid-reach area. Note the cottonwoods planted along banks and cattails in channel (August 4, 2010).

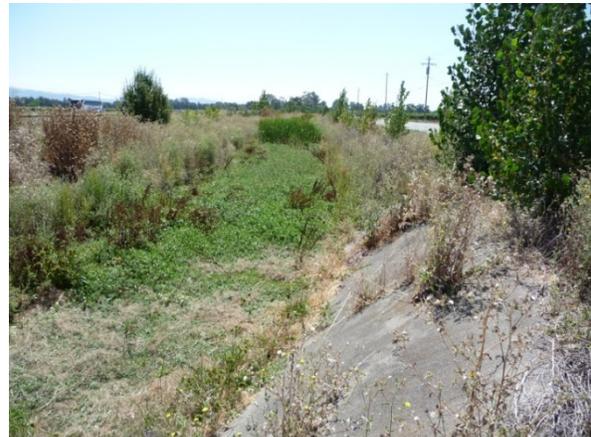
**Photo 4.** Looking upstream from the confluence with the Yountville Outfall. Note dense *Ludwigia* in the channel (August 4, 2010).

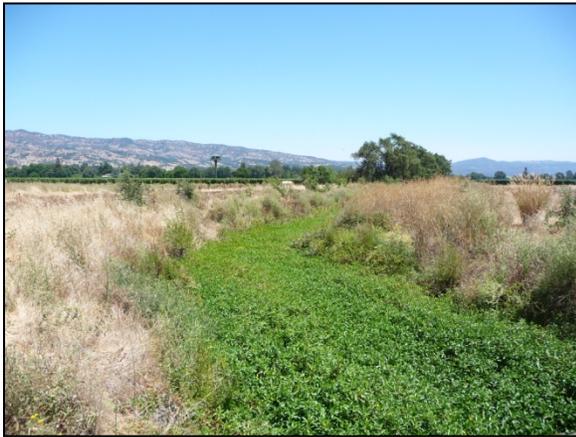
**Photo 1.** Looking downstream from upstream end of the Yountville Outfall near Hwy 29. Note the dense aquatic vegetation in the channel (August 4, 2010).

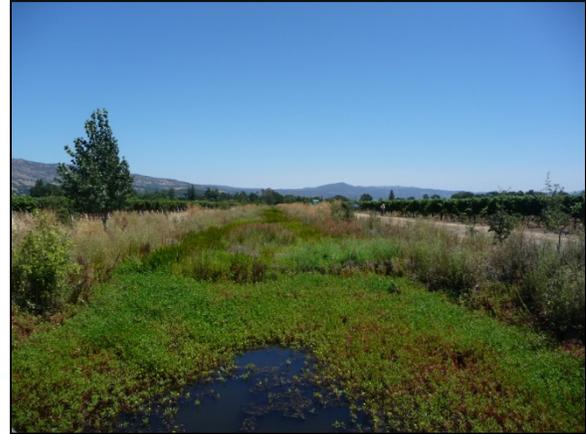
**Photo 2.** Looking downstream from a bridge approximately 500 feet downstream of Hwy 29. The channel is dominated by aquatic vegetation (predominantly *Ludwigia*). Large instream bars collect sediment. The District has planted native trees along the channel (August 4, 2010).

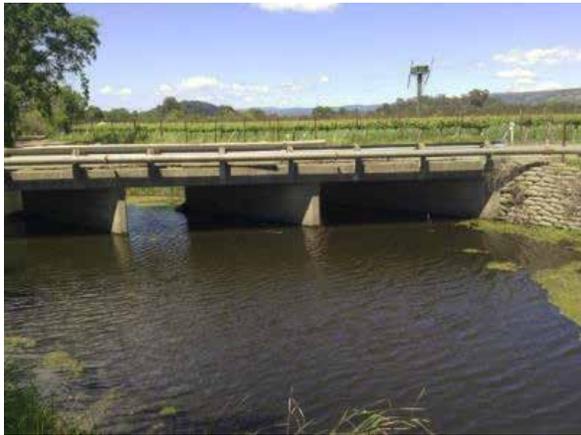
**Photo 3.** Agricultural bridge.

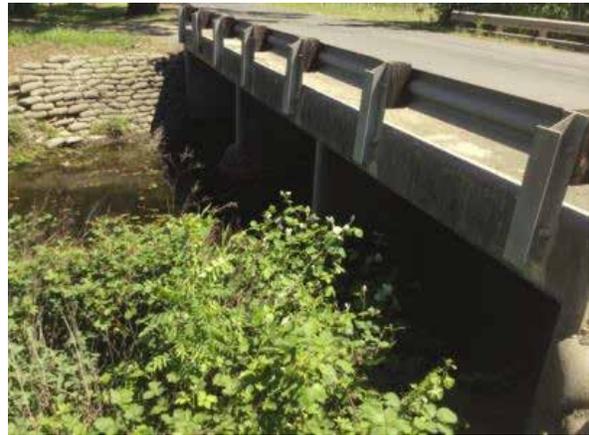
**Photo 4.** Ragatz Lane bridge at upstream end of the reach.

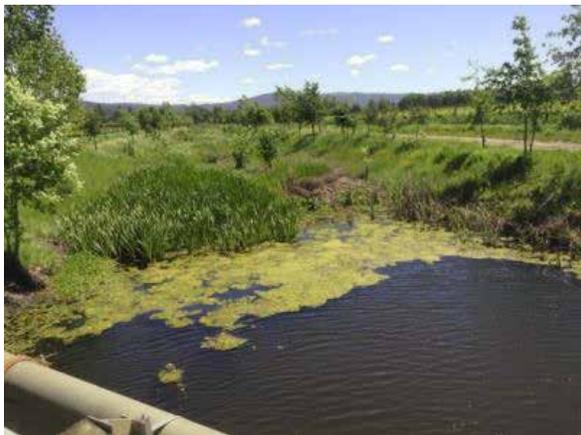
**Photo 5.** Sediment deposition downstream of agricultural bridge.

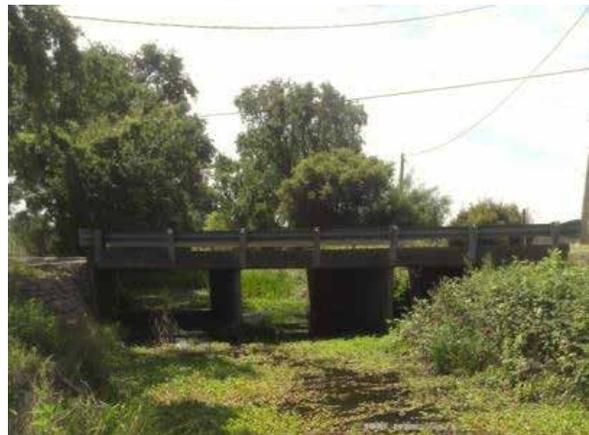
**Photo 6.** Ragatz Lane box culvert with invasive *Ludwigia* colonizing channel upstream.

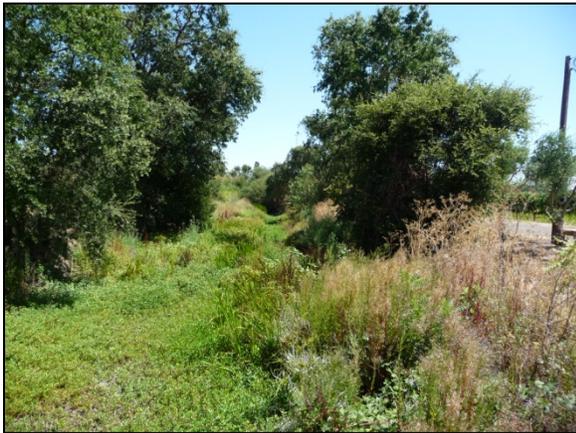
**Photo 1.** Looking downstream from Ragatz Lane. Note the well-established trees along the riparian corridor (August 4, 2010).

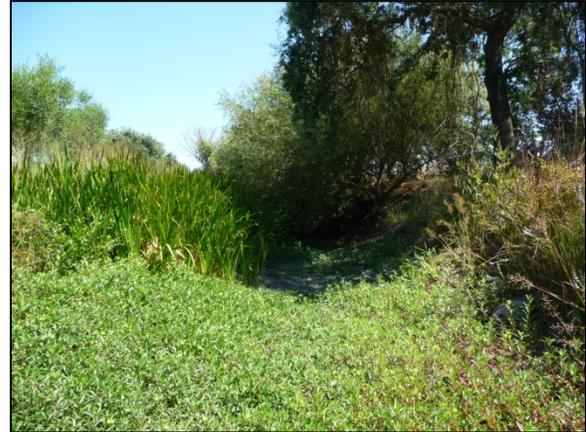
**Photo 2.** Typical conditions in the upper portion of the reach (Looking downstream from approximately 200 feet downstream of Ragatz Lane bridge). The channel bed is dominated by aquatic vegetation (predominantly *Ludwigia*). Native trees form a relatively well established riparian corridor (August 4, 2010).

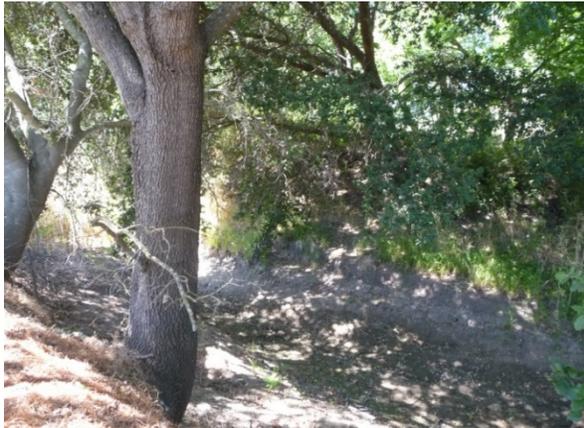
**Photo 3.** A relatively dense riparian canopy shades portions of the channel (*Looking upstream, August 4, 2010*)

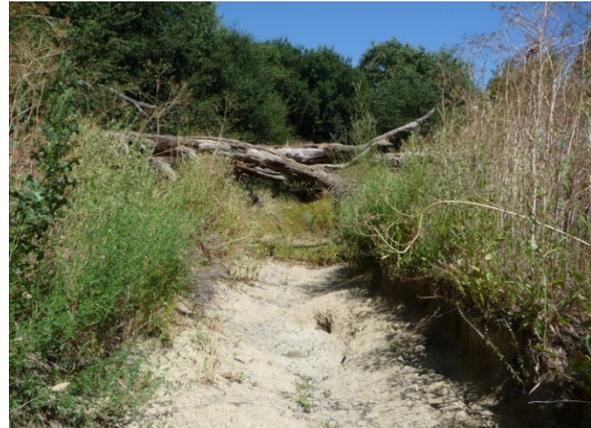
**Photo 4.** In the downstream portion of the reach a bankfull channel has formed within the larger flood conveyance channel; note large woody debris crossing channel (*Looking downstream near Trubody Lane, August 4, 2010*).

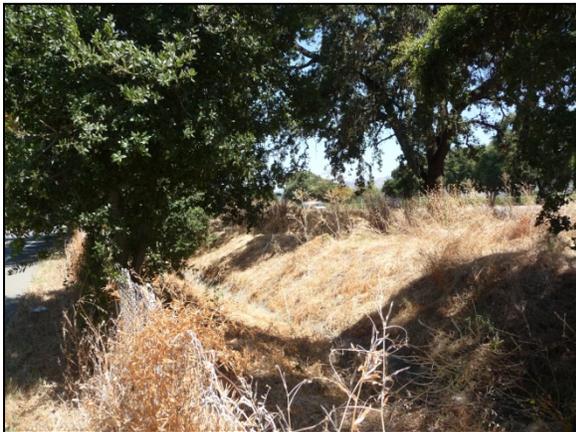
**Photo 1.** Looking downstream near Oak Knoll Ave [Solano Ave to west (left)]. Mature oaks grow along the upstream portion of the Solano Ditch corridor (August 4, 2010).
