## **Napa County Stream Maintenance Manual**

*Prepared for:*

Napa County Flood Control and Water Conservation District  
804 First Street  
Napa, CA 94559  
Contact: Michael Gordon, Watershed and Flood Control Resource Specialist  
707/259- 8684

January 2019

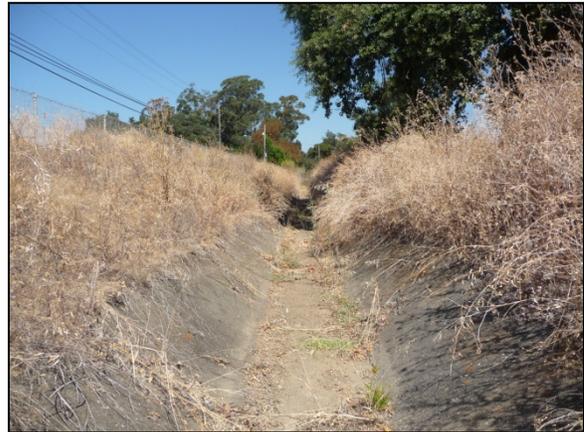
**Photo 2.** Looking downstream from the mid-point of the Solano Ditch. The channel bottom and low banks are lined with concrete. The upper banks are formed in native soils. Vegetation on the upper banks consists of non-native herbaceous species (August 4, 2010).

**Channel processes:** Runoff and fine sediment are transported from adjacent vineyards, natural drainages, and roadways to the west into the channel. The concrete lined channel appears to efficiently convey runoff and sediment; no significant deposition was observed (Photo 2).

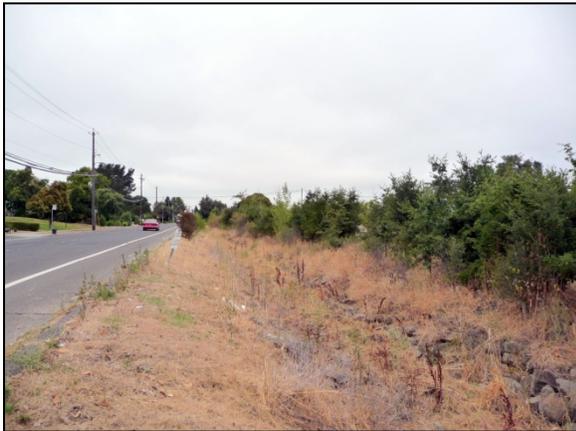
**Photo 1.** Reach 1 is an intermittent stream that is dry much of the year. In channel vegetation is dominated by mesic species. Riparian trees, predominately oaks, planted by the District line the east side of channel (right side of the photo) (Looking upstream from mid-point in the reach, August 4, 2010).

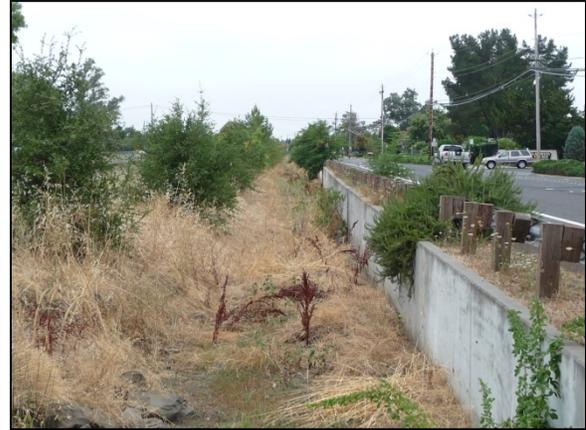
**Photo 2.** Looking downstream from Luke Road (Solano Ave to west (left). Note riparian enhancement plantings (primarily oaks) on the left bank and retaining wall on right bank (August 4, 2010).

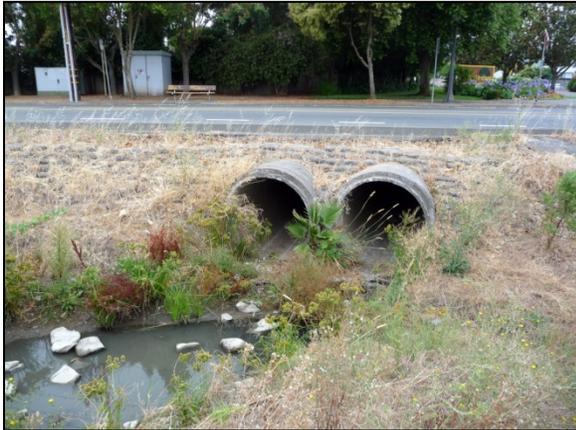
**Photo 1.** Near the upstream end of Reach 2, two 60-inch concrete culverts deliver flows from upper Salvador Creek, which originates in the Mayacamas Mountains to the west (August 4, 2010).

The North Salvador Collector (NSC) is a linear trapezoidal engineered channel that collects runoff from vineyards and natural drainages to the west. Reach 2 of the NSC begins at the Salvador Ave. crossing. Approximately 60 feet downstream of the crossing, twin concrete culverts enter the channel from the west (right bank, Photo 1). These culverts convey flows from a culverted reach of (upper) Salvador Creek. Downstream, Reach 2 joins the South Salvador Collector and then flows east beneath Hwy 29, becoming (lower) Salvador Creek.

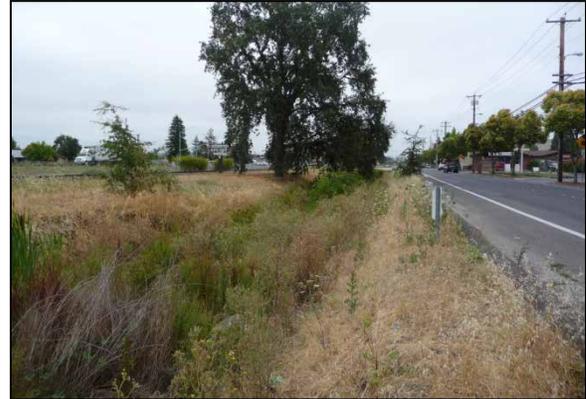
**Photo 2.** Looking downstream near the mid-point Reach 2. Reach 2 NSC collects more runoff than Reach 1 NSC. Consequently, hydrophytic vegetation is present through most of the channel (August 4, 2010).

**Water quality:** Some areas of ponding were observed in Aug 2010. Water clarity appeared poor-fair at the upstream end (Photo 2), and good at the downstream end. Small areas of sheen were observed (less than 5 ft<sup>2</sup>).

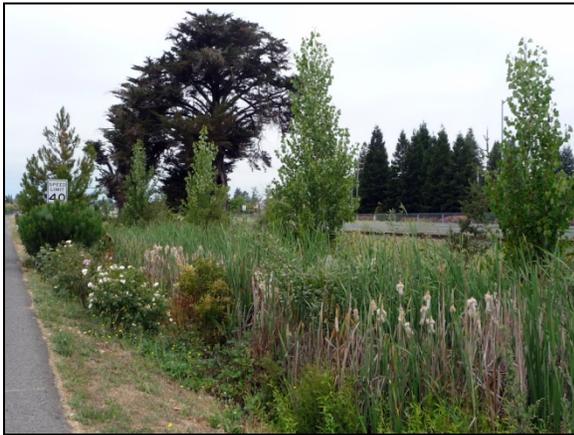
**Photo 1.** Typical section of the SSC (Looking downstream from upper portion of the reach; August 4, 2010). Note dense emergent vegetation growing in the channel.

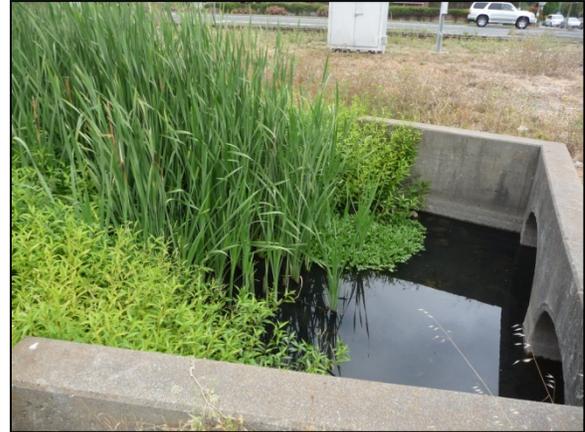
**Photo 2.** Culvert outlet at upstream end of the SSC. Water clarity at this location was good (August 2010). Note emergent vegetation growing immediately downstream of outfall.

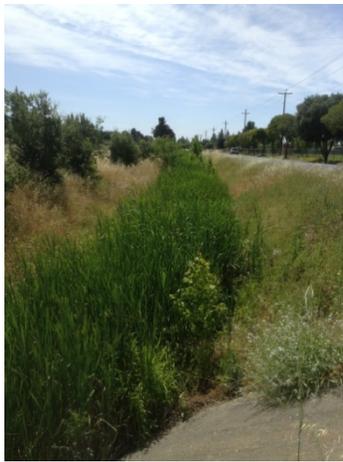
**Photo 3.** Looking downstream at cattails from Trower Avenue. (2014)

In 2014, the District conducted cattail removal along a 300-foot section of channel near Trower Avenue. Photos 3 and 4 show before and after images of the cattail management area. 2016 maintenance work included cattail removal (1,000 linear feet), invasive plant removal (25 cubic yards), and blackberry removal (10 cubic yards).

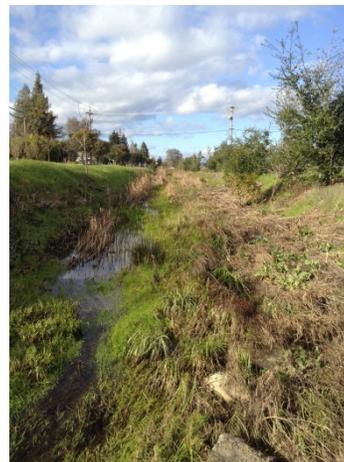
**Photo 4.** Looking upstream at cattail management area after cattail removal. (2014)

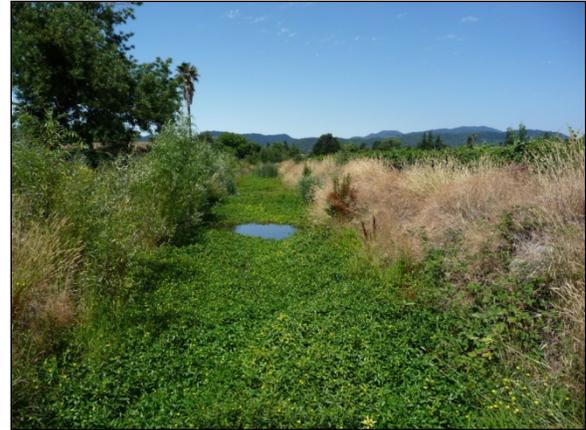
**Photo 2.** Looking upstream from a bridge approximately 1,600 ft downstream of Hwy 29. Dense growth of *Ludwigia* covers the channel. The District has planted native trees along the south bank (right side of photo) (July 2010).

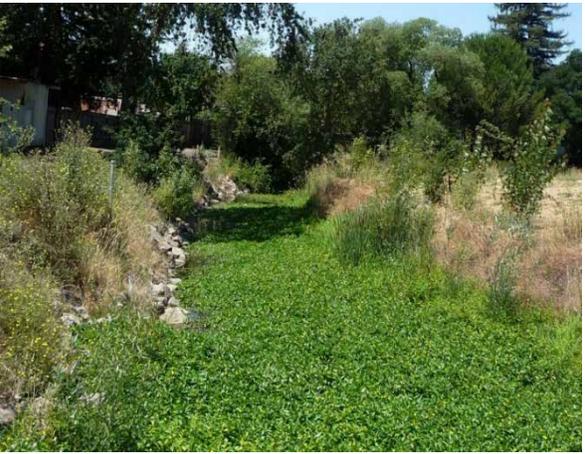
<p><b>Photo 3.</b> Looking downstream from a bridge approximately 1,600 ft downstream of Hwy 29 (July 2010).</p>	<p><b>Photo 4.</b> Looking upstream from Jefferson St. Note riprap at the toe of slope on south bank (left side of photo) (July 2010).</p>

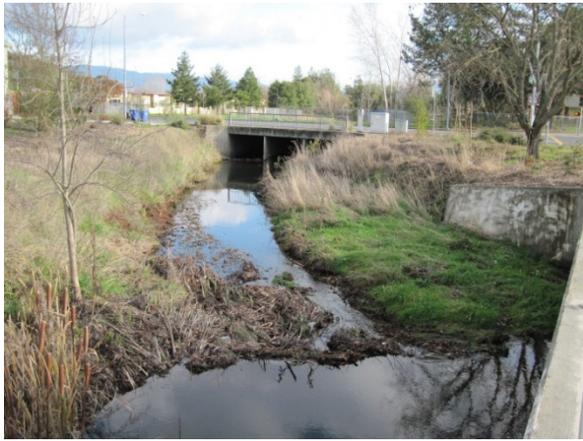
**Photo 5.** Sediment accumulation along the south bank (right side of photo) between Jefferson St. and Trower Ave. (December 2009).

There is sediment accumulation in the short section between the Jefferson Street and Trower Ave. crossings (Photo 5), including some culvert blockage at the Trower Ave. crossing. The sediment at these locations was targeted for removal during the summer of 2012. The underlying cause of sediment deposition at this site (as shown in Photo 5) is the widening of the overall channel area between the Trower Ave. and Jefferson St. This channel section is culverted and the combination of the slight gradient, widened channel, and channel bend (creating a point bar on the inner bend between Jefferson St. and Trower Ave. has resulted in the observed deposition.

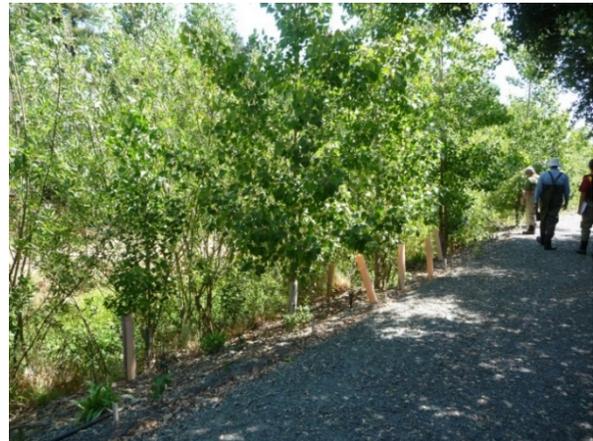
**Photo 6.** Extensive planting of native trees along the south (right) bank (July 2010).

The District has taken steps to enhance ecological conditions in this reach through extensive planting of native trees (Photo 6). Additional planting was conducted in 2013. There is dense growth of aquatic vegetation in the reach. *Ludwigia* management strategies could be considered, along with other management approaches for the existing invasive plant species. In 2016, recent maintenance activities included downed tree removal (Photos 7 and 8), vegetation management (10 cubic yards), invasive plant removal (24 cubic yards), and removal of blackberry bushes (30 cubic yards).

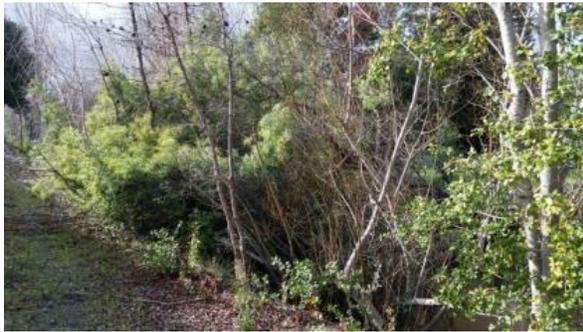
**Photo 7.** Looking upstream at downed tree crossing creek at Valencia St. (2016)

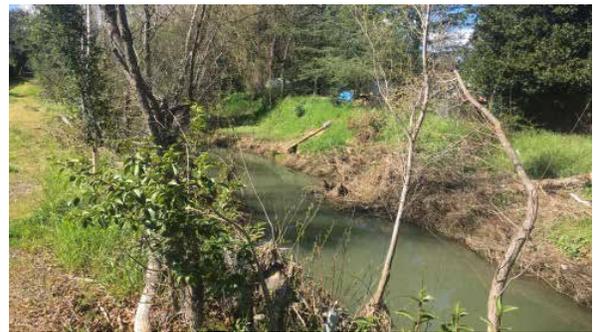
**Photo 8.** Looking upstream at downed tree removal site at Valencia St. (2016)

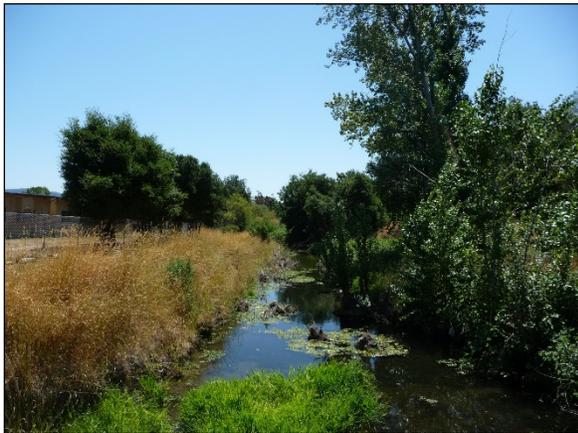
**Photo 1.** Typical conditions in the upstream portion of the reach. Water is pooled downstream due to beaver dam seen in Photo 2 (*Looking downstream from Trower Ave, July 8, 2010*).

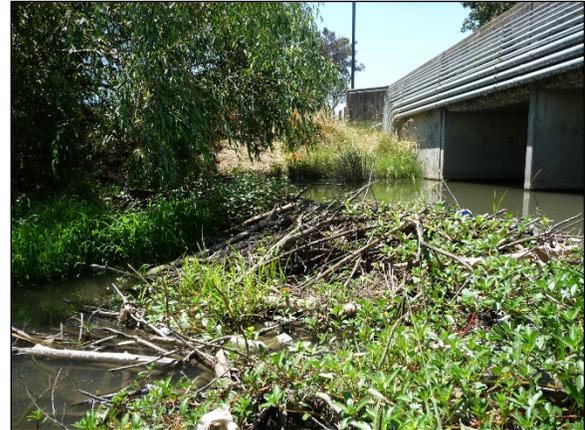
**Photo 2.** The first beaver dam located approximately 600 ft downstream of Trower Ave. Dam pools water upstream as seen in Photo 1 (*July 8, 2010*).

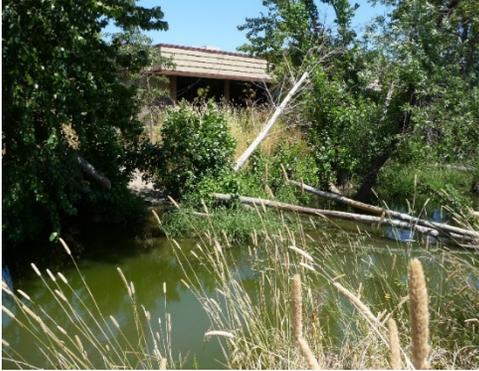
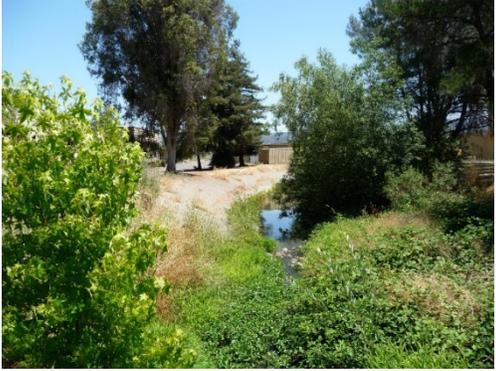
<p><b>Photo 3.</b> Downed trees crossing the channel from beaver activity (July 8, 2010).</p>	<p><b>Photo 4.</b> Looking downstream from a bridge in the lower portion of the reach. Note concrete lining on north bank (left side of photo) (July 8, 2010).</p>

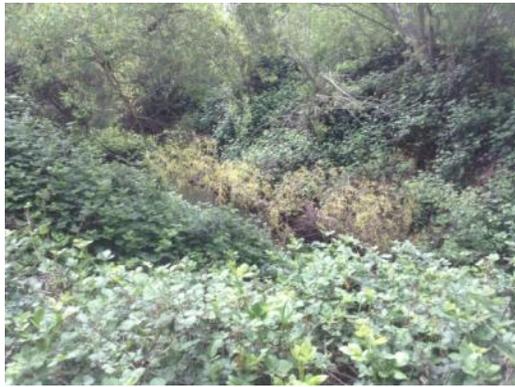
**Photo 5.** Looking downstream at non-native invasive blackberry and willows in channel. (2016)

In 2014, maintenance work completed included vegetation management (20 cubic yards), invasive plant removal (24 cubic yards), and blackberry bush removal (30 cubic yards) at Jefferson Street. In 2016, recent maintenance activities conducted within this reach included vegetation management (20 cubic yards), removal of invasive plants (30 cubic yards), and removal of blackberry bushes (30 cubic yards) at Jefferson Street (see Photos 5 and 6).

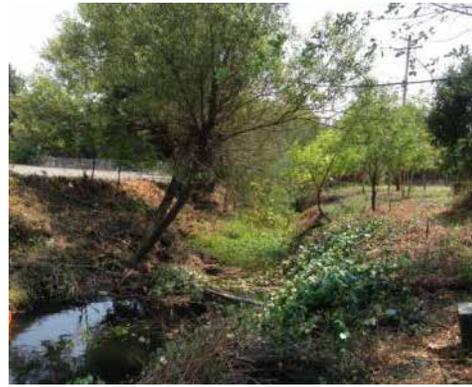
**Photo 6.** Looking downstream after willow pruning and blackberry removal. (2016)

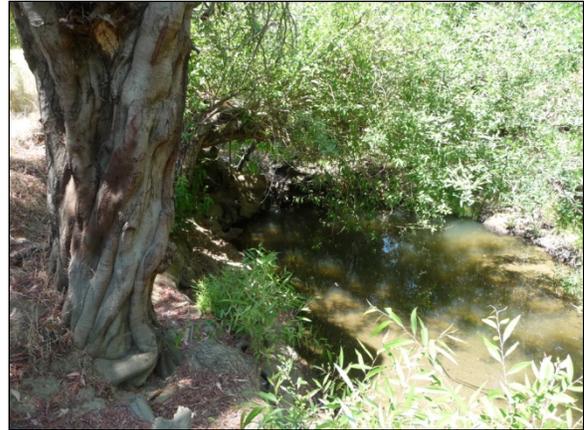
**Photo 2.** An active headcut marks the upstream extent of the incised portion of the reach (Looking upstream, July 8, 2010).

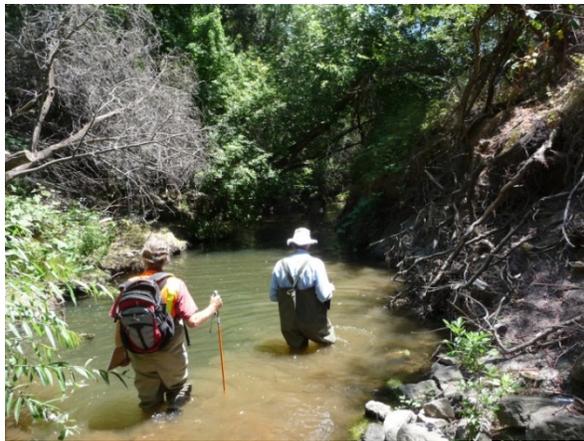
**Photo 3.** Typical conditions in the lower portion of the reach, with deep pools and undercut streambanks (to right). (Looking downstream, July 8, 2010).

Compared to upstream Reaches 1 and 2, Reach 3 of Salvador Creek is a more natural channel that flows through a well established riparian corridor. The upstream portion of Reach 3 has dense riparian vegetation on both banks and relatively good floodplain connectivity. Bank angle and height gradually increase in the downstream direction. The downstream portion of the reach is deeply incised with very steep streambanks (Photos 3, 4 and 5). Many streambanks are highly unstable (Photo 5).

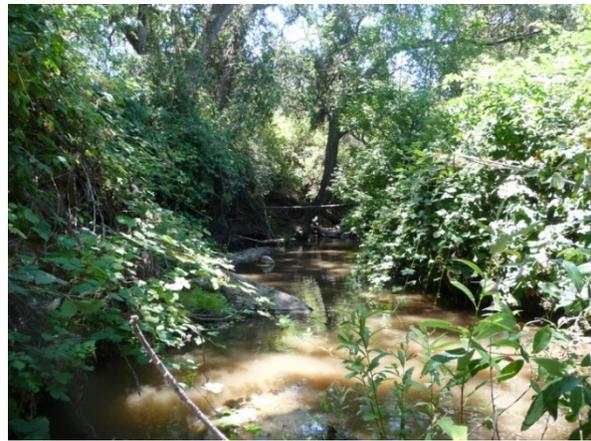
**Photo 4.** Looking upstream from Big Ranch Road. Note streambank erosion on left side of photo, undercutting the streambank (July 8, 2010).

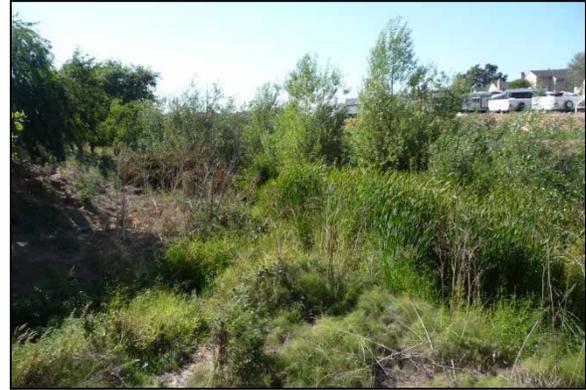
**Photo 2.** Near confluence of Camille Creek, the more natural Tulocay Creek section transitions to a more modified flood control type channel (Looking downstream from the Tulocay-Camille Creek confluence, September 2010).

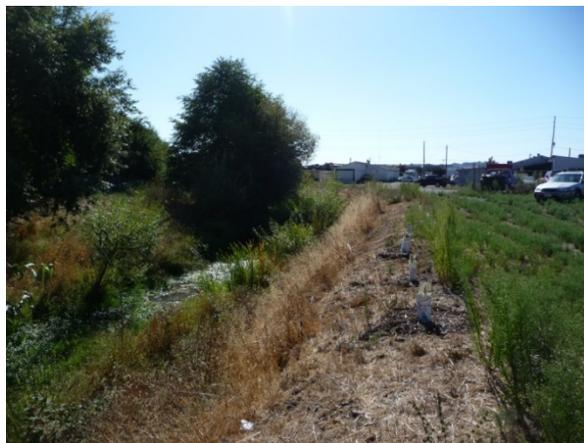
**Photo 3.** Tulocay Creek - typical channel conditions between Camille Creek and Soscol Ave. (Looking downstream, September 22, 2010).

Reach 1 Tulocay Creek begins as a natural/semi-natural channel surrounded by residential development. The channel appears to have been modified in the past, but has recovered from historical disturbance. There is well developed instream and riparian habitat in this portion of the reach (Photo 1). This condition persists for approximately 500-700 ft as the creek gradually transitions to a more modified channel with uniform bed and banks. Between the confluence of Camille and Soscol Ave (Map A), the creek is a highly modified drainage channel, with the exception of the well-established riparian trees on the south (left) bank (Photo 3).

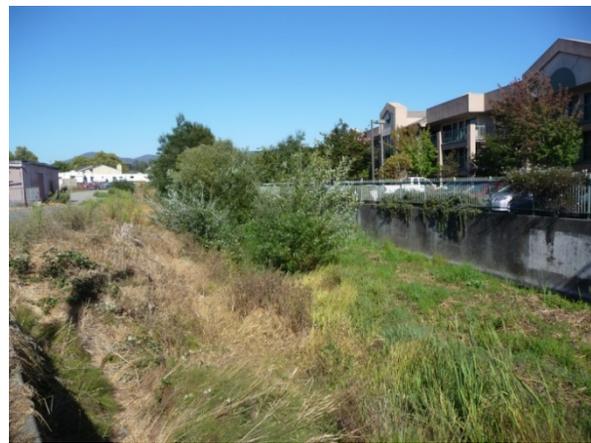
**Photo 4.** Looking upstream from Soscol Ave crossing. Abundant sediment collects in a large and well developed mid channel bar (sediment wedge). Vegetation grows on deposited sediment, debris is caught on bar too. September 22, 2010).

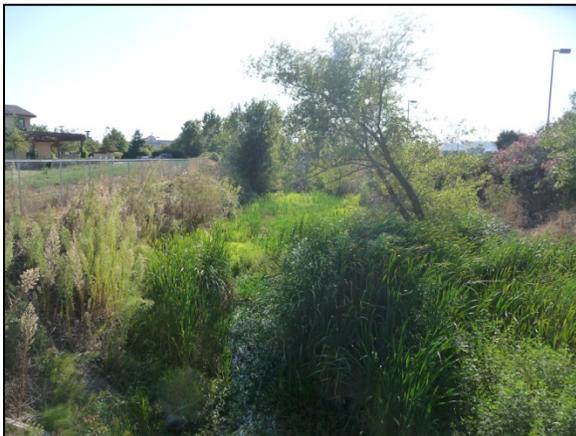
**Photo 1.** Looking downstream from Soscol Ave. abundant in-stream vegetation over deposited sediment. (September 22, 2010).

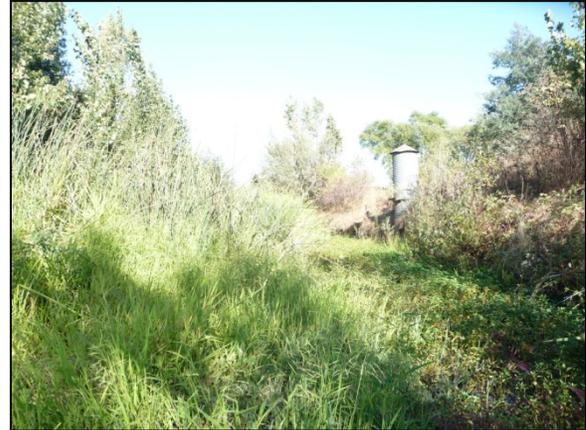
**Photo 2.** Looking upstream in the upper portion of the reach, Dense aquatic and emergent vegetation in the upstream portion of the reach. Note USGS gauging station on right side of photo (September 22, 2010).

**Bank structure:** The channel has 15-18 ft high earthen banks that slope more gently along northern bank 2:1 to 3:1, and steeper at outer bend on south bank 1:1 to 2:1 where bank erosion is observed just upstream of the USGS gage (Photo 5).

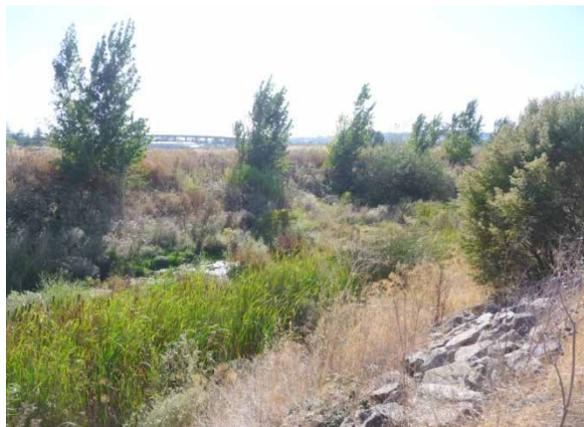
**Photo 3.** Typical channel conditions near the mid-point of the reach. Note, some isolated sections of riprap are found along the banks (*Looking downstream, September 22, 2010*).

Overstory: Extensive planting of native trees along both banks; predominantly cottonwood (*Populus fremontii*). These trees are well established and thriving (Photos 3 and 4).

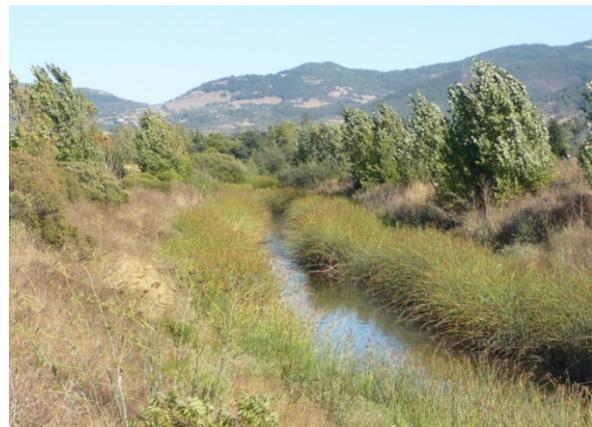
**Photo 4.** Bulrush line the lower channel banks in the tidal portion of the reach. Cottonwoods have been planted along the upper banks throughout the length of the reach (*Looking upstream from the UPRR bridge., September 22, 2010*).

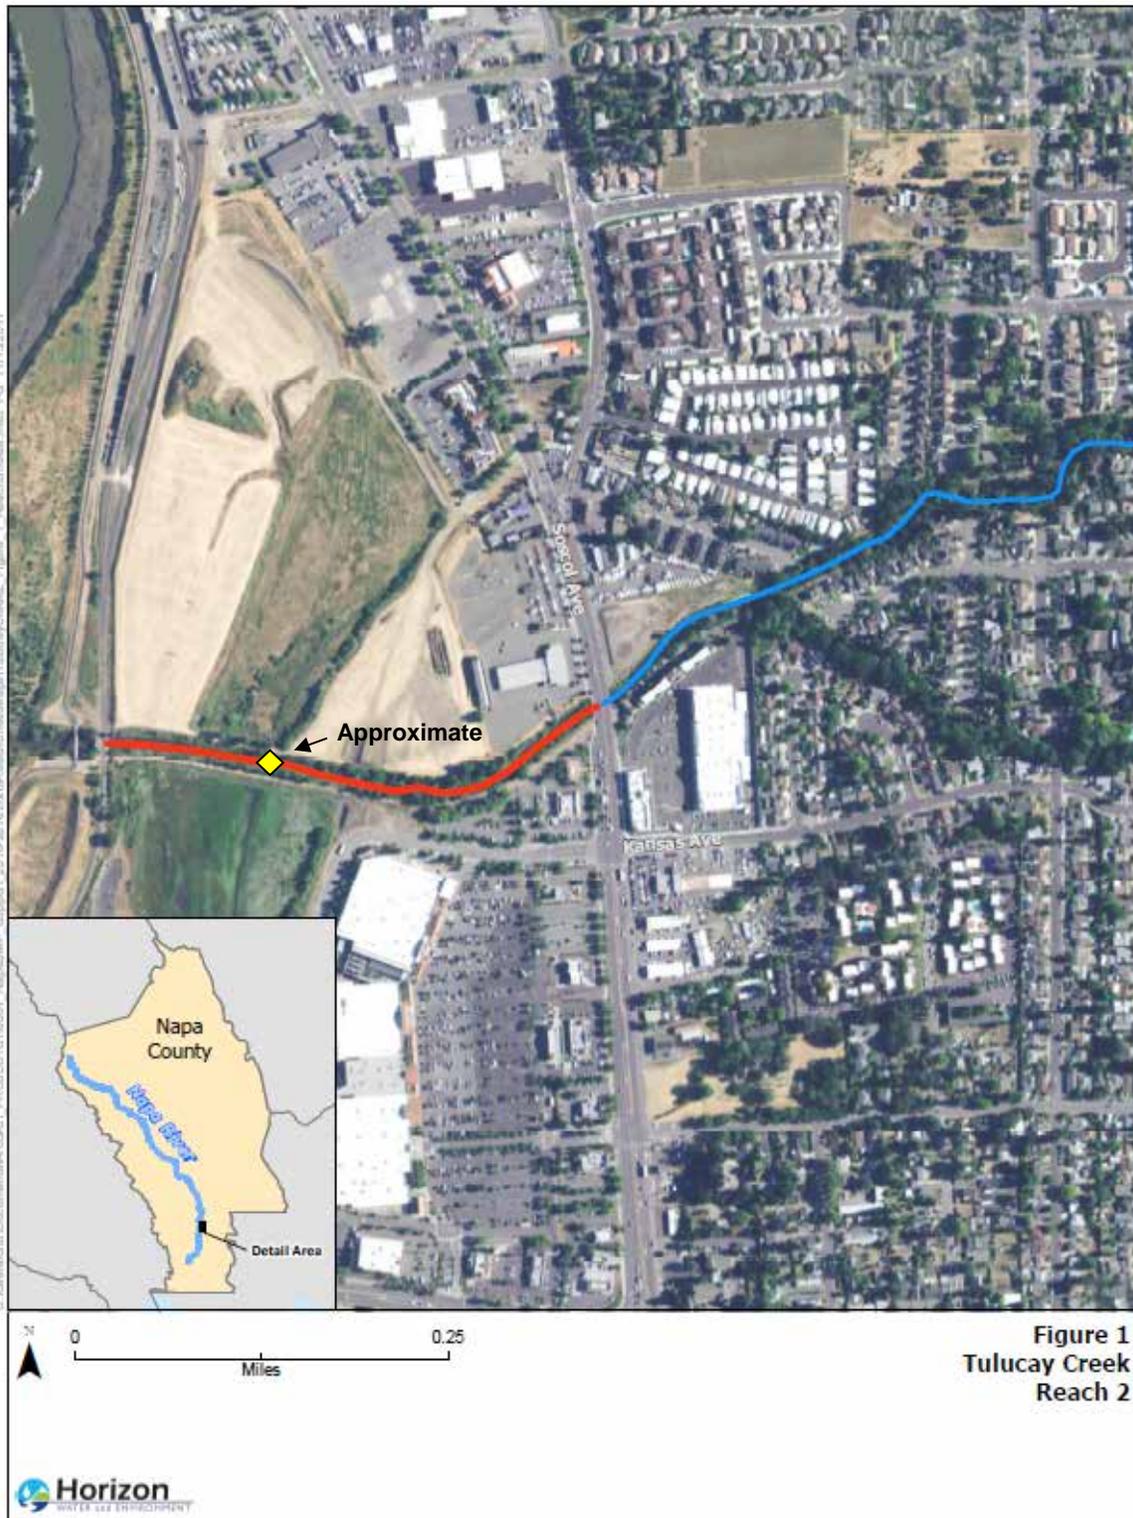
Figure 1  
Tulocay Creek  
Reach 2

**Map A.** Reach 2 of Tulocay Creek is depicted as the red line above. Reach 2 begins at Soscol Ave. and extends downstream to the UPRR bridge. The approximate extent of tidal influence is denoted above.

Reach 2 of Tulocay Creek is a modified drainage channel with uniform bed and banks. The upper 2/3<sup>rd</sup> of the reach is a freshwater drainage; the lower 1/3<sup>rd</sup> is a tidally influence brackish channel (Map A). There is commercial development adjacent to the channel in the upper 400 ft of the reach (Map A); in the downstream portion the adjacent land use is largely open space, areas that may serve as a floodplain for the Napa River.

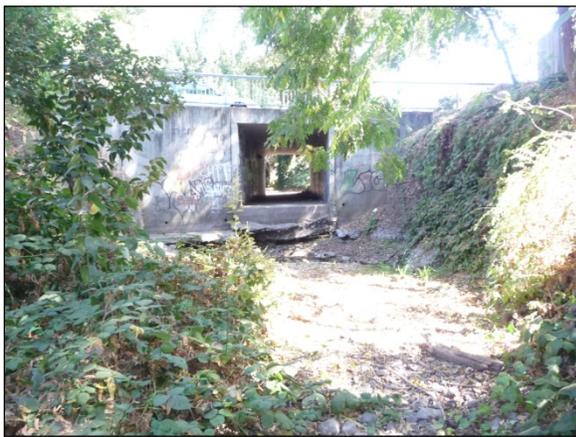
**Photo 1.** Looking upstream at the South Terrace Road culvert crossing. Note the significant drop in bed elevation at the culvert and steep streambanks bounding the channel (September 2010).

Camille Creek is a natural channel tributary to Tulocay Creek. The upstream portion of the reach is deeply incised with very steep streambanks (Photos 1 and 2). Bank angle and height gradually decrease in the downstream direction (Photos 3 and 4). The reach has good riffle-run habitat and a well established riparian corridor.

**Channel processes:** The channel has incised over the last several decades as evidenced by the perched culvert and steep banks in the upstream portion of the reach (Photo 1). The streambed appears to have stabilized more recently with no apparent localized degradation (e.g., headcuts) observed. During large flow events, discharges exiting the culvert at South Terrace Road likely have the potential to cause significant bed and bank erosion.

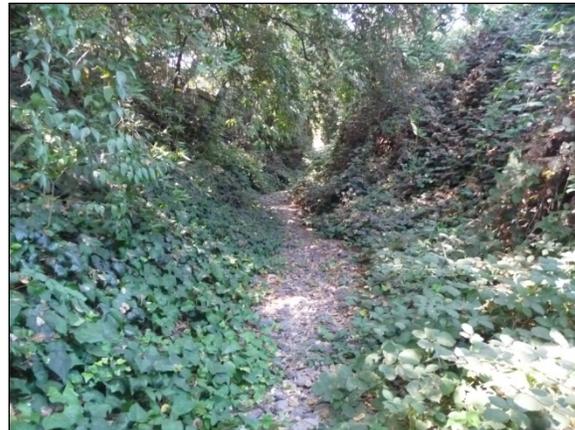
**Photo 2.** Looking downstream near South Terrace Drive. Note the well defined low flow channel, coarse bed material and steep streambanks (September 2010).

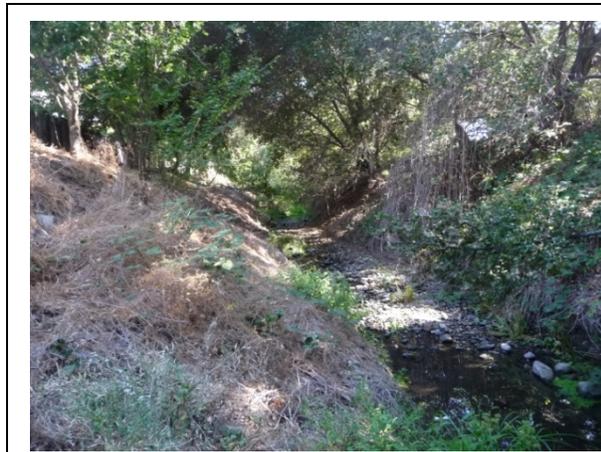
**Photo 3.** Typical conditions in the middle portion of the reach (Looking upstream, September 22, 2010).

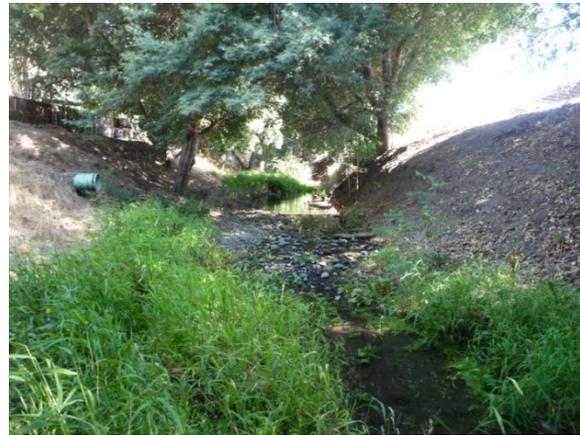
**Photo 4.** Typical conditions in the lower portion of the reach (Looking upstream, September 22, 2010).

**Banks:** Understory: English ivy is dominant in the upper section. Himalayan blackberry (*Rubus discolor*) and stinging nettle (*Urtica dioica*) are also common. Streambanks in the lower section are often bare ground (Photo 4).

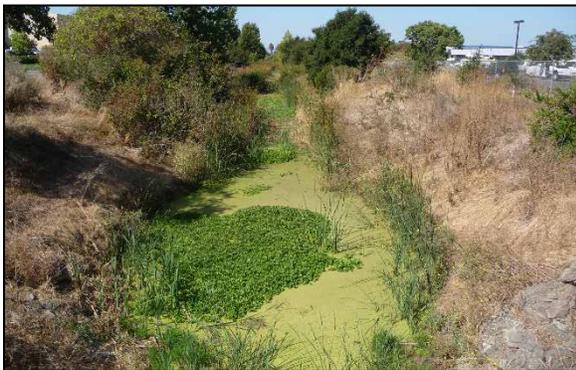
**Photo 1.** Looking downstream (west) from the bridge at North Kelly Road (September 2010). Stagnant water and poor water quality observed.

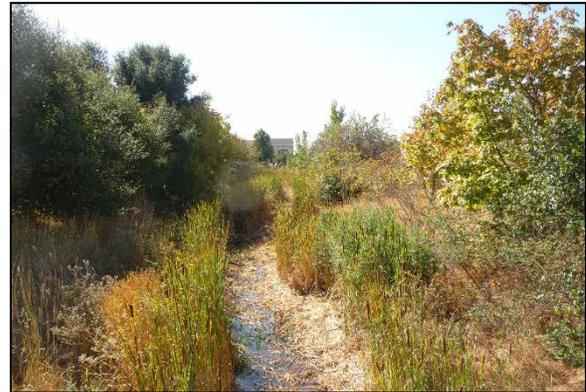
**Photo 2.** Looking upstream from the pedestrian footbridge in the middle portion of the reach. Note well established riparian plantings on both banks (September 2010).

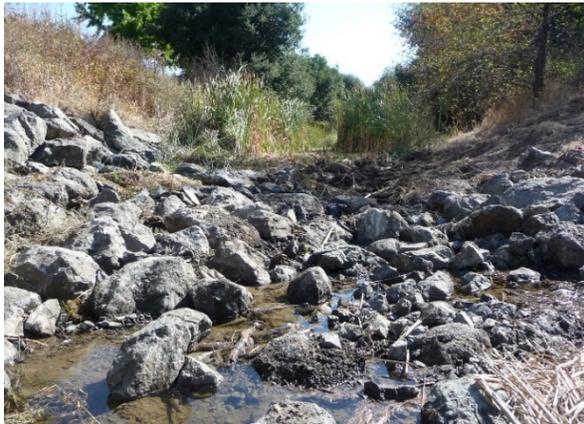
**Photo 3.** Looking upstream near Highway 29 crossing. Recent riprap was placed along banks and channel bed. Channel bed and riprap crossing create depositional area upstream where sediment accumulates and cattails grow (September 22, 2010).

In 2010, bank stabilization work was performed at the downstream end of the reach (Photos 3 and 4). Cattails in the middle of the main channel are mowed on a routine basis. In 2016, 250 linear feet of cattails were removed.

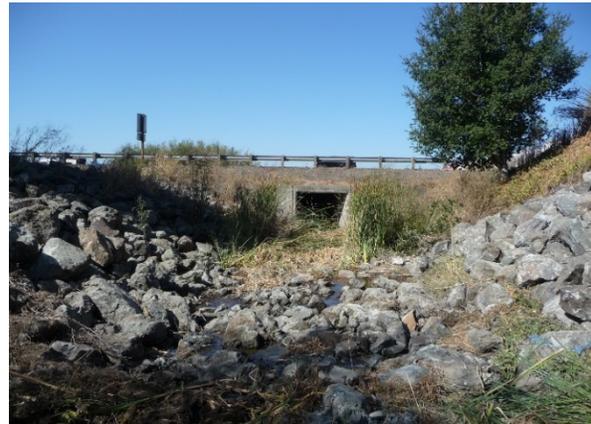
**Photo 4.** Recent bank stabilization work performed by District included riprap placement upstream of the Highway 29 culvert crossing (view is looking downstream, September 22, 2010).

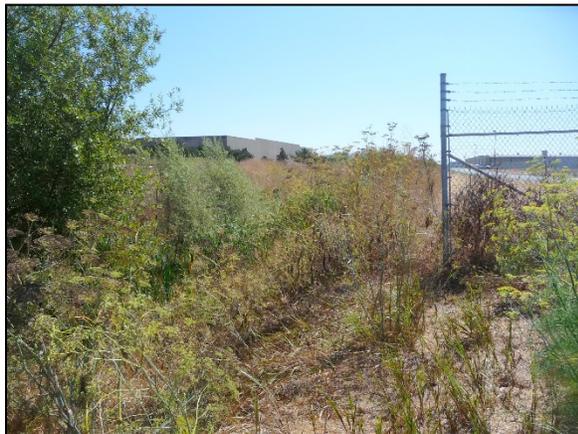
**Photo 1.** Looking upstream from Airport security fence in the upper portion of the reach. Areas upstream of this point were not surveyed by foot due to access limitations, but from a distance, this section appeared to be of similar character to the channel immediately downstream (September 22, 2010).

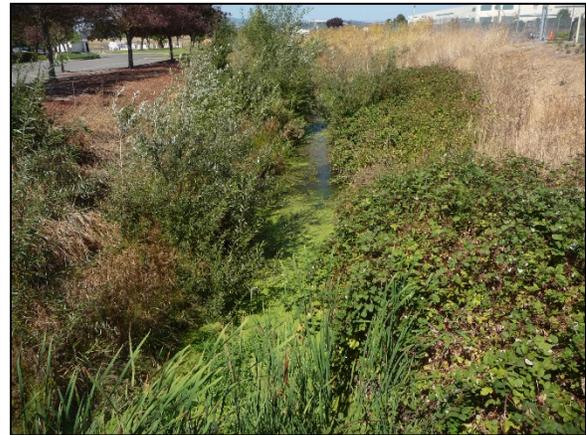
**Photo 2.** Looking downstream from the bridge at Airport Road. Note willow and blackberry growing on channel banks. (September 22, 2010)

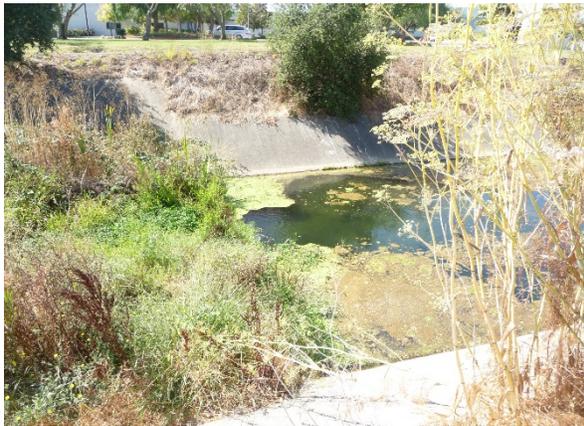
**Photo 3.** A sediment “plug” has accumulated upstream of a concrete-reinforced cross-section of the channel. (Looking west, September 2010).

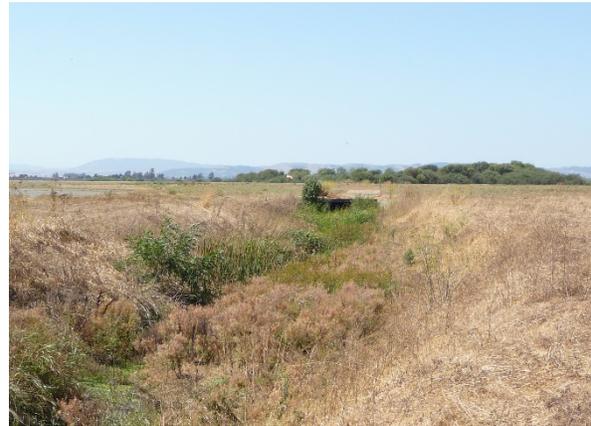
**Photo 4.** In the lower portion of the reach the open channel transitions to a culverted section (background) that flows beneath the airport runways (Looking west, September 22, 2010).

The District-maintained portion of Fagan Creek is a trapezoidal engineered channel. The entire reach lies adjacent to or within the boundaries of the Napa County Airport. The upper 3,400 ft is open channel, which transitions to a 1,350 ft culverted section that flows underneath the airport runways, followed by 600 ft of open channel that discharges to Fagan Slough (Map A). Fagan Slough is a tidal channel that is tributary to the Napa River. The Fagan Creek

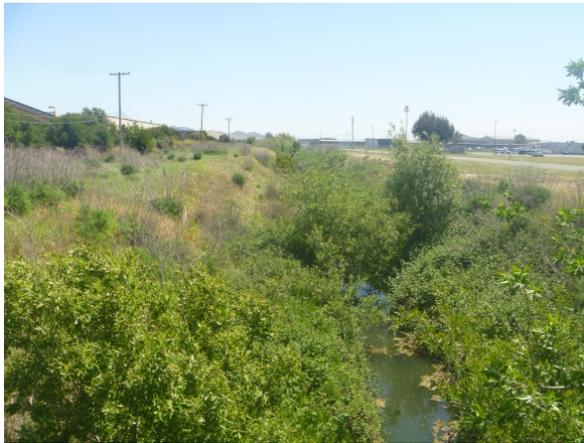
**Photo 5.** Looking upstream at blackberry along banks near Airport Blvd. (2014).

Based on a channel inventory completed in 2014, maintenance needs identified for Fagan Creek included removal of blackberry bushes and revegetating the banks with native plants, willow pruning every two years, and monitoring the creek for erosion and sedimentation issues every 5 years. The District should also continually monitor the culvert underneath the airport runway, box culvert under road crossing and the railroad abutment. 2014 maintenance activities included vegetation management (10 cubic yards), blackberry bush removal (8 cubic yards) (see Photos 5 and 6). Similar maintenance activities took place in 2016.

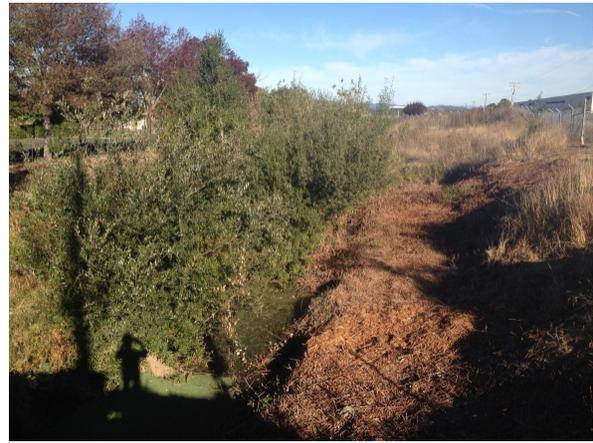
**Photo 6.** Looking downstream after blackberry removal near Airport Blvd. (2014).

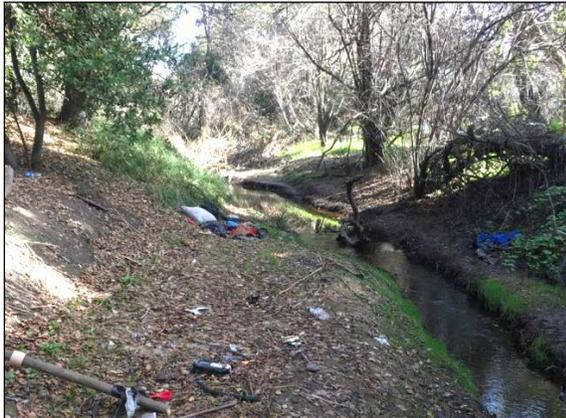
**Photo 1.** Looking upstream in the middle portion of the reach with well-defined channel structure and well-developed riparian canopy. Impairments frequently include trash and trampled understory vegetation (*February 2018*).

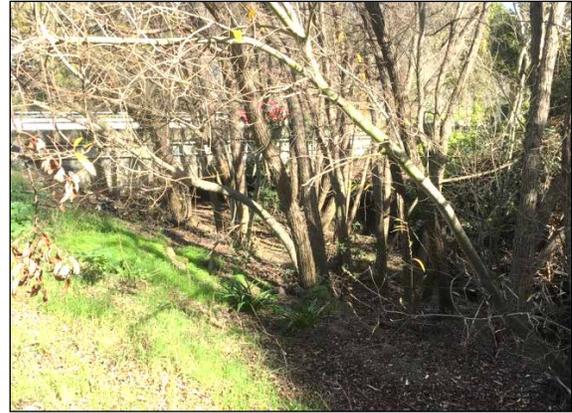
**Photo 2.** Dense willow growth along the floodplain bench immediately downstream of the American Canyon Road bridge (background) near Silver Oak Trail. Sediment appears to be aggrading as a result of willow growth obstructing flow (*February 2018*).

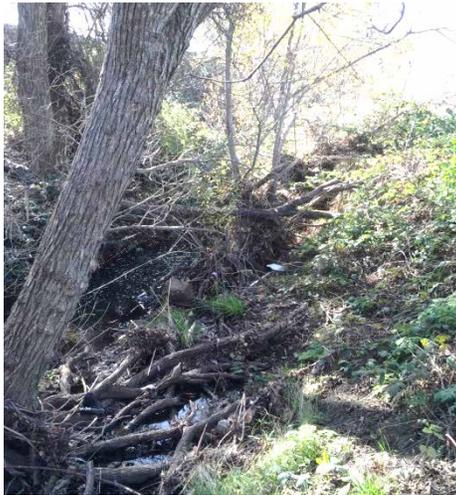
**Photo 3.** Section of the creek with a constricted channel and dense non-native blackberry along the banks. (February 2018)

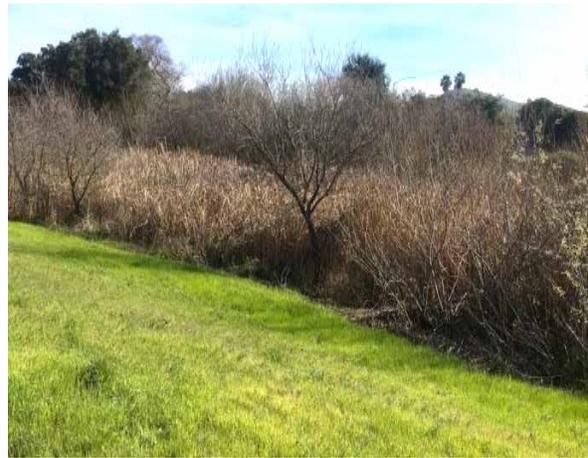
**Photo 4.** In-channel basin near the confluence with Newell Creek. Dense emergent vegetation (consisting mostly of cattails) fill the basin (February 2018).

**Basins:** The sediment basins along American Canyon Creek feature dense stands of bulrushes (*Schoenoplectus acutus*) and cattails (*Typha latifolia*). Basins appear to be relatively homogenous in shape, without any notable gaps in the vegetation cover.

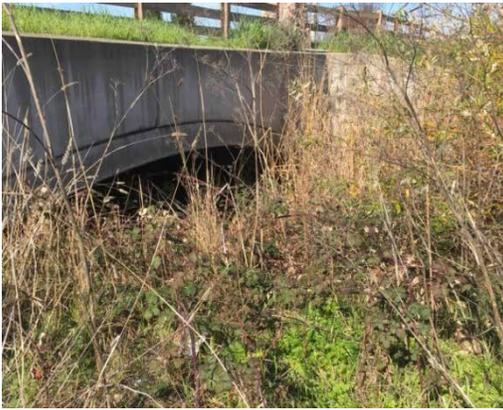
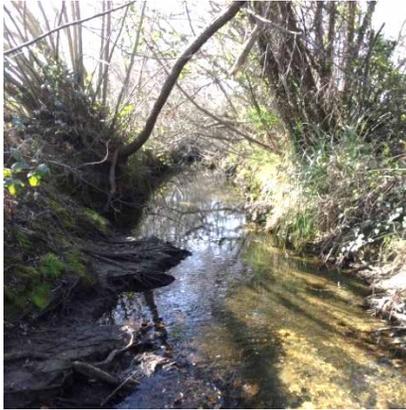
<p><b>Photo 5.</b> Sediment accumulation and vegetation encroachment upstream of the crossing of Newell Drive at American Canyon Road. (February 2018)</p>	<p><b>Photo 6.</b> Example of well-defined channel and riparian vegetation along the banks looking downstream. Few branches are low enough on these mature willows cause to cause significant flow constrictions. (February 2018)</p>

Sediment routinely accumulates at several bridge crossings. The underlying causes of sediment deposition at these sites are a combination of factors. Upstream of the crossing on American Canyon Road, a near 90 degree bend in the channel creates a depositional point bar on the inner bend. Downstream of the crossing, mature willows appear to be causing local eddying and sediment deposition. Farther downstream at the lower end of the reach, sediment accumulation appears to be caused by the natural widening of the channel cross-section and a decrease in channel slope.

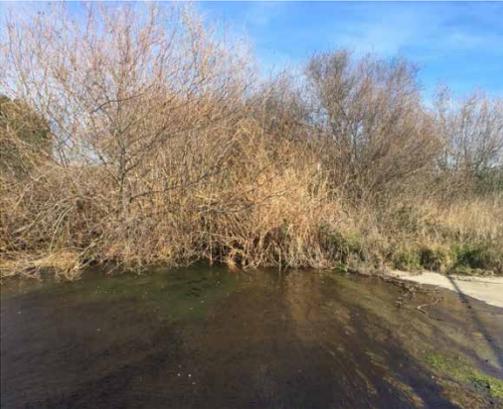
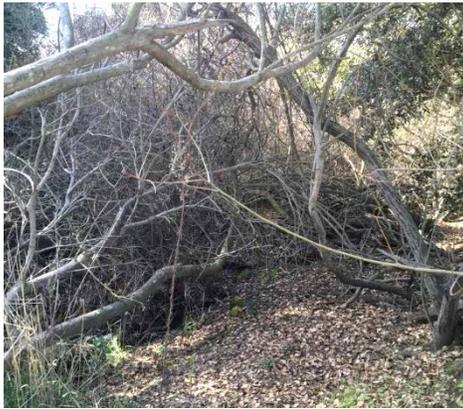
<p><b>Photo 7.</b> Looking upstream from the concrete apron at the Elliot Drive bridge crossing. Aggraded sediment and dense vegetation significantly reduce the conveyance capacity of the channel (February 2018).</p>	<p><b>Photo 8.</b> Dense willow growth obstructs a significant portion of the channel upstream of Broadway Road (February 2018).</p>

The reach has numerous locations where vegetation management would alleviate flow constrictions and reduce flood risks. In most instances, management of non-native vegetation (such as Himalayan blackberry and Pampas grass) and selective willow pruning (removing only lower branches and retaining mature willow habit) would increase the flow conveyance of the channel while providing riparian habitat for wildlife. Periodic removal of cattails from the constructed basins along American Canyon Creek would restore capacity of the features. This vegetation management would typically involve manual cutting and removal of the cattail biomass. Sediment removal at the constructed basins may also periodically be necessary to restore their intended function.

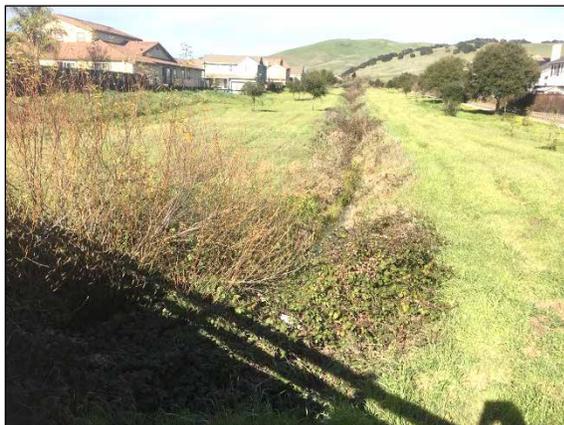
**Photo 1.** Looking upstream from Shenandoah Drive. This reach is a modified, straight, earthen channel. The banks support mostly grasses and herbaceous vegetation (March 2018).

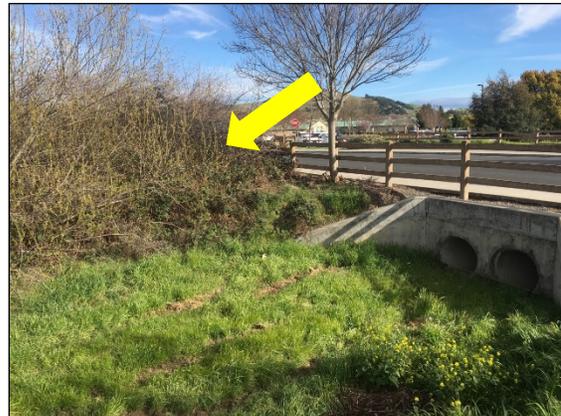
**Photo 2.** Dense willow growth (as indicated by the arrow) is causing a significant flow obstruction within the main channel upstream of Silver Oak Trail. The culverts in the foreground provide overflow capacity (March 2018).

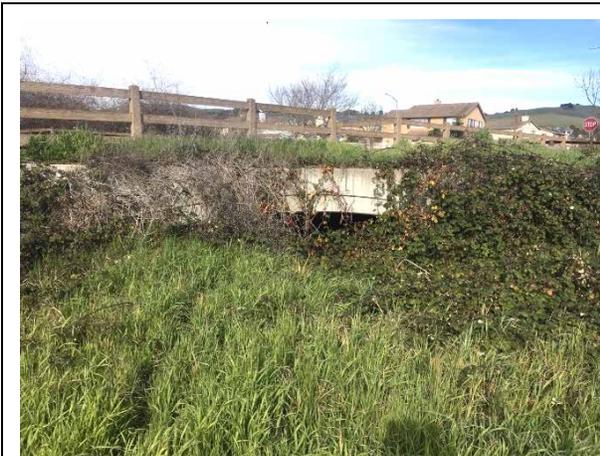
**Photo 3.** Downstream face of the Silver Oak Trail crossing. Non-native blackberry constrict the crossing opening and reduce conveyance capacity (March 2018).

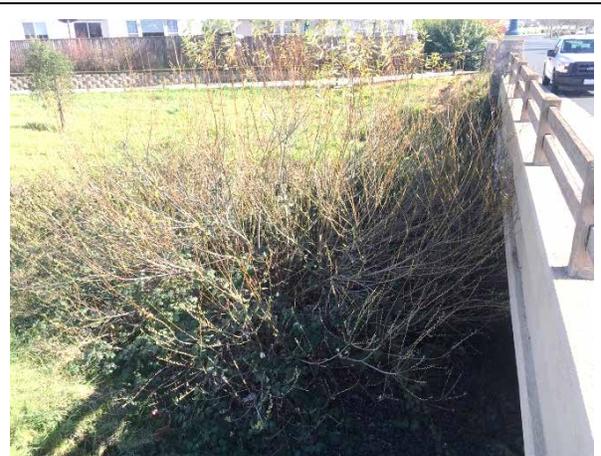
**Photo 4.** Dense willow growth upstream of the Shenandoah Drive bridge (March 2018).

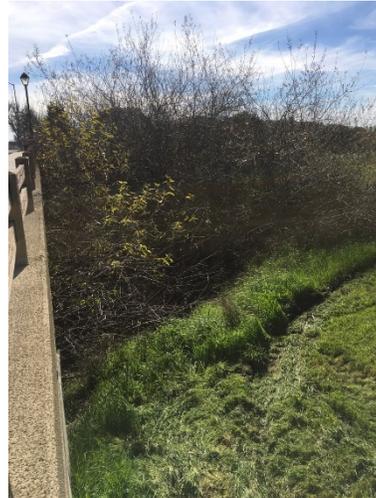
**Photo 6.** Willows are relatively sparse throughout the reach, but they are present at nearly every bridge undercrossing where they have the potential to cause significant flow constrictions. (*February 2018*).

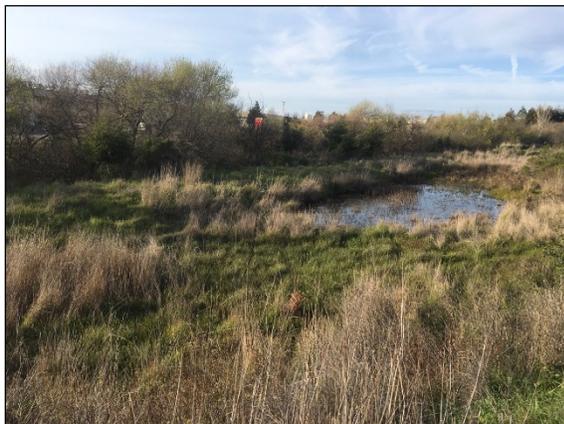
**Photo 1.** The downstream portion reach of North Slough is well vegetated and has generous, high quality buffer lands immediately adjacent to the channel. This section contains several constructed off-channel basins (March 2018).

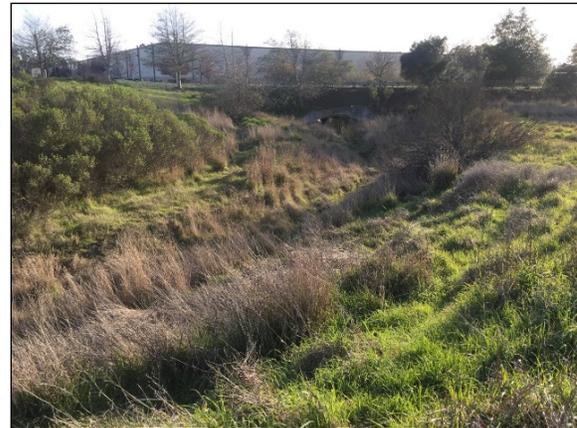
**Photo 2.** A swale has formed outside of the high earthen banks through middle section of the reach near Commerce Boulevard. The buffer separates the channel from a complex of warehouses (March 2018).

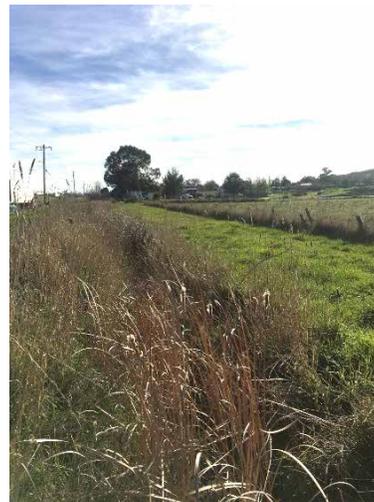
**Photo 4.** One of the minor stormwater ditches draining into North Slough near Highway 29. Cattail growth is abundant throughout ditch (February 2018).

There seems to be limited need for sediment removal in the reach at present. Small ditches feeding into North Slough around Hwy 29 may benefit from vegetation management in lieu of sediment removal. Downstream of the bridge on Commerce Boulevard, heavy vegetation growth and about 1-foot of sediment have accumulated on the concrete apron. Sediment removal may be needed to provide sufficient capacity for flow conveyance.

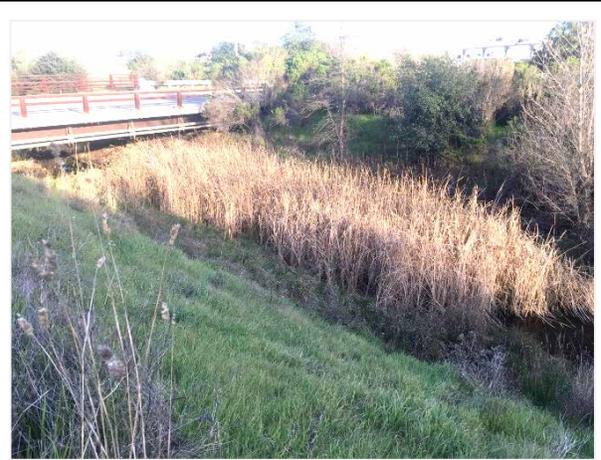
**Photo 6.** Dense cattail downstream of the Commerce Boulevard crossing (March 2018).

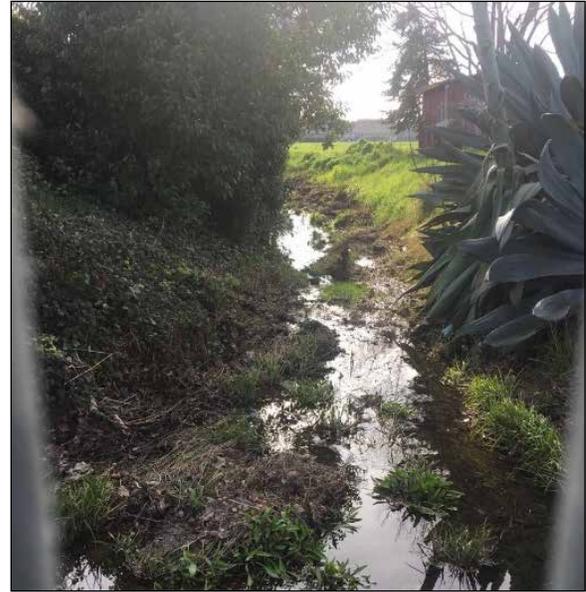
**Photo 2.** The upstream portion of the reach downstream of Donaldson Way. Understory vegetation is dominated by invasive plants. Trash is a frequent impairment (March 2018).
