## **Napa County Stream Maintenance Manual**

*Prepared for:*

Napa County Flood Control and Water Conservation District  
804 First Street  
Napa, CA 94559  
Contact: Michael Gordon, Watershed and Flood Control Resource Specialist  
707/259- 8684

January 2019

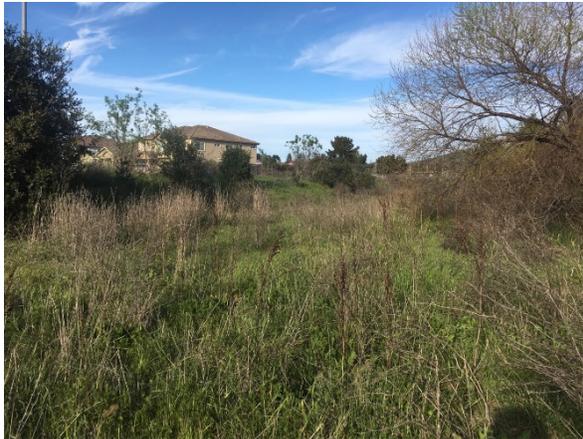
**Photo 3.** Downstream section of the reach, adjacent to Spikerush Circle, with a broad floodplain and mature willows along the channel (February 2018).

The downstream portion of the reach features abundant willow growth, some of which could cause a local flow obstruction. However, infrastructure in the area is well removed from the areas does not appear to be immediately threatened. Pruning and thinning lower limbs that cross the channel in these areas while maintaining an intact canopy could be beneficial.

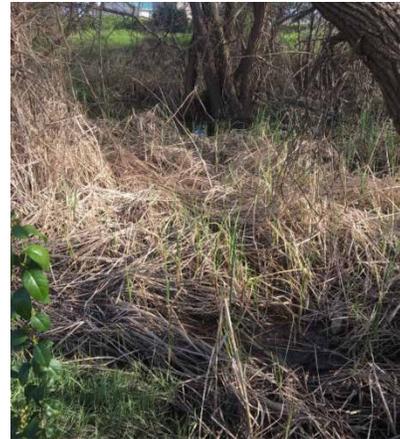
**Photo 4.** Emergent aquatic vegetation is abundant in the area adjacent to Spikerush Circle, where the channel is more broad and flow diffuse (February 2018).

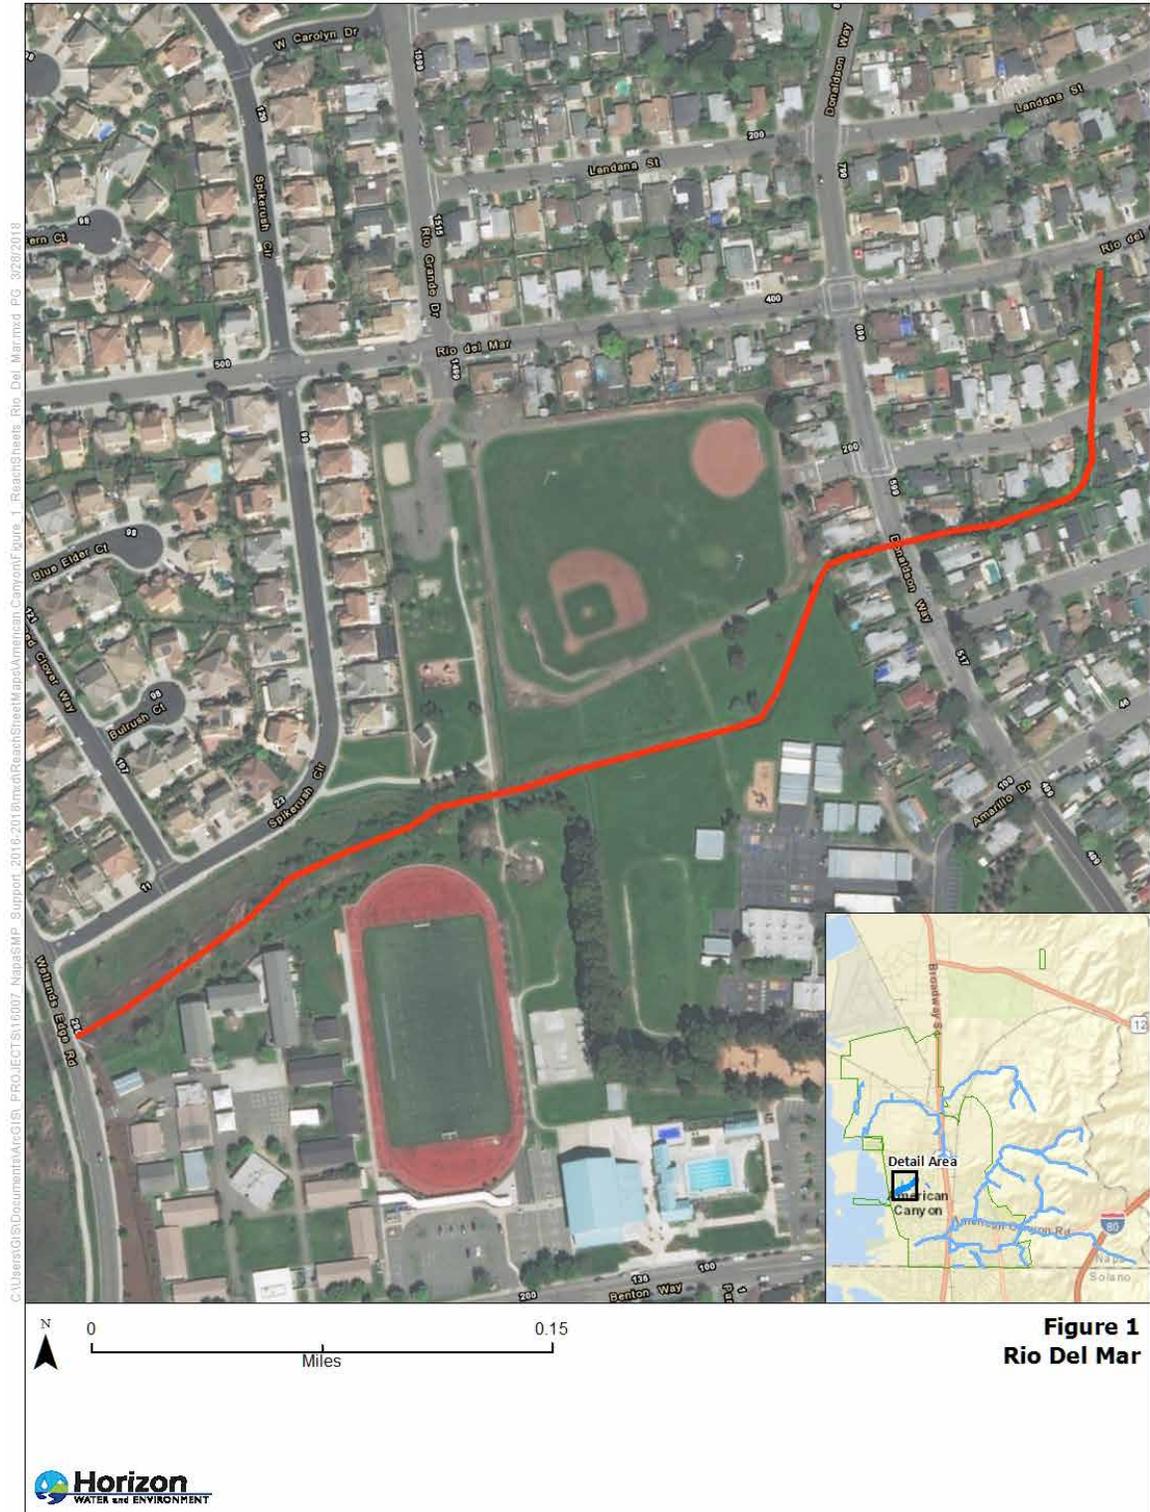
**Map A.** Rio Del Mar Reach (Red) from Rio Del Mar Road downstream to Wetlands Edge Road.

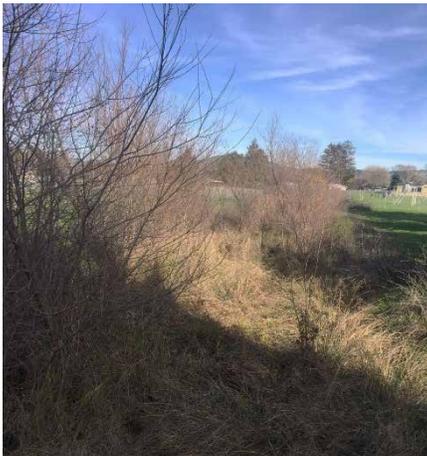
**Photo 5.** Young willows and cattails upstream of a pedestrian bridge on the Donaldson Elementary School property (February 2018).

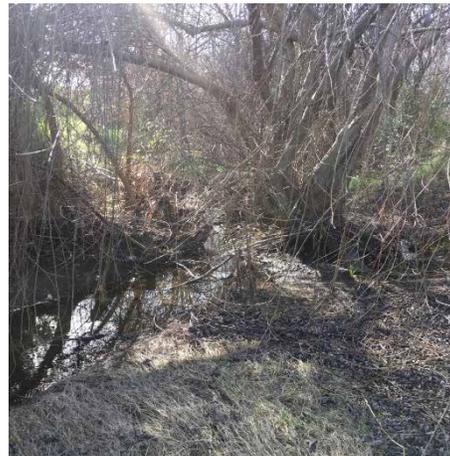
**Photo 6.** Downstream of the pedestrian bridge on the Donaldson Elementary School property. Abundant willow growth is promoting minor sediment accumulation (February 2018).

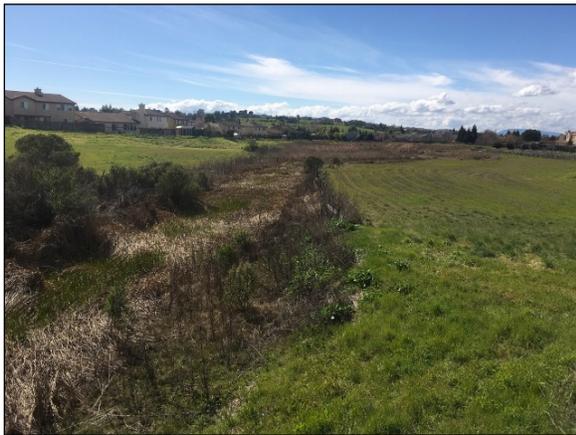
**Photo 1.** Upstream of Flosden Road, the channel corridor is broad with minimal woody riparian vegetation and abundant emergent aquatic vegetation. Channel appears to join with adjacent constructed basins (March 2018).

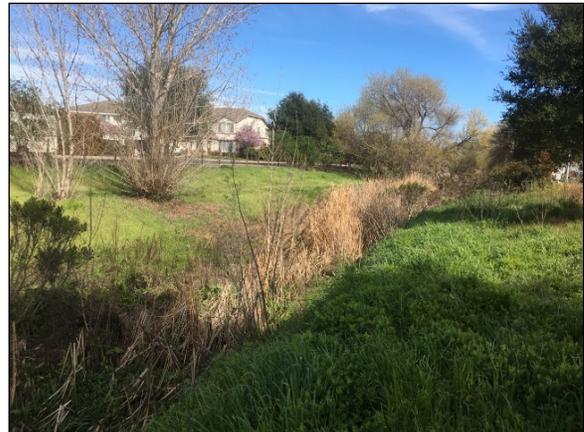
**Photo 2.** Downstream of Flosden Road, the channel corridor narrows with limited woody riparian vegetation on the upper banks and floodplain benches. Emergent aquatic vegetation is abundant within the channel (March 2018).

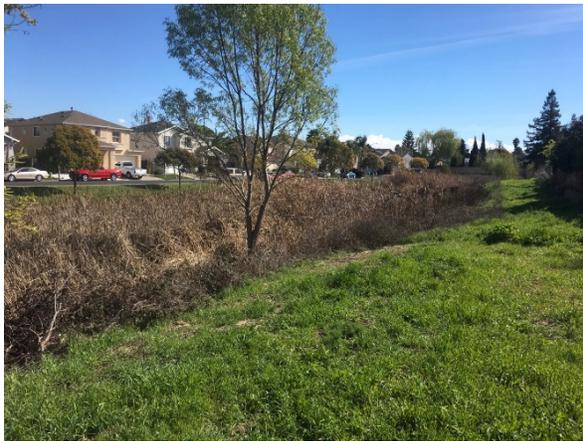
**Photo 3.** Section of the creek along Independence Drive with abundant aquatic vegetation in the channel and few riparian trees along the banks (March 2018).

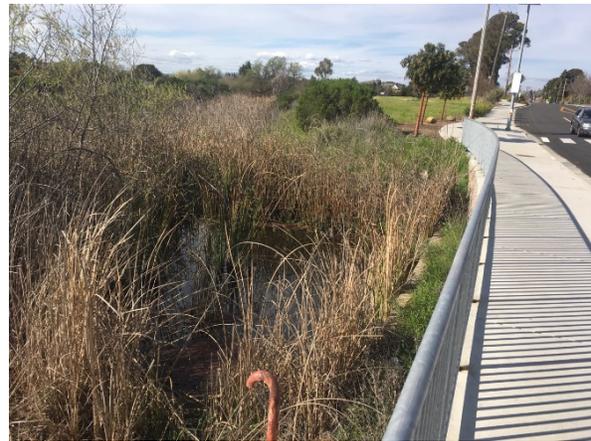
**Photo 4.** Downstream of Broadway Avenue bridge, sediment has accumulated and emergent aquatic vegetation obstructs the channel (March 2018).

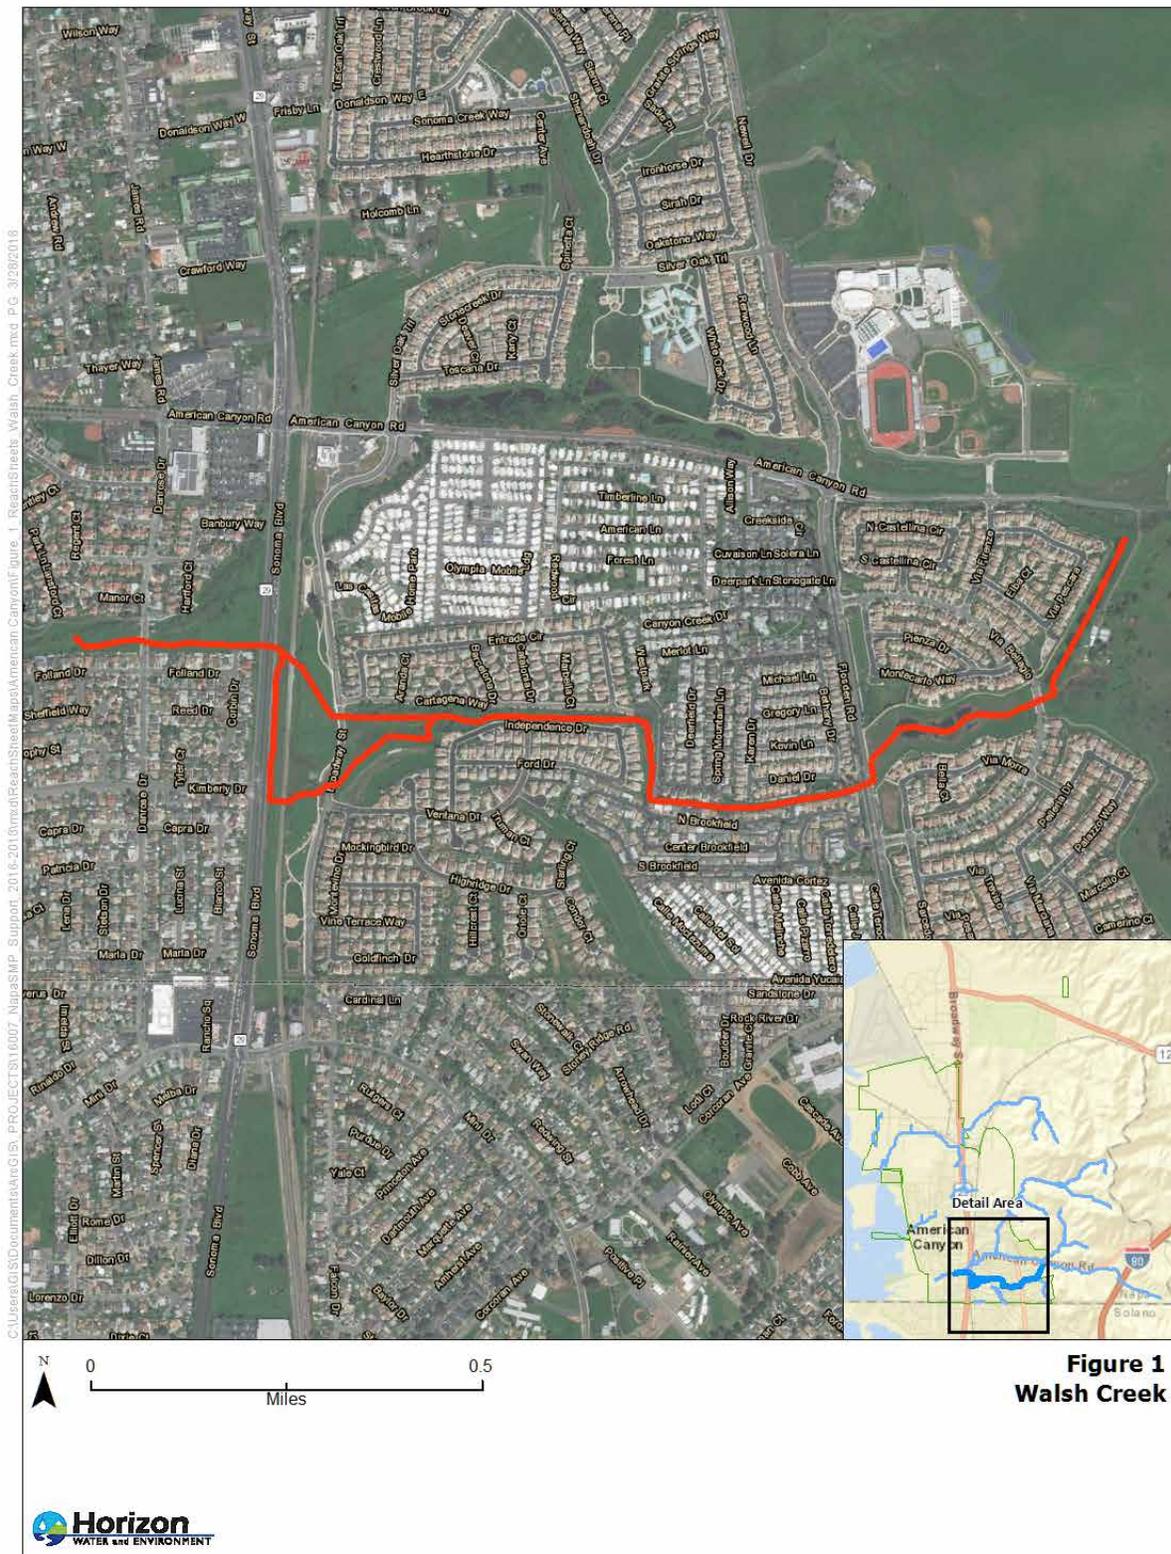
**Figure 1**  
**Walsh Creek**

**Map A.** Walsh Creek Reach (Red) from near American Canyon Road downstream to confluence with American Canyon Creek at Lansford Court.

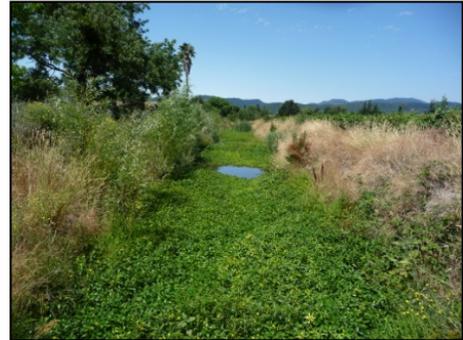
*Ludwigia in Yountville Outfall*

Mechanical removal is the primary method to control Ludwigia and is generally conducted using a long-reach excavator from maintenance roads adjacent to the project site channel. Where the channel is too wide, the excavator may occasionally travel partially down the bank in areas that will not impact existing native and riparian vegetation. The excavator will work from the mid-bank position, thus reducing the need for multiple trips along the bank slope by smaller equipment. The District anticipates the need to periodically manage Ludwigia between June 15<sup>th</sup> and October 31<sup>st</sup>.

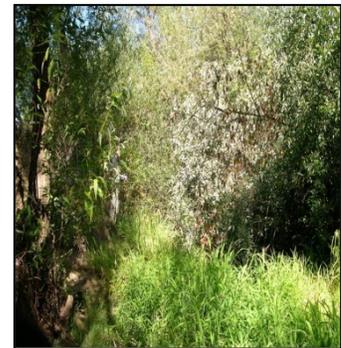
*Salvador Creek before willow pruning*

The District generally conducts willow removal from June 15th to October 31st. Arroyo willows are removed wherever they are significantly impeding flows and reducing the channel conveyance capacity. If arroyo willows are not removed (in cases where the canopy is needed and channel integrity is not at risk), they are pruned to minimize their ability to catch debris and impede the flow of water. Red and yellow willows are generally retained but pruned to reduce the number of branches and trunks below the top of the channel banks.

Willow removal generally requires hand clearing using chainsaws, pole saws, pruners, and loppers. Willow stumps may be hand treated with an herbicide such as glyphosate to prevent future growth. Cut vegetation must then be removed from the channel. This is achieved using a variety of methods including hand removal (passing branches up the slope), attaching a line to the cut limbs and pulling them up the slope with the aid of an excavator arm, using an excavator reaching into the channel from top-of-bank, by angled pulls using a line, or using a winch on a truck or tractor.

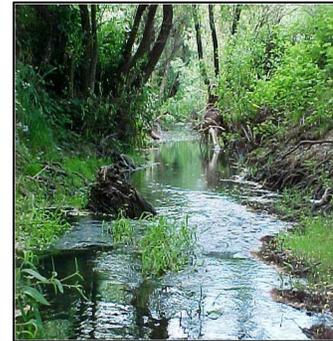
*Salvador Creek after willow pruning*

In cases where arroyo willow root wads protrude from the channel bottom after limbs have been pruned, these are generally left in place but depending on the channel size and geometry, the root wad may require removal to reduce roughness on the channel bed. See Chapter 7 for further details on large woody debris management.

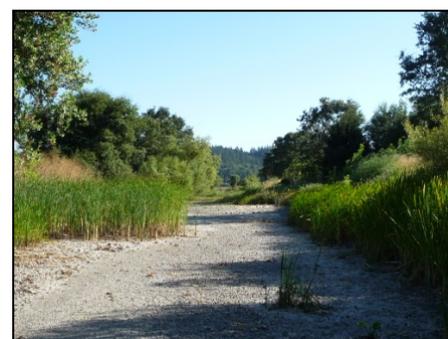
Cattails are commonly (but not necessarily) found in reaches with little to no riparian canopy. Cattails generally establish in low-gradient channels in areas of slow-moving or stagnant flow. Finer sediments naturally settle out in these locations, but further sedimentation is encouraged by cattails which trap sediment and further reduce flow velocities. Cattails are often the climax community (the final stage in ecological succession) developed in channels in need of sediment removal. In the photo (right), cattails have established within a portion of the channel bed. When this growth expires at

*Cattails*

the end of the dry season, dead plant matter can settle and redirect flows to the opposite side of the channel, which can lead to bank erosion if not managed.

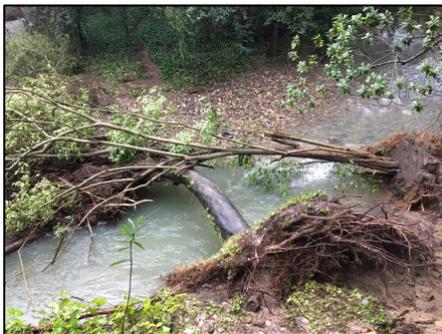
*Downed trees monitored in Redwood Creek.*

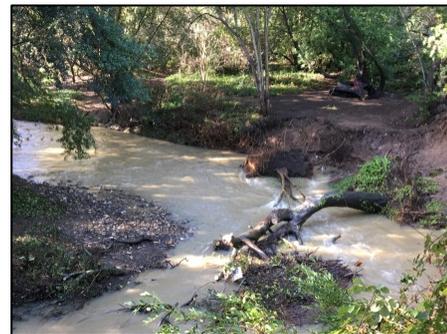
*Downed trees retained as LWD, providing habitat complexity in Redwood Creek.*

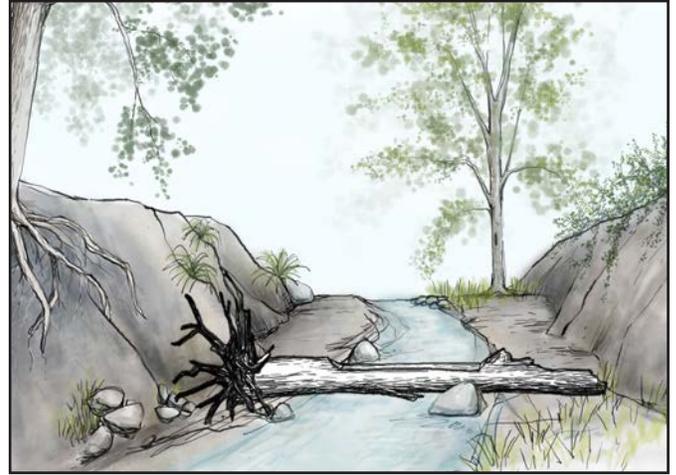
Photo 2. Downed tree limbed, left in place, and modified slightly to function as a weir.

- 2) **Limb downed tree branches:** if based on the wood retention rationale evaluation, the downed tree provides habitat functions, and does not significantly decrease flood capacity or alter streamflow – then the down tree will be left in place. But, if the downed tree exhibits branches that are perpendicular to flow, extend higher than two feet above the streambed, or has branches that could collect debris, those branches will be trimmed or limbed but the majority of the downed tree will be left in place. See Photo 2 in **Figure 7-2** and below.

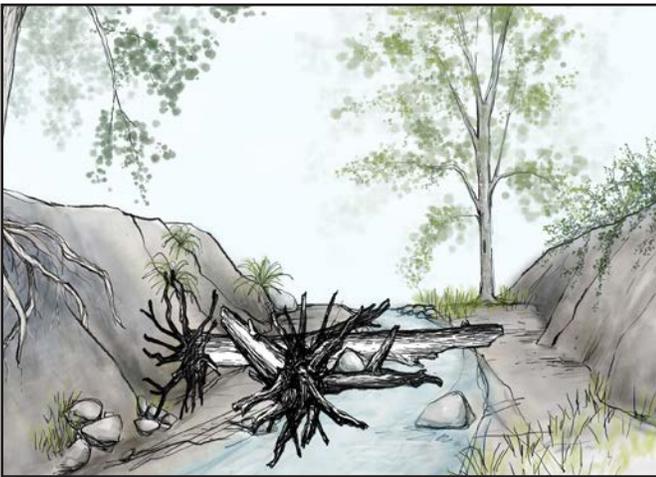
Photo 3. Downed tree, cut into smaller sections and repositioned in the channel to create instream complexity.

or a portion of the tree impedes flow or could catch debris, the tree may be cut into shorter lengths or specific sections of the tree may be removed. See Photo 3 in **Figure 7-2**.

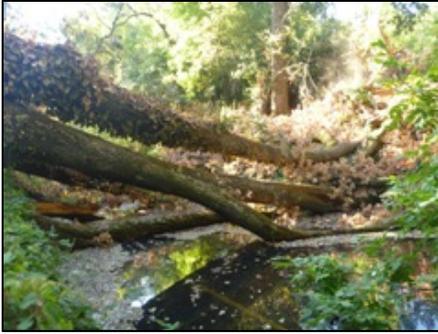
*Before: Large downed tree constricting flow along the Napa River*

If necessary, hand-held tools will be used to limb or cut downed trees. No heavy equipment is involved with preserving downed trees within the channel environment. The photos presented after **Figure 7-2** show before and after photos of a large downed tree that required removal of tree limbs.

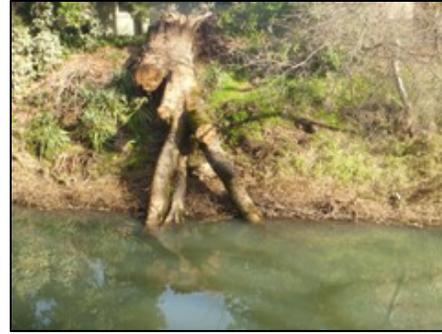
*After: Tree limbs crossing channel removed and large wood preserved on streambank to enhance instream habitat.*

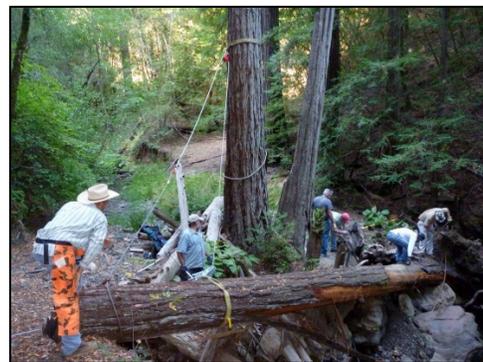
*Field crew repositioning a downed tree in Wing Canyon*

Trees that are repositioned to be more parallel to flow currents in the channel will not be secured in place, unless needed (see Photo 4 in **Figure 7-2**). In some cases, it may be necessary to secure wood in a specific place to create instream habitat, such as inducing a scour pool for use by salmonids. If necessary, the repositioned wood will be cabled or anchored in place to the banks or some other method with input from regulatory agencies, such as CDFW and NMFS (see Photo 5 in **Figure 7-2**). The District will retain root masses of the downed trees to the extent feasible. Repositioning of downed trees is conducted using hand-held tools and occasionally heavier mechanical

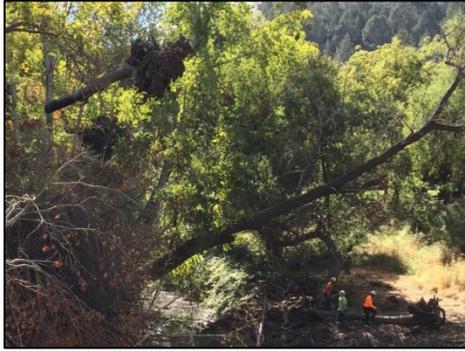
*Tree Crew utilizing a crane to re-orient downed tree instream and remove debris jam.*

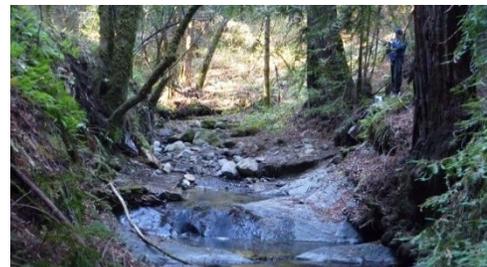
*Wing Canyon Creek after removal of the abandoned instream dam in 2012*

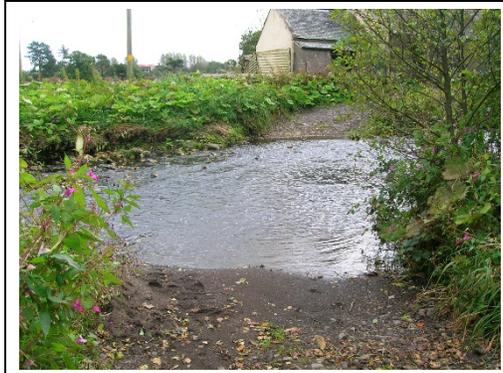
**Figure 11-1.** Example of a ford stream crossing

- **Ford Crossings.** Ford crossings are designed so that the vehicle travels across the stream bed. These are installed in locations where the existing road crossing is already eroding or the crossing is vulnerable to erosion. The advantage of ford crossings is that no culvert is installed which keeps the stream crossing open, avoids sediment plugging of culverts, and maintains a more continuous stream profile. No fill or armor material is placed in the stream bed to accommodate the crossing. They are constructed with a dip in the axis of the crossing to prevent diversion of the stream flow. By design, this type of stream crossing is adequately sized for the 100-year peak storm flow and has reduced diversion potential (**Figure 11-1**). See Appendix L, typical drawings 5a and 20 for further description.

- **Ford crossings.** Ford crossings are excavated in the same way as a decommissioned road crossing but an adjoining fillslope is constructed to maintain access across the stream bed. No fill or armor material is placed in the stream bed. By design this type of stream crossing is adequately sized for the 100-year peak storm flow and has reduced diversion potential (Figure 11-1). See Appendix L, typical drawing 5a and 20 for further description.

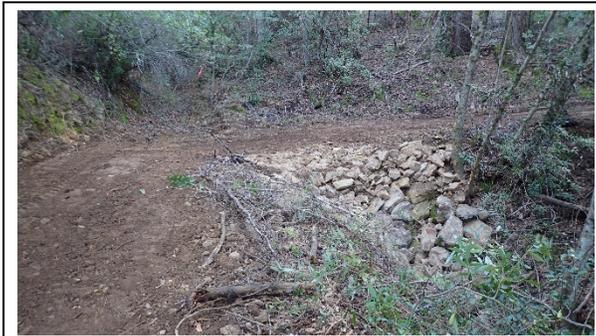
**Figure 11-2.** Example of an armored fill stream crossing at Simmons Canyon Creek

- **Armored Fill Stream Crossings.** Armored fill crossings are constructed by using interlocking rock armor of sufficient size to fortify the channel as well as resist sediment transport on the road by stream flow. They are constructed with a dip in the axis of the crossing to prevent diversion of the stream flow, and focus the flow over the part of the fill that is most densely armored. By design, this type of stream crossing is adequately sized for the 100-year peak storm flow and has reduced diversion potential (**Figure 11-2**). See Appendix L, typical drawings 5a-7 for further description.

- **Armored fill crossings.** A majority of the fill material is excavated from the stream crossing but a 4 to 6-foot wide armored fill crossing is constructed near the top of the excavated area to provide for hiking or quad four-wheeler access. Armored fills are constructed using the same methods described for routine road maintenance above. By design, this type of stream crossing is adequately sized for the 100-year peak storm flow and has reduced diversion potential (Figure 11-2). See Appendix L, typical drawings 5a-7 for further description.

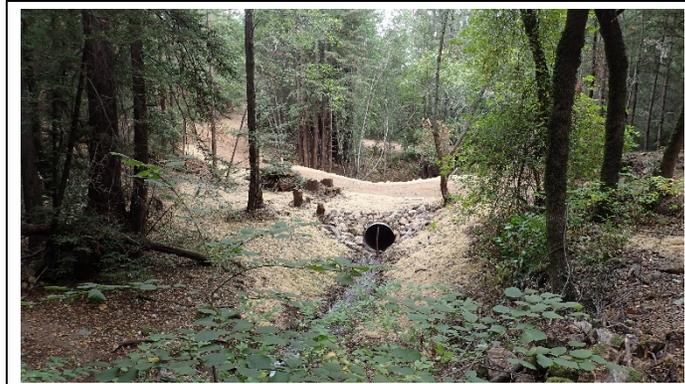
**Figure 11-3.** Example of culverted stream crossing with a single post trash rack

- **Culverts at Stream Crossings.** Where culverts show sign of failure or erosion, the Napa County RCD recommends replacing them with culverts that are sized to accommodate the 100-year peak storm flow, and set at the base of the roadfill in line with the natural channel gradient (i.e., channel slope), to prevent further erosion at the culvert outfall. This requires replacing and installing culverts that are of a sufficient length to construct fill slopes at a stable 50% (2:1) slope angle (**Figure 11-3** and **Figure 11-4**). See Appendix L, typical drawings 1a, 1b, and 2 for further description.

- **Secondary Structures at Stream Crossings.** Secondary structures installed at stream crossings include downspouts and trash racks to support culvert function, and rock armor to buttress and/or reduce erosion of steep fill-slopes (Figure 11-3 and Figure 11-4). See Appendix L, typical drawings 1c, 3, and 4 for further description.

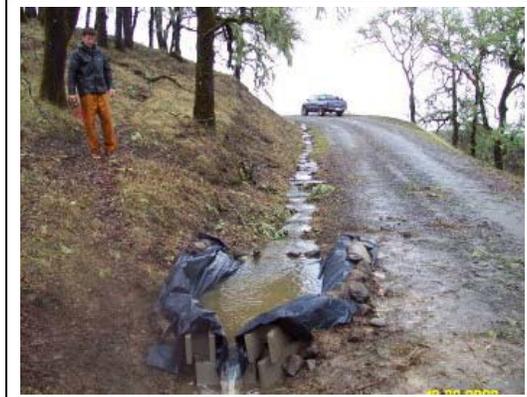
**Figure 11-5.** Example of sediment basin adjacent to roadway

- **Critical Dips at Stream Crossings with Diversion Potential.** These features are essential to directing flood flows across the road and back into the original channel downstream of the crossing in a stable and non-erosive manner (Figure 11-4). See Appendix L, typical drawing 1c for further description.
- **Earthen Sediment Retention Basins.** Sediment basins are a simple but effective measure for capturing and storing roadbed derived sediment along road approaches where there are no options for changing road drainage patterns to disconnect the roadbed and inboard ditch from the adjacent stream channel (**Figure 11-5**).

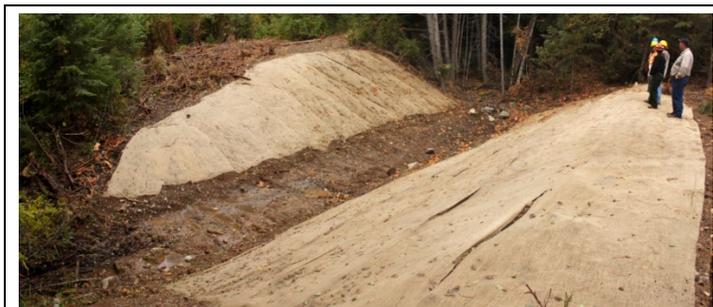
**Figure 11-6.** Example of a decommissioned stream crossing

- **Decommissioned Stream Crossings.** Stream crossing excavations are decommissioning treatments used for roads that are built across stream channels. The fill material (including the culvert) is completely excavated and the original streambed and side slopes are exhumed. Excavated spoil is permanently stored at nearby, stable upland locations where it will not erode. As a final measure, the sides of the channel may be cut back to slopes of 2:1, and mulched and seeded for erosion control (**Figure 11-6**). See Appendix L, typical drawing 14 for further description.

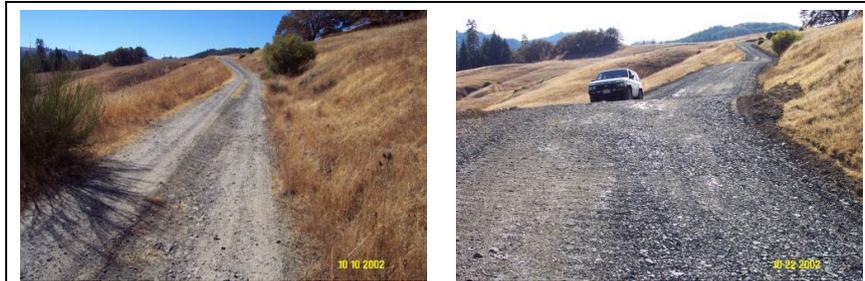
**Figure 11-7.** Example pre- and post-cnstruction photos of road outsloping and rolling dip construction

- **Increasing Drainage Dispersal.** This activity focuses on changing road shapes to disperse and diffuse runoff, versus concentrating runoff and increasing its erosive potential. This activity involves grading roadbeds to outsloped, insloped or crowned roadbed shapes, with no outside berm or with frequent berm breaches along the outside edge of the road (Figure 11-6). This approach allows collected road runoff to disperse more frequently than running down a long length of road and becoming erosive. See Appendix L, typical drawings 9a-9c, and 12 for further description.
- **Road Drainage.** Constructing rolling dips, Waterbars, cross road drains or ditch relief culverts can be an effective approach to reduce the erosion potential. Rolling dips,

waterbars, and cross road drains are a road-shaping practices that disperse road surface runoff, and ditch relief culverts disperse runoff from cutbanks and inboard ditches (**Figure 11-7**). See Appendix L, typical drawings 8, 10, 11, 11b, 17 19a-19c, and 21 for further description.

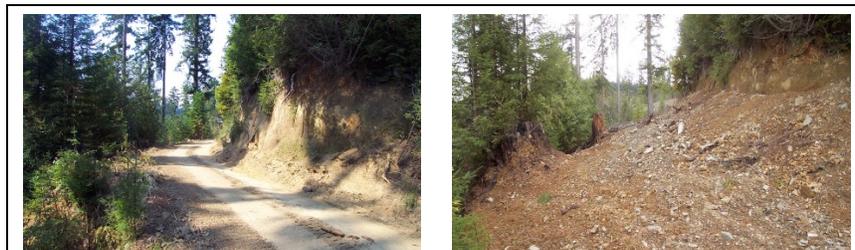
**Figure 11-8.** Example pre- and post-photos of a decommission outsloped road

- **Road Ripping or Decompaction.** Road ripping is a technique in which the surface of a road is disaggregated or "decompacted" to a depth of at least 18 inches using mechanical rippers. This action increases infiltration of precipitation and runoff and thereby reduces or eliminates surface runoff and may enhance revegetation success. See Appendix L, typical drawings 10 and 17 for further description.
- **Decommission Outslope.** This treatment approach places excavated materials from the stream crossings and unstable fillslopes along the cutbank portion of the road surface. These stockpiled fills will act to not only buttress the cutbanks and disperse runoff but to also allow for vegetative growth on these otherwise overstepped areas (**Figure 11-8**). See Appendix L, typical drawing 15 for further description.

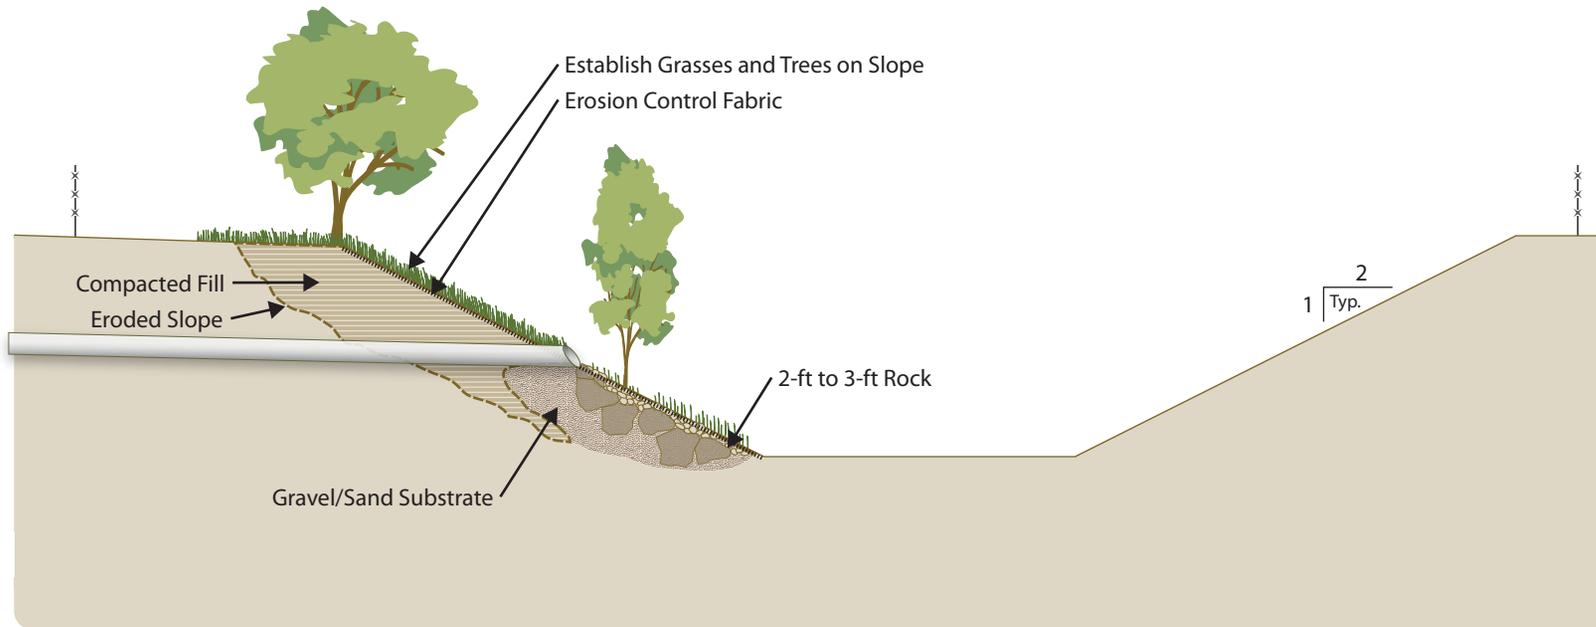
Photo 1. Example of a Culvert Failure.

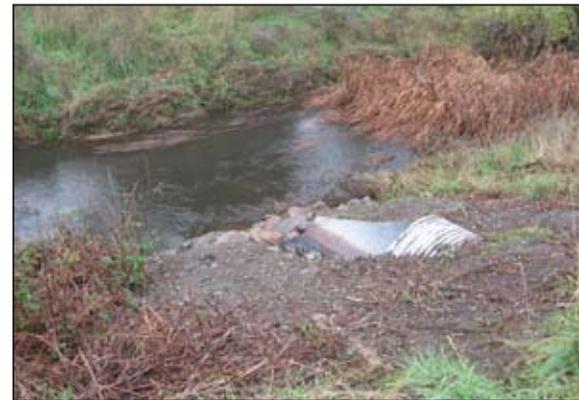
Photo 2. Same site as Photo 1 after bank repair using minimum necessary rock rip-rap.

- Sediment has substantially accumulated in an existing culvert and requires removal.
- Repair or replacement of an existing culvert will occur within the same footprint as the original culvert.
- The culvert outfall path, from the culvert edge down to toe-of-slope will be protected with erosion control material as needed to dissipate energy and reduce the erosion potential.
- The culvert placement and outfall will be installed to minimize outfall velocity and reduce the potential for future bank erosion and scour from outfall. Energy dissipation approaches will be used as needed.

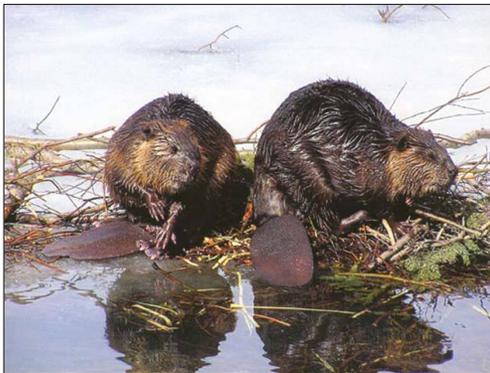
Heavy beaver activity, such as observed in Salvador Creek (Reach 2) (see Photo 1 in **Figure 12-2**), presents several maintenance concerns. Beaver dams block the channel and introduce woody debris into the creek. The beaver felled logs become the basis to catch debris and develop a more solid dam as seen in Photo 1 of Figure 11-2. Beaver activity also reduces riparian habitat at rates that exceed the recruitment and growth of trees, as the beavers target younger trees (Photo 2 in Figure 11-2) and larger and older trees (Photo 3 in Figure 11-2). If left unabated, this

activity will likely continue through the reach and multiple flow obstruction dams will develop. As an area becomes backwatered (ponded) by the beaver dams, sediment may begin to accumulate in the ponded area. Ponded environments encourage the growth of aquatic vegetation, such as Ludwigia and cattails, which further reduces flood carrying capacity and degrades in-channel habitat.

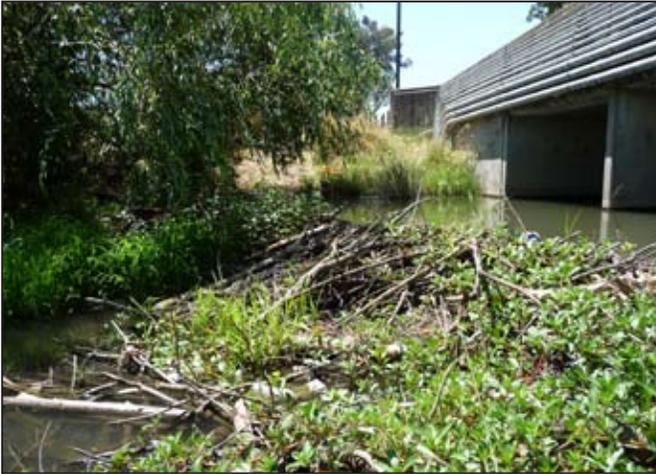
Photo 1. Beaver dam located in Salvador Creek, approximately 600 ft downstream of Trower Avenue (July 8, 2010).

- Debris dams build up to a degree such that upstream and downstream reaches are adversely affected. Adverse conditions may entail sediment accumulation and subsequent cattail growth upstream of a beaver dam and flood carrying capacity has been noticeable reduced.

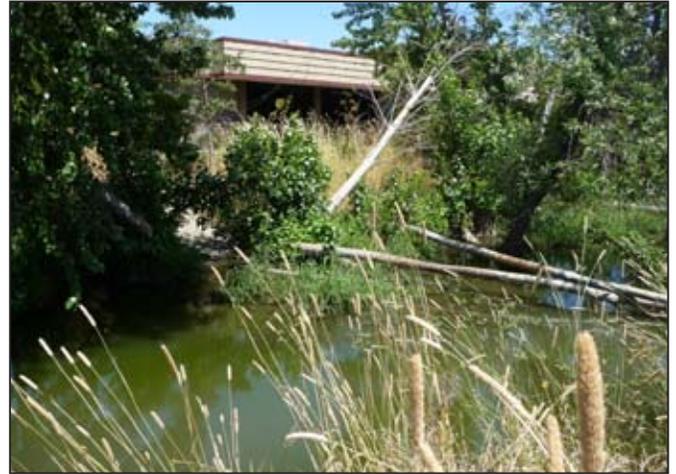
Photo 2. Downed trees crossing the channel from beaver activity (July 8, 2010).

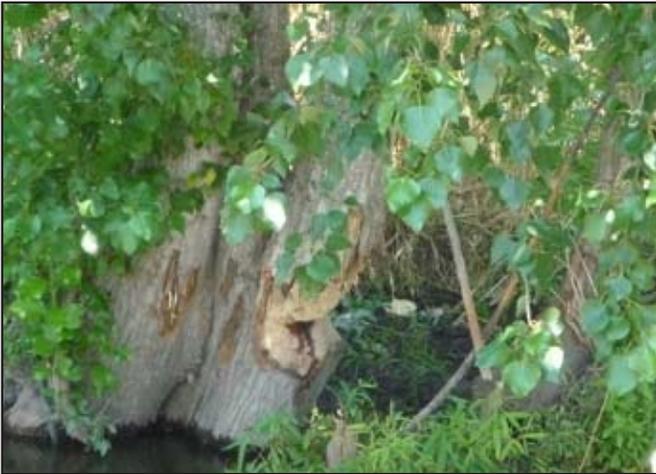
Photo 3. Beaver activity on large cottonwoods (July 8, 2010).

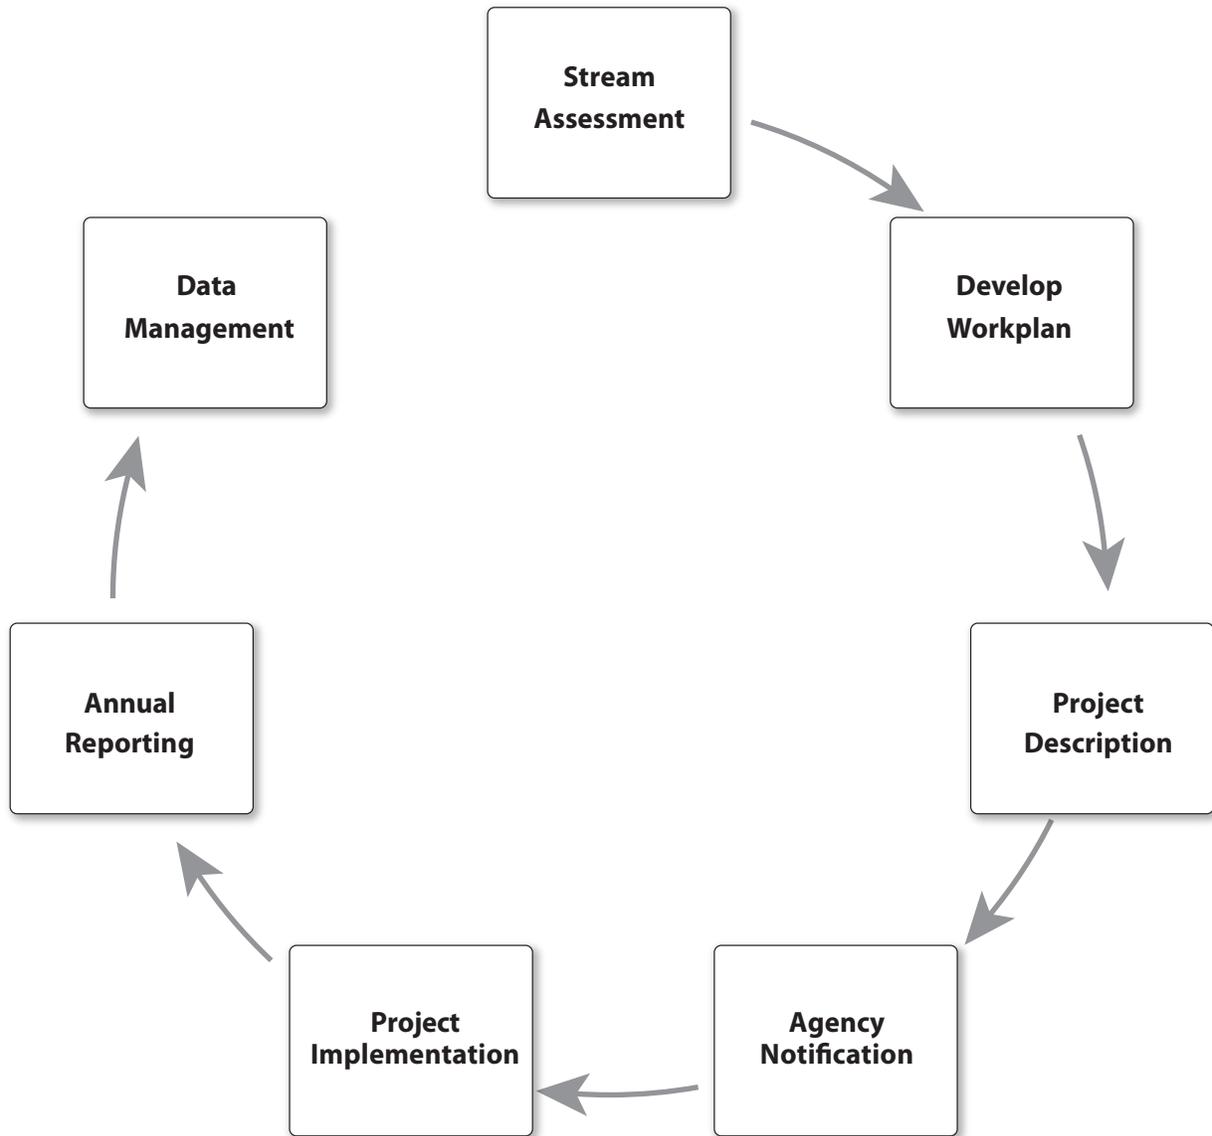
Figure 14-1  
Annual Work Cycle

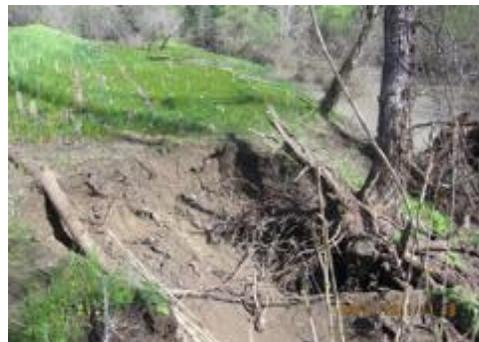
Photo 2: Erosion issue at restoration site.

Constructed features, such as biotechnical stabilization areas and habitat enhancement structures, will need to be monitored to ensure that they are performing correctly and to identify any areas of damage or failure. Depending on their performance, some features may require repair or maintenance.

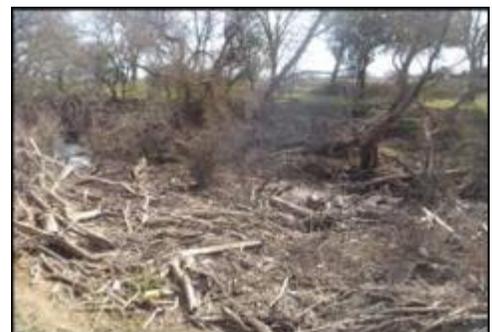
Photo 3: Debris jam along Napa River.

clearing of vegetation debris that racks up on restoration features, on downed trees, or on other channel vegetation. Debris jams will be disassembled if they are significantly blocking the channel, redirecting flows and causing erosion issues, or degrading the function of a restoration feature. Methods used to remove debris will vary depending upon the size of material and available access. When feasible, debris removal activities will be conducted by work crews using hand tools. However, removal of larger materials may require the use of heavy equipment. Native vegetative debris may be cut up or chipped on-site, removed and transported to a suitable disposal site, or burned in accordance with State and local permits. Non-native vegetative debris (i.e., giant reed) will be removed and transported to a suitable disposal site, mulched (for materials that do not contain viable seed) in place, or burned in accordance with State and local permits.

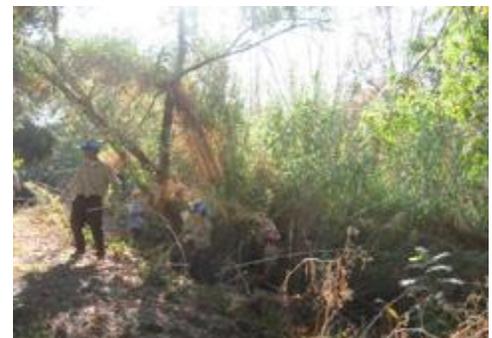
Photo 4: CCC crews removing Arundo .

***Invasive Non-Native and Pierce's Diseases Host Vegetation:*** A number of invasive non-native and Pierce's disease host plants occur within the Project. These species reduce the value of habitat for native wildlife by preventing the establishment and growth of desirable native species and decreases overall plant diversity. Additionally, some of these species act as host plants for the bacterium that causes Pierce's disease, resulting in significant damage to streamside vineyards.

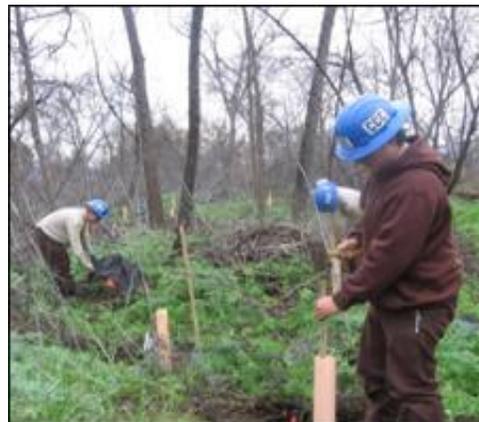
Photo 5: CCC during riparian planting.

Areas subject to minor erosion may be hydroseeded with an appropriate native or sterile seed mix, and/or planted with native riparian species to stabilize eroding banks and reduce localized flow velocities and erosion potential. The goal of riparian planting is to enhance habitat for fish, birds, amphibians, and other wildlife using terrestrial riparian areas while providing shading, sources of organic matter and coarse woody debris, and water quality benefits to aquatic species. The planting palette will be consistent with the Project; the list of species will evolve to mimic the successional development of the riparian forest. Opportunities for riparian planting and restoration will be evaluated on a case-by-case basis at all maintenance locations within the Project.

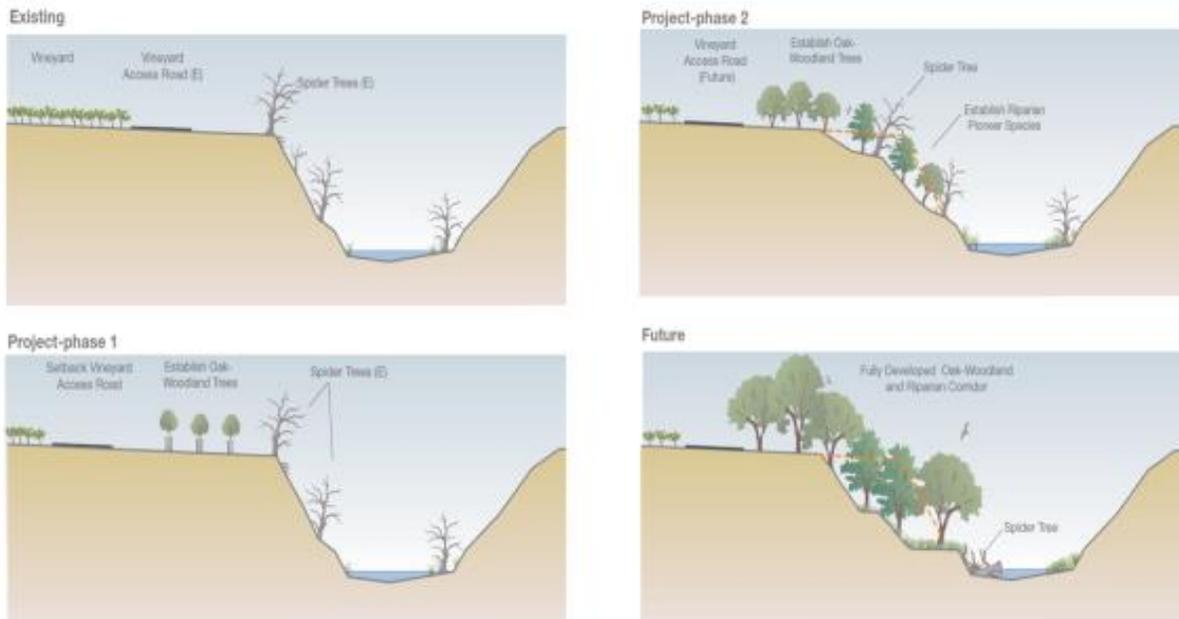
Figure 2: Theoretical example of managed retreat concept.

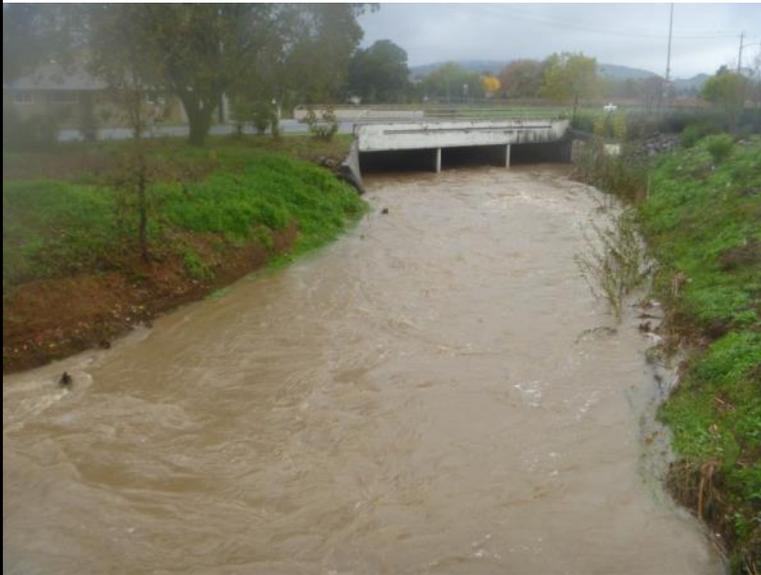
**Photo 1:** Trower St. bridge on 12-2-2012 at 9:34 am

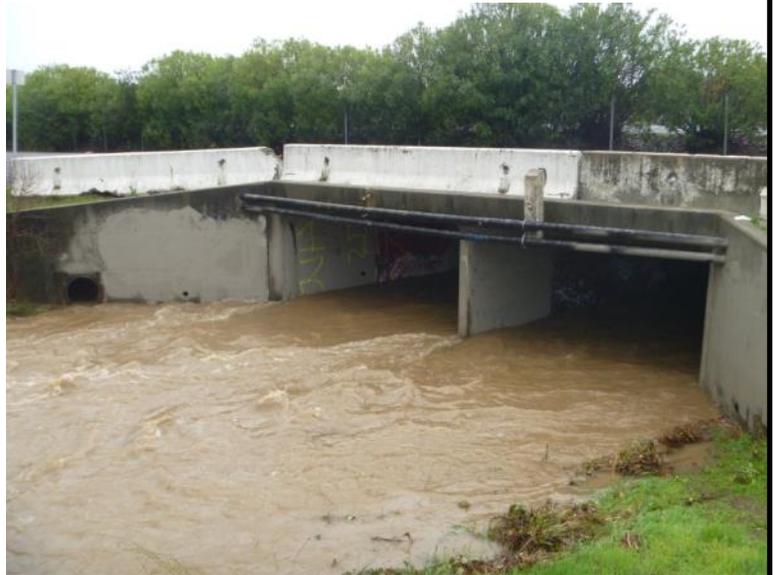
**Photo 2:** Byway east bridge on 12-2-2012 at 9:44 am

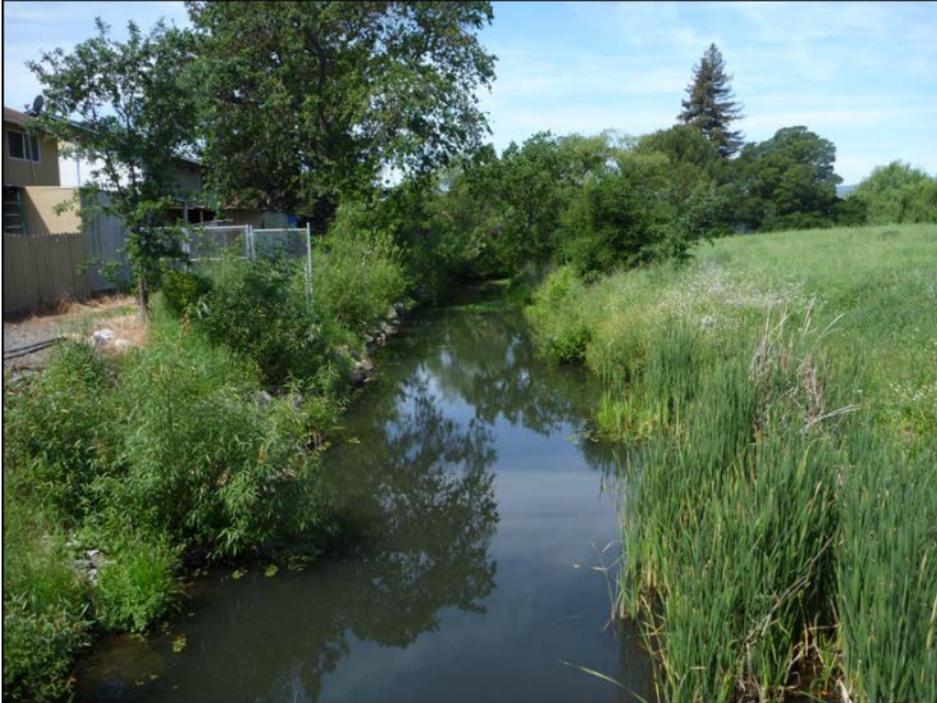
**Photo 3:** Reach 1 looking upstream showing channel roughness.  $n=0.030-0.040$

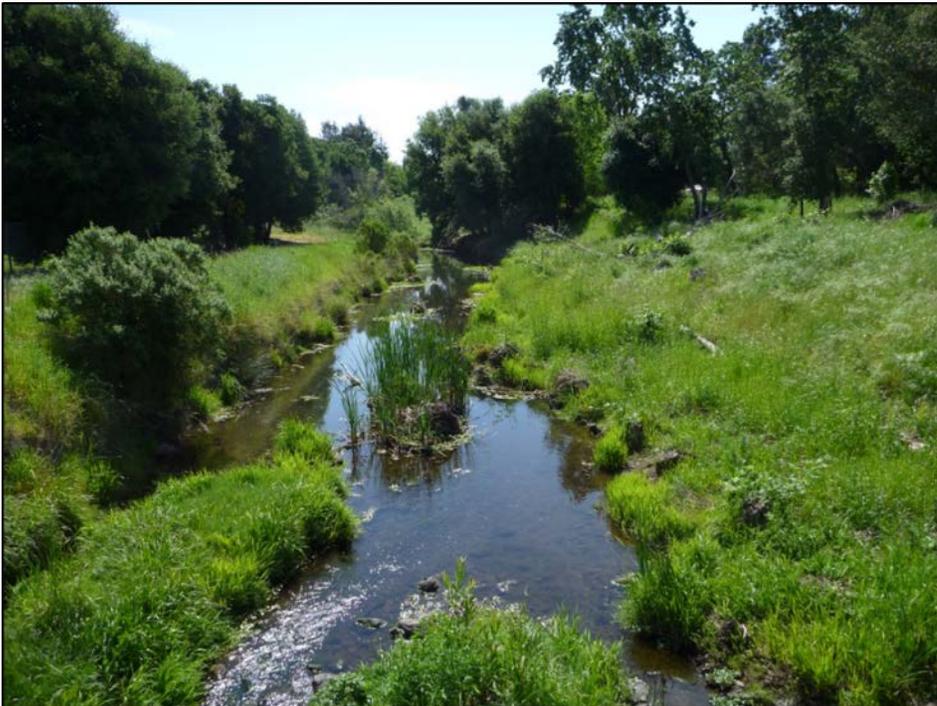
**Photo 4:** Reach 2 looking downstream showing channel roughness.  $n=0.030-0.040$

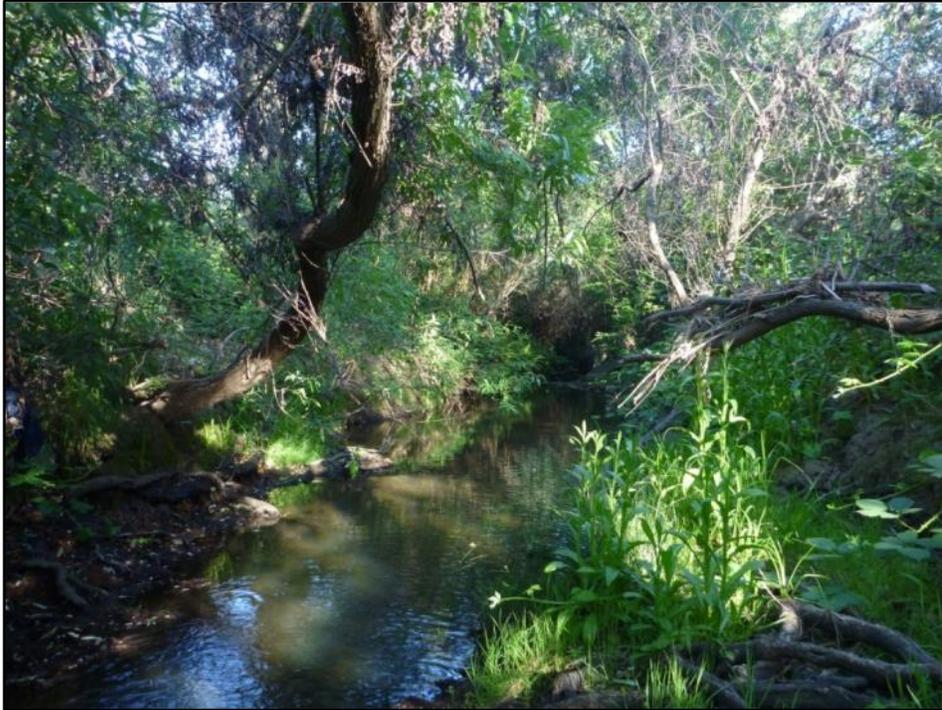
**Photo 5:** Reach 3 looking downstream showing channel roughness.  $n=0.040-0.050$
