## **Napa County Stream Maintenance Manual**

*Prepared for:*

Napa County Flood Control and Water Conservation District  
804 First Street  
Napa, CA 94559  
Contact: Michael Gordon, Watershed and Flood Control Resource Specialist  
707/259- 8684

January 2019

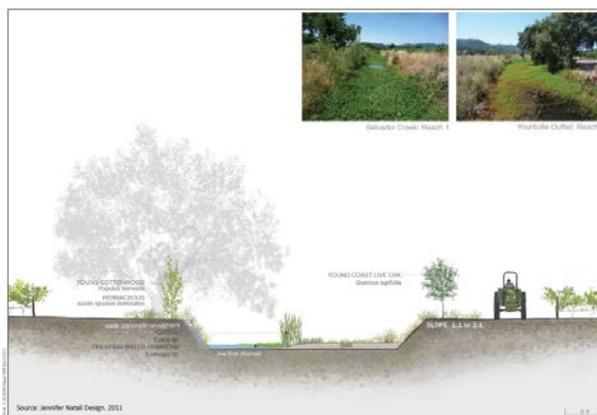
**Figure 10:** Example of modified channel

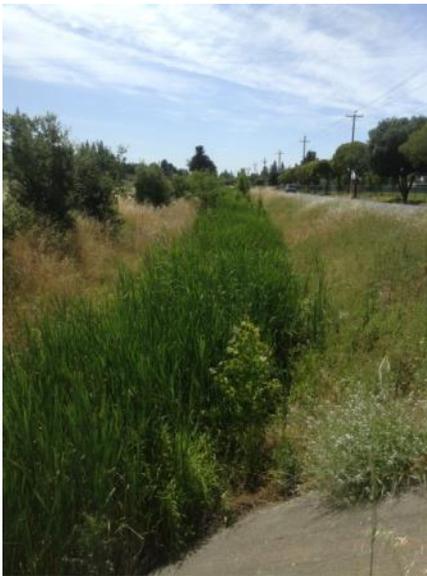
Photo 6: Salvador Collector cattails

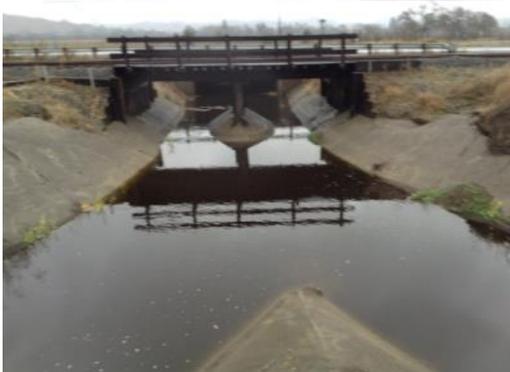
**Photo 9:** Confluence of south and north Yountville collectors upstream of railroad bridge and HWY 29, first winter after sediment removal project.

Issue	Cause	Corrective Action
Invasive vegetation (Ludwigia)	Slow water	Sediment management, physical removal, and maintenance of planted trees to establish canopy.
Sediment	Confluence of South and North Yountville Collector	Sediment was removed in 2013, monitor sediment deposition.
Erosion	Drainage culvert causing bank erosion	Working with roads department on repair in 2014 or 2015.
Sediment	Box culvert & confluence	Sediment was removed in 2013, monitor sediment deposition.
Sediment	Box culvert & confluence	Sediment was removed in 2013, monitor sediment deposition.

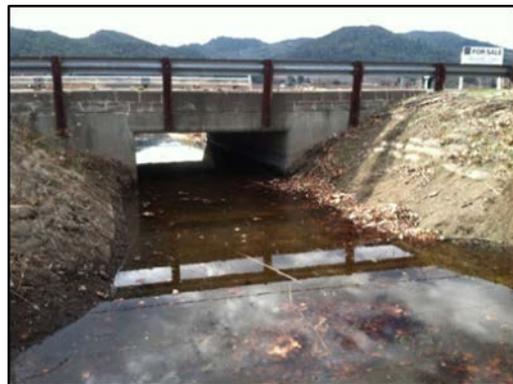
**Photo 10:** Confluence of upstream drainage and south Yountville collector, first winter after sediment removal project.

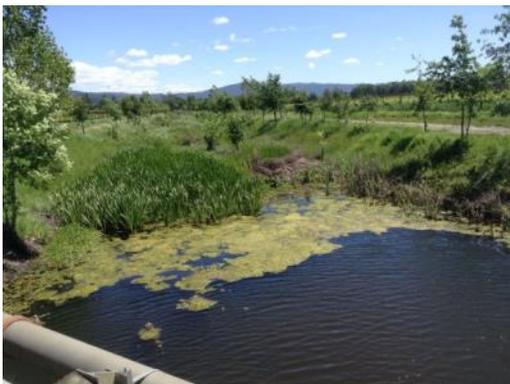
Photo 13: Sediment deposition downs stream of agricultural bridge

Issue	Cause	Corrective Action
Sediment	Box culvert Outfall	Monitor/Sediment Management every 5-8 years
Invasive Vegetation	Ludwigia	Establish tree canopy through maintaining top of bank plantings, physical removal and treatment.
Sediment	Agricultural Bridge Abutment	Monitor/Sediment Management every 5-8 years
Sediment	Straightened Channel	Monitor/Sediment Management every 5-8 years

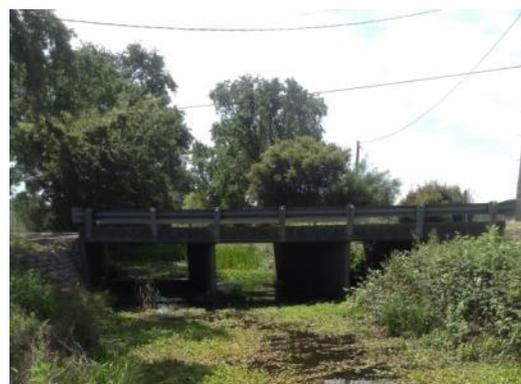
Photo 14: Ragatz lane box culvert with invasive ludwigia colonizing channel upstream

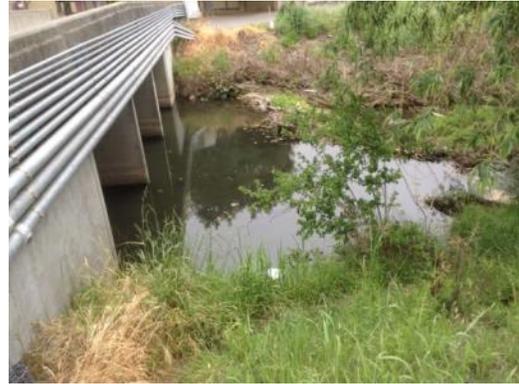
**Photo 16:** First Vintage High School footbridge and downstream beaver dam

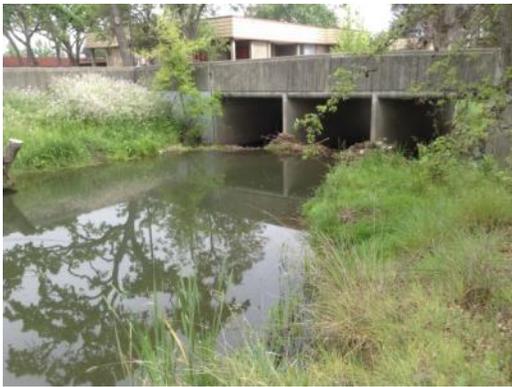
**Photo 17:** Second Vintage High School footbridge with beaver dam upstream

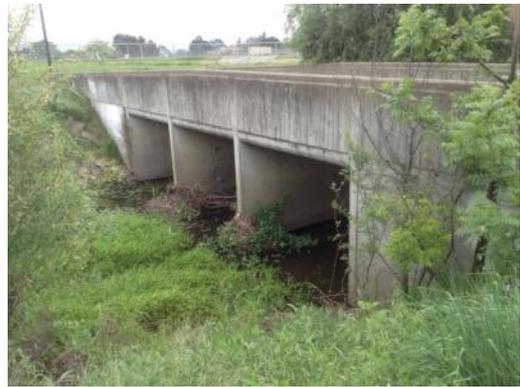
**Photo 18:** Third Vintage High School footbridge with beaver dam upstream

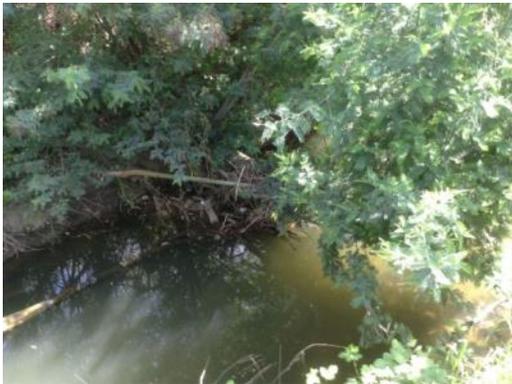
**Photo 19:** Non-native Accacia tree infestation degrading channel capacity and native plant diversity

Issue	Cause	Corrective Action
Sediment	Box culvert	Sediment was removed in 2012, monitor sediment deposition.
Sediment	Box culvert	Sediment was removed in 2012, monitor sediment deposition.
Sediment	Box culvert	Sediment was removed in 2012, monitor sediment deposition.
Sediment	Box culvert	Sediment was removed in 2012, monitor sediment deposition.
Erosion	Top of bank drainage & foot traffic	Biotechnical bank repair
Invasive Vegetation	Accacia tree infestation	Annually remove trees starting at the upstream extent, monitor regrowth and revegetate with natives.

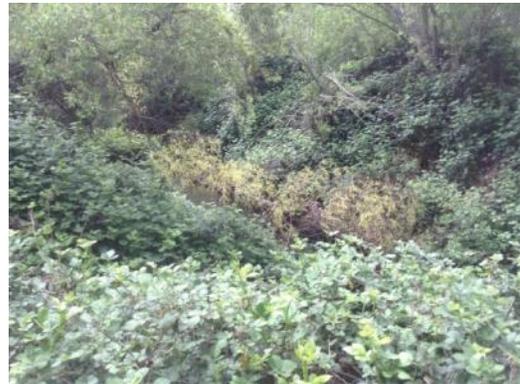
**Photo 20:** Non-native blackberry scheduled to be removed during 2014 maintenance season

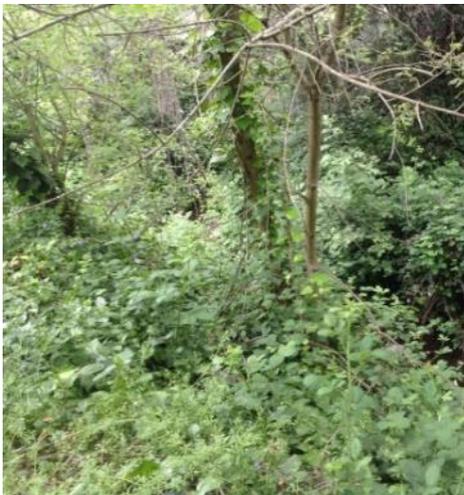
Photo 21: Invasive vegetation

Issue	Cause	Corrective Action
Tulocay Creek		
Erosion	Further assessment	Outreach to property owner to provide Bank Stabilization Cost Share program and further assessment.
Erosion	Undercut tree slipped into channel	Implement Biotechnical bank repair project
Sediment	Confluence of Tulocay and Camille Creek	Monitor and manage cattails
Camille Creek		
Vegetation	Ivy	Banks infested with ivy and damaging trees should be removed, treated and revegetated with natives.

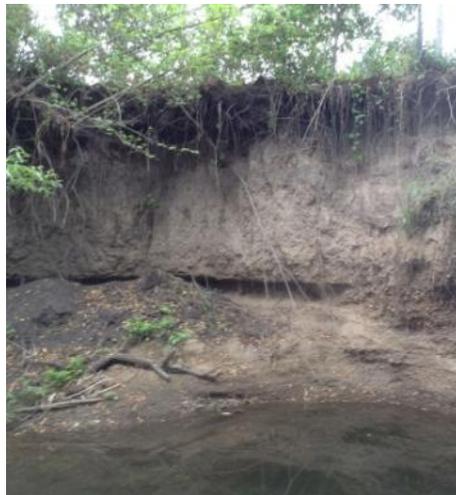
Photo 22: Significant erosion outreaching to property owner

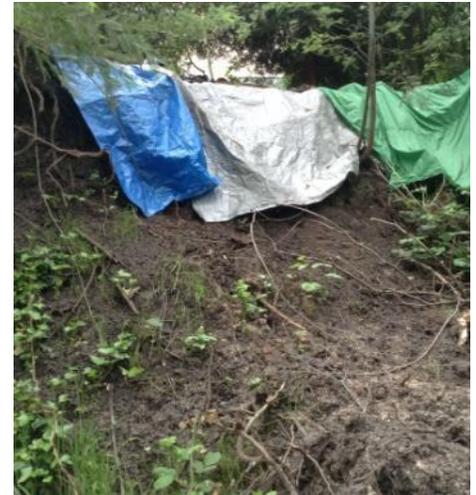
Photo 23: Erosion along bank due to fallen tree, repair

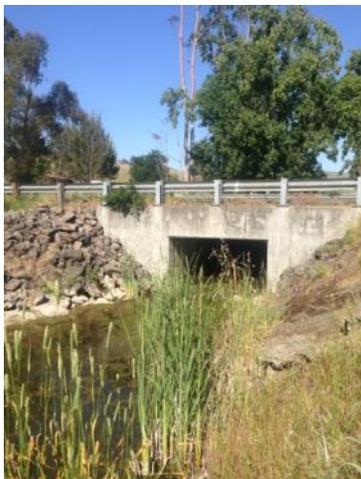
**Photo 24:** Box culvert with beaver dam upstream and downstream on Sheehy Creek

Issue	Cause	Corrective Action
Fagan Creek		
Erosion	Additional assessment	Monitor
Sediment	Straightened channel and drainage outfall	Monitor and manage sediment every 5 years
Sheehy Creek		
Flooding	Beaver dam upstream of box culvert	Annual monitoring prior to winter
Flooding	Beaver dam downstream of box culvert	Annual monitoring prior to winter
Flooding	Channel bend	Monitor vegetation and drainage outfalls
Vegetation	Cattails and bulrush	Establish tree canopy through maintaining top of bank plantings, physical removal and treatment.

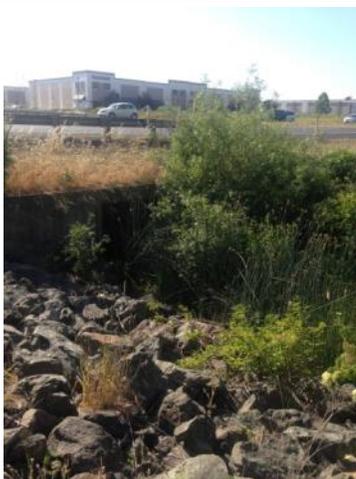
**Photo 25:** Vegetation blocking downstream box culvert on Sheehy Creek

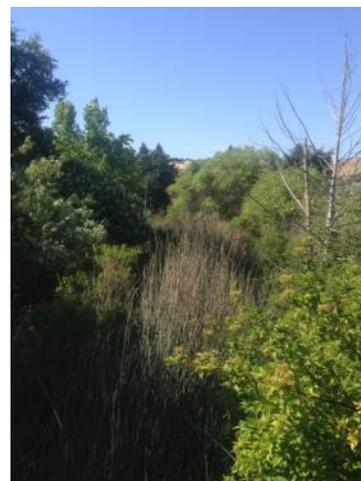
**Photo 26:** Bulrush in Sheehy Creek

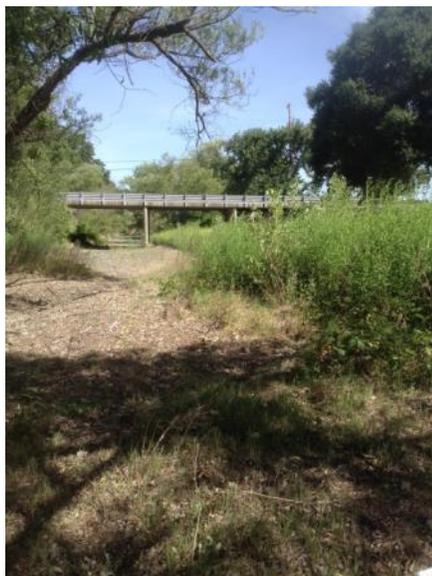
**Photo 27:** Downstream of Oakville Cross Rd. bridge sediment build

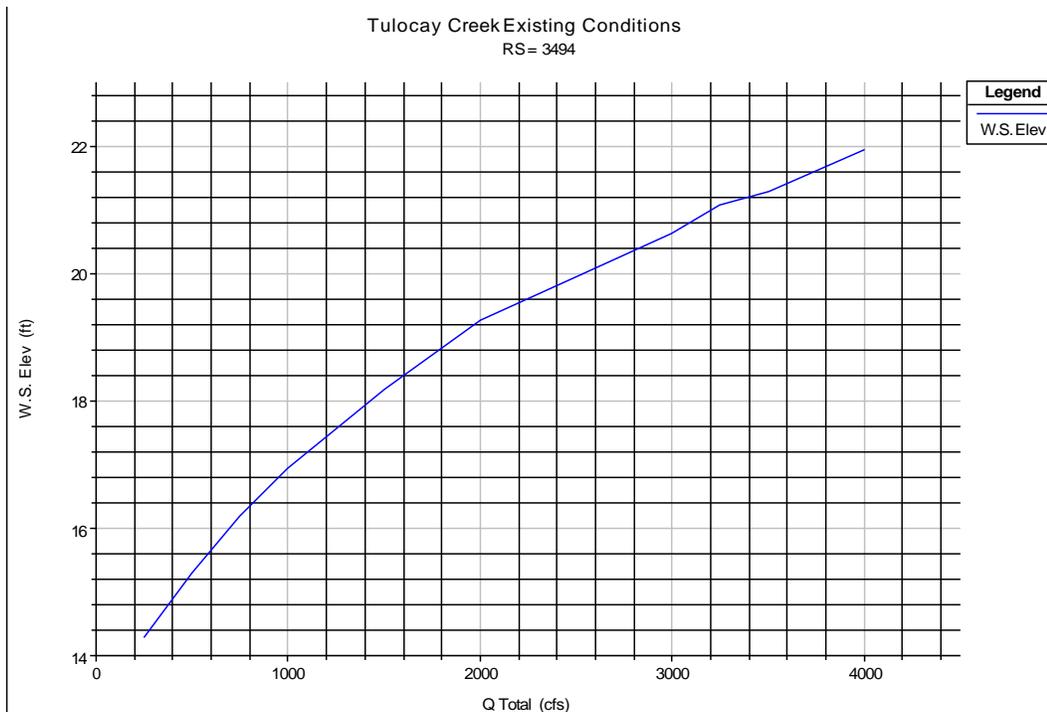
**Figure 1.** Stage-discharge rating for Tulucay Creek Reach 1, obtained from HEC-RAS analysis.

The HEC-RAS analysis was also used to generate stage-discharge ratings for both reaches (Figures 1 and 2). Ratings are associated with a particular cross section location on a stream, so RCD selected cross sections from the model that represented the reach. For Reach 1, RCD selected the downstream-most cross section that was above the poorly-represented “flood wall” subreach described above. For Reach 2, RCD selected a cross section near the top of the reach which represents the minimum capacity of the channel.

As evident from Figures 1 and 2, Reach 1 has been completely inundated with backwater from a beaver dam located just upstream of the Soscol Avenue bridge. Beavers are common in the Napa River system and seem to be increasing in population. In general, local beaver activity is not known to lead to significant channel capacity decreases and potential stream flooding issues due to the large size and intensity of local winter

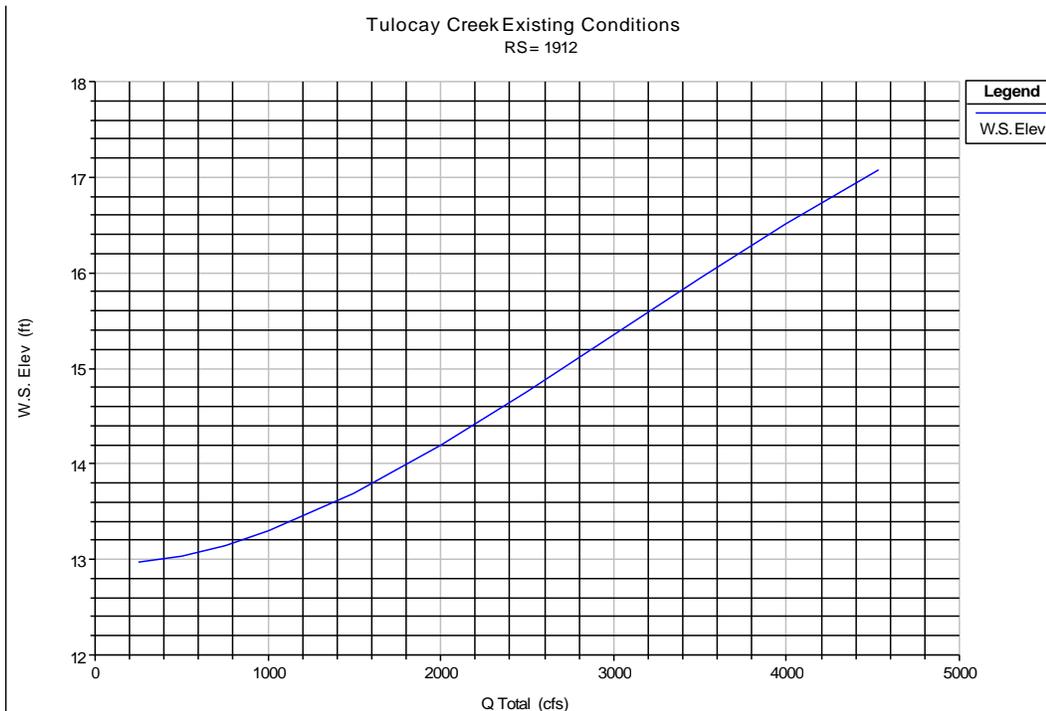
**Figure 2.** Stage-discharge rating for Tulocay Creek Reach 2, obtained from HEC-RAS analysis.

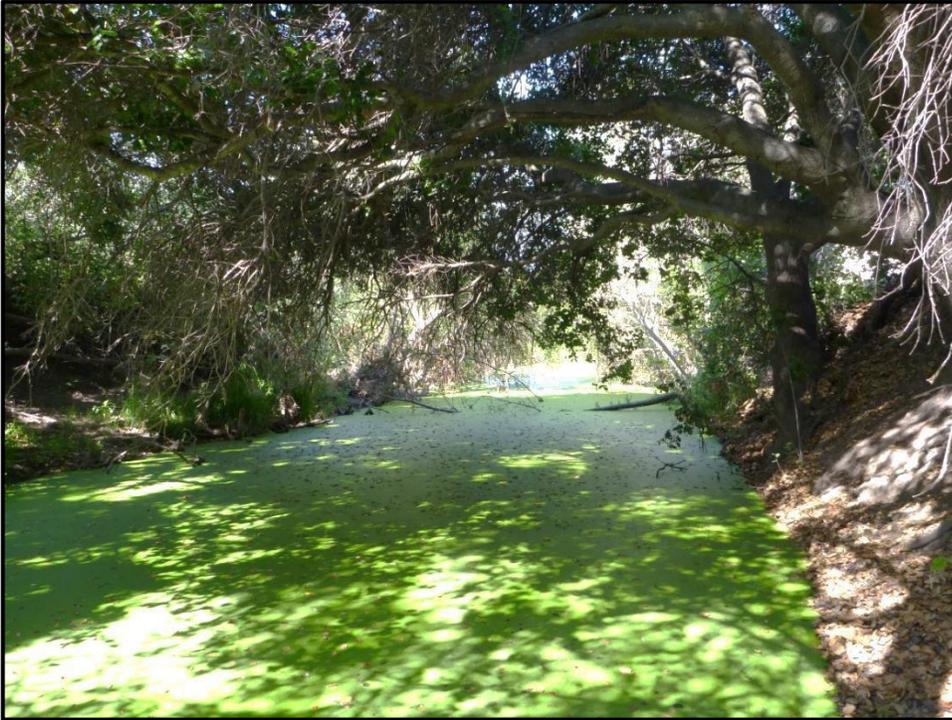
**Figure 5.** The upstream portion of Tulucay Creek Reach 1, looking downstream, showing channel roughness and inundation from beaver activity.  $n=0.04-0.05$

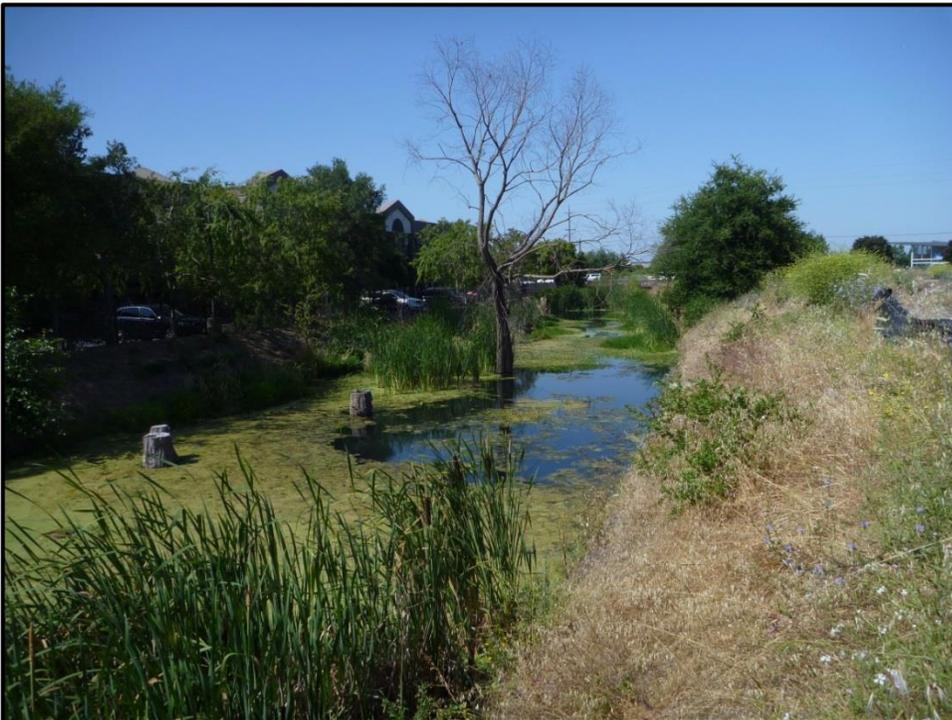
**Figure 6.** The downstream portion of Tulucay Creek Reach 1 looking downstream showing channel roughness and inundation from beaver activity.  $n=0.04-0.05$

RCD conducted a visual assessment of roughness in Tulucay Creek Reaches 1 and 2, collected photographs, and estimated Manning’s roughness coefficients. Figures 5 through 8 depict roughness conditions representative of each reach. Estimated Manning’s roughness coefficients are provided in the figure captions.

RCD's selection of Manning's Roughness Coefficients for Reach 1 (n=0.04 to 0.05) closely agree with those used by WEST in the HEC-RAS analysis (n=0.045). Since the analysis indicated that the reach will convey the channel capacity objective flow under these roughness conditions, the channel roughness objective for Reach 1 should be set at 0.045.

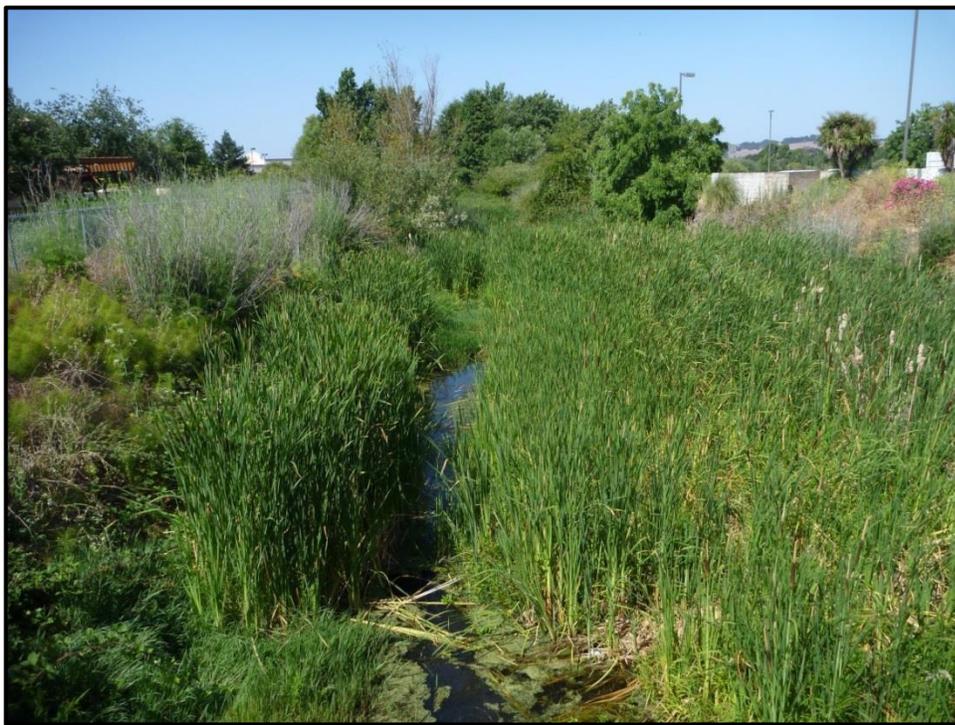
**Figure 7.** Tulucay Creek Reach 2 looking downstream from Soscol Avenue bridge showing channel roughness.  $n=0.1-0.15$

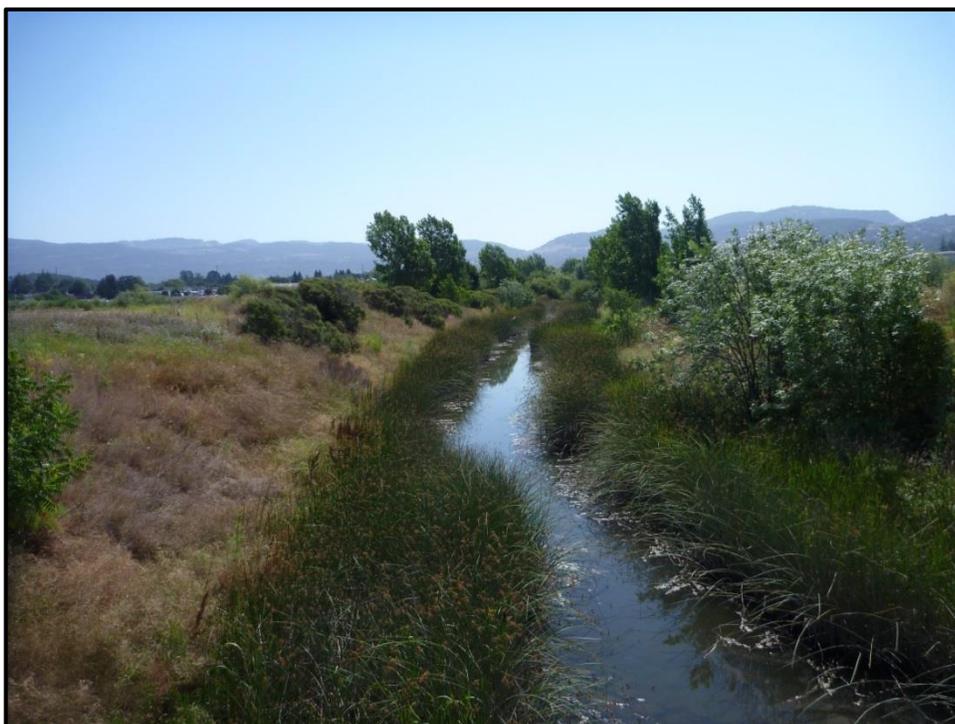
**Figure 8.** Tulucay Creek Reach 2 looking upstream from the railroad bridge at the downstream boundary of the reach, showing channel roughness.  $n=0.04-0.045$

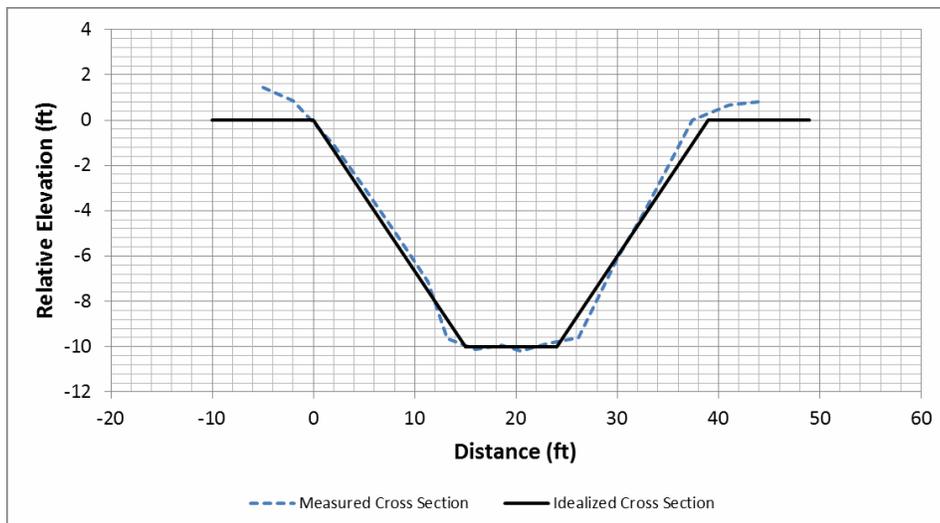
RCD measured the cross section by stretching a tape between the tops of the banks perpendicular to the channel centerline. Elevations were measured with a theodolite and stadia rod relative to NGVD29. The measured cross section was plotted and an idealized cross section was fit to the plot (Figure 9). This idealized cross section represents the most-contracted, yet stable, configuration of the channel. The capacity of the actual channel, which widens downstream, will be greater.

**Figure 9.** Idealized cross section, Camille Creek, based on a measured cross section at a carefully selected location.

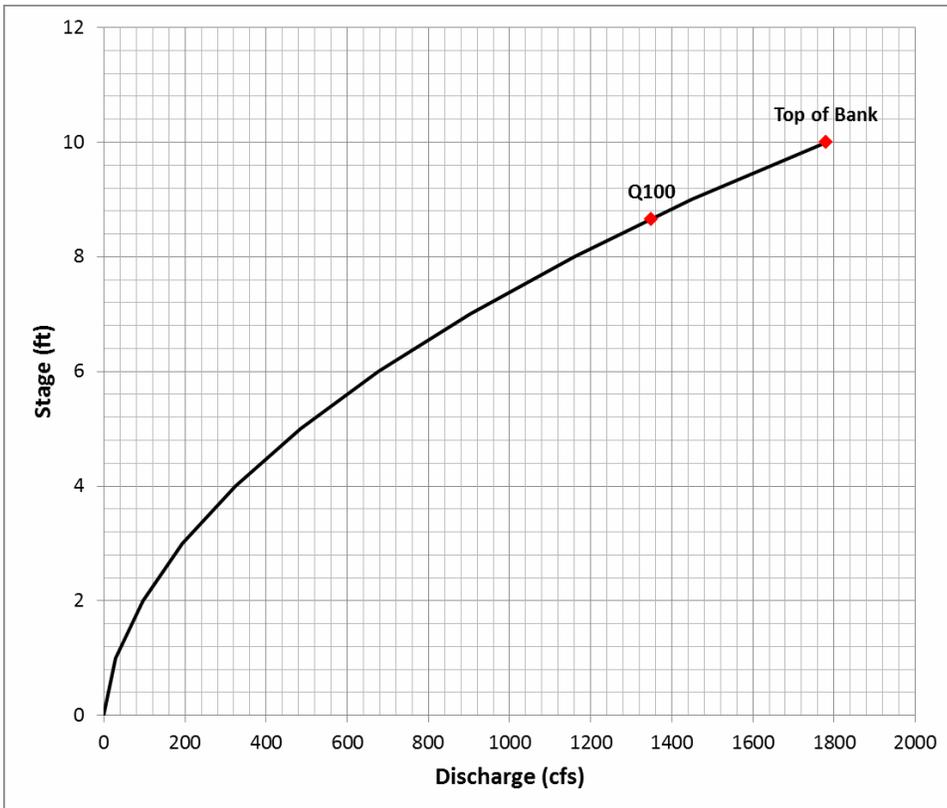
This rating, though useful for estimating channel capacity and specifically for comparison of channel capacity to the Q100, is based on generalizations and applies to the reach as a whole, not to stage at a specific location. To estimate the discharge associated with an observed stage in the reach, the headwater elevation to discharge rating from the HY-8 analysis of the South Terrace Drive culvert is provided as Figure 11. This rating predicts discharge based on the headwater depth of the South Terrace Drive culvert. Due to the short length of the reach, the absence of tributaries, and the small amount of additional contributing drainage area, this estimate is also applicable to any location in the maintained reach for many purposes, including guiding channel maintenance decisions.

Figure 10. Stage-discharge rating for Camille Creek, obtained from channel analysis using idealized cross section.

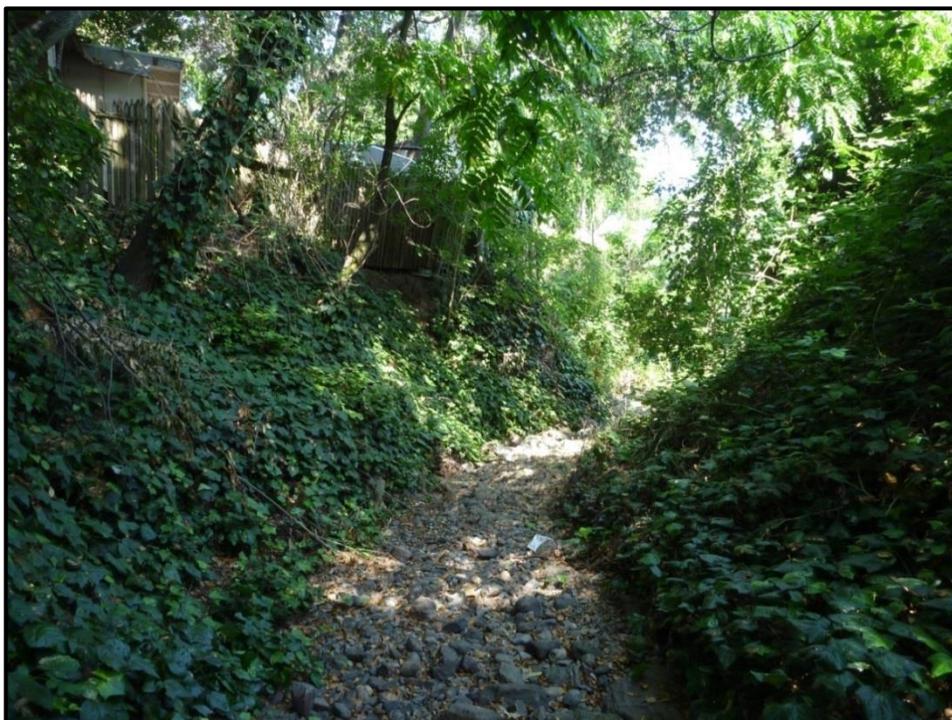
RCD considers the current condition of the channel to be stable and in a quasi-equilibrium state, and analysis reveals that the most-confined portion of the reach will convey the Q100 under the current roughness conditions. Therefore, the current roughness conditions should be maintained to ensure continued conveyance of the Q100, and the Channel Roughness Objective should be set at 0.05.

**Figure 12.** Camille Creek looking downstream showing channel roughness. RCD selected an overall Manning's Roughness Coefficient of 0.05 for the reach.

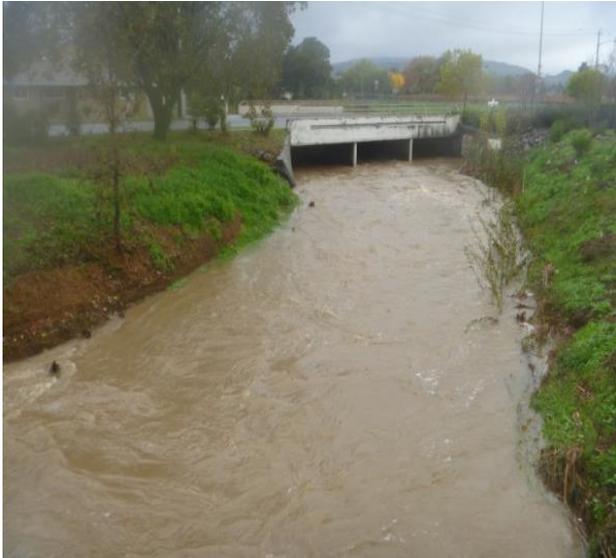
**Photo 2-1:** Trower St. bridge on 12-2-2012 at 9:34 am

The District will carry out high flow monitoring during winter months for all flood control channels being assessed. The high flow monitoring photos will help the District develop a more accurate understanding of channel capacity and stage discharge relationships.

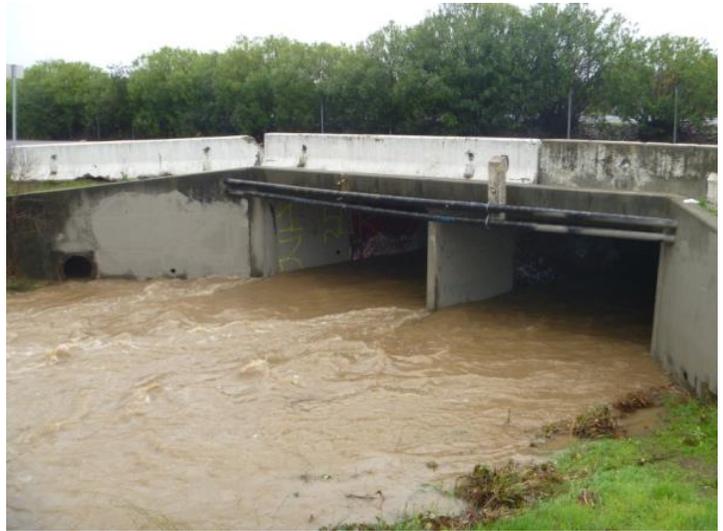
**Photo 2-2:** Byway east bridge on 12-2-2012 at 9:44 am

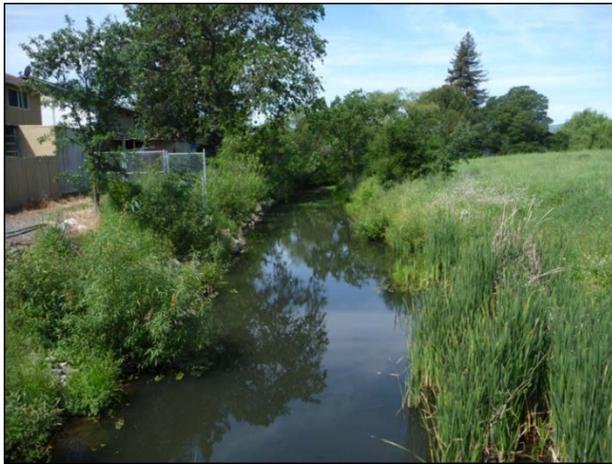
**Photo 2-3:** Reach 1 looking upstream showing channel roughness.  $n=0.030-0.040$

These n values are estimates of the maximum channel roughness in each reach that will convey the channel capacity flow through the idealized cross section, and represent the roughness objectives for the reaches. RCD collected photographs of the three reaches to depict current roughness conditions for comparison to the roughness objectives. Photos 2-3, 2-4, and 2-5 show roughness conditions that are representative of Reaches 1, 2, and 3, respectively. Roughness estimates for each reach are provided in the figure captions.

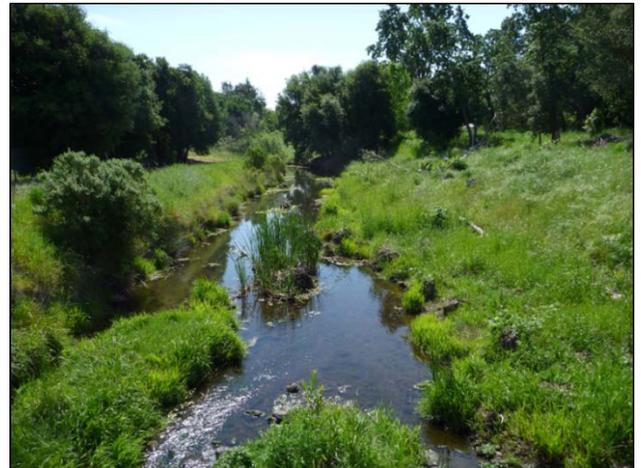
**Photo 2-4:** Reach 2 looking downstream showing channel roughness.  $n=0.030-0.040$

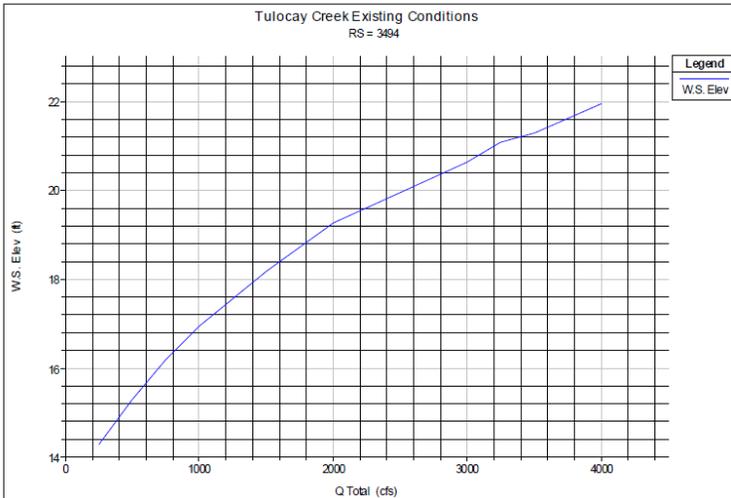
**Figure 3-1:** Stage-discharge rating for Tulucay Creek Reach 1, obtained from HEC-RAS analysis.

The HEC-RAS analysis was also used to generate stage-discharge ratings for both reaches (Figures 1 and 2). Ratings are associated with a particular cross section location on a stream, so RCD selected cross sections from the model that represented the reach. For Reach 1, RCD selected the downstream-most cross section that was above the poorly-represented "flood wall" subreach described above. For Reach 2, RCD selected a cross section near the top of the reach which represents the minimum capacity of the channel.

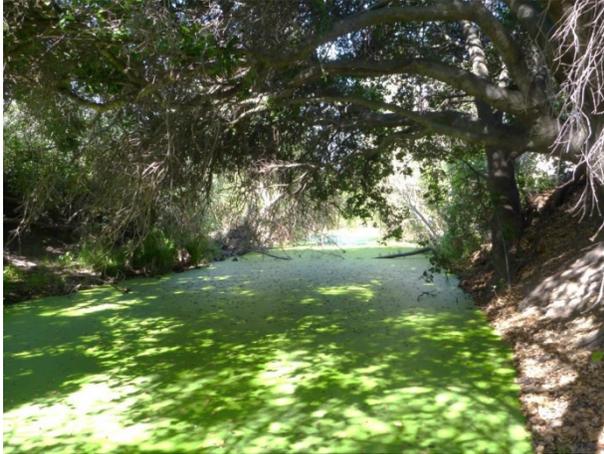
**Photo 3-1:** The upstream portion of Tulucay Creek Reach 1, looking downstream, showing channel roughness and inundation from beaver activity.  $n=0.04-0.05$

RCD conducted a visual assessment of roughness in Tulucay Creek Reaches 1 and 2, collected photographs, and estimated Manning's roughness coefficients. Photos 3-1 through 3-4 depict roughness conditions representative of each reach. Estimated Manning's roughness coefficients are provided in the figure captions.

RCD’s selection of Manning’s Roughness Coefficients for Reach 1 (n=0.04 to 0.05) closely agree with those used by WEST in the HEC-RAS analysis (n=0.045). Since the analysis indicated that the reach will convey the channel capacity objective flow under these roughness conditions, the channel roughness objective for Reach 1 should be set at 0.045.

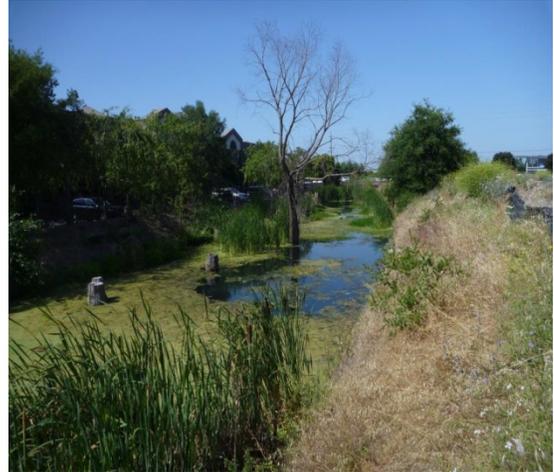
**Photo 3-2:** The downstream portion of Tulucay Creek Reach 1 looking downstream showing channel roughness and inundation from beaver activity.  $n=0.04-0.05$

As evident from Figures 1 and 2, Reach 1 has been completely inundated with backwater from a beaver dam located just upstream of the Soscol Avenue bridge. Beavers are common in the Napa River system and seem to be increasing in population. In general, local beaver activity is not known to lead to significant channel capacity decreases and potential stream flooding issues due to the large size and intensity of local winter storm flows, which tend to wash out the dams on an annual basis; however, this particular dam appears to be quite resilient. It seems to have withstood a medium-size flow on December 11, 2014, estimated (roughly) at approximately 800 cfs, with little damage, or at least in a condition in which it could be quickly repaired. It is still assumed that larger flows would wash out beaver dams and restore full channel capacity.

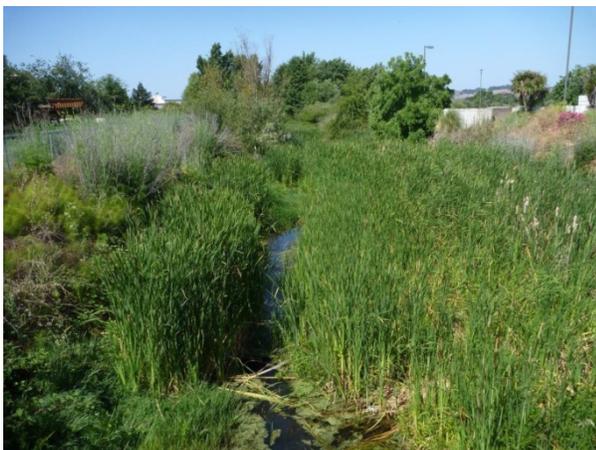
**Photo 3-3:** Tulucay Creek Reach 2 looking downstream from Soscol Avenue bridge showing channel roughness.  $n=0.1-0.15$

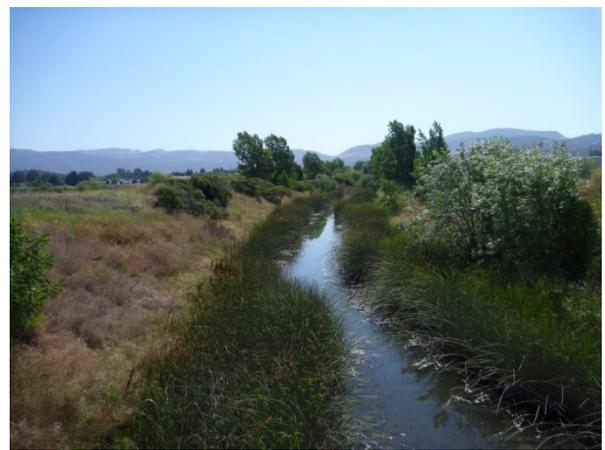
**Photo 3-4:** Tulucay Creek Reach 2 looking upstream from the railroad bridge at the downstream boundary of the reach, showing channel roughness.  $n=0.04-0.045$

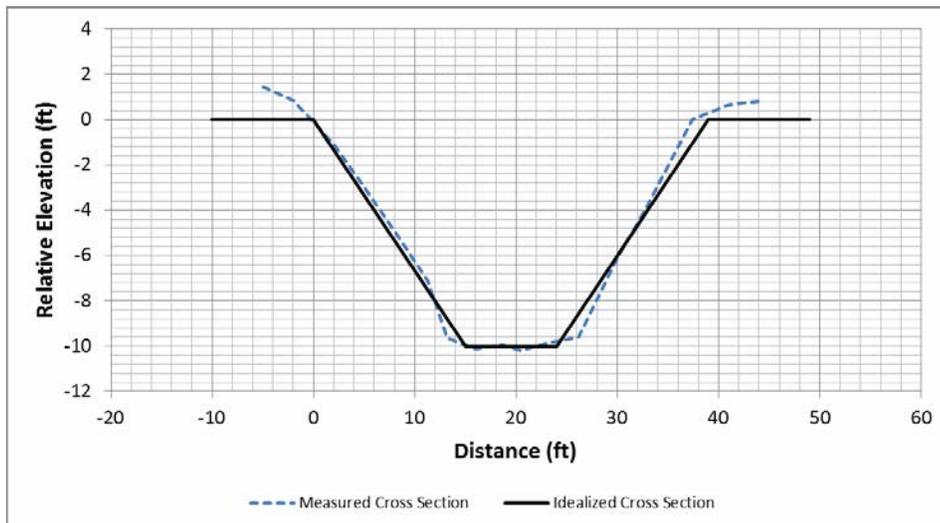
RCD measured the cross section by stretching a tape between the tops of the banks perpendicular to the channel centerline. Elevations were measured with a theodolite and stadia rod relative to NGVD29. The measured cross section was plotted and an idealized cross section was fit to the plot (Figure 4-1). This idealized cross section represents the most-contracted, yet stable, configuration of the channel. The capacity of the actual channel, which widens downstream, will be greater.

**Figure 4-1:** Idealized cross section, Camille Creek, based on a measured cross section at a carefully selected location.

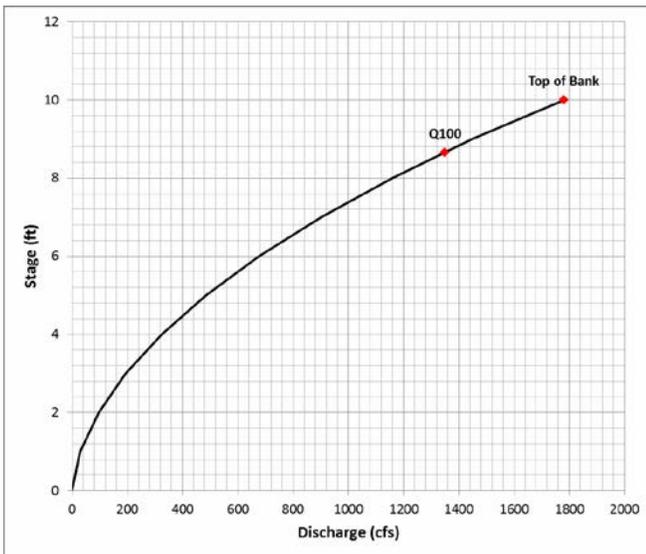
This rating, though useful for estimating channel capacity and specifically for comparison of channel capacity to the Q100, is based on generalizations and applies to the reach as a whole, not to stage at a specific location. To estimate the discharge associated with an observed stage in the reach, the headwater elevation to discharge rating from the HY-8 analysis of the South Terrace Drive culvert is provided as Figure 4-3. This rating predicts discharge based on the headwater depth of the South Terrace Drive culvert. Due to the short length of the reach, the absence of tributaries, and the small amount of additional contributing drainage area, this estimate is also applicable to any location in the maintained reach for many purposes, including guiding channel maintenance decisions.

**Figure 4-2:** Stage-discharge rating for Camille Creek, obtained from channel analysis using idealized cross section.

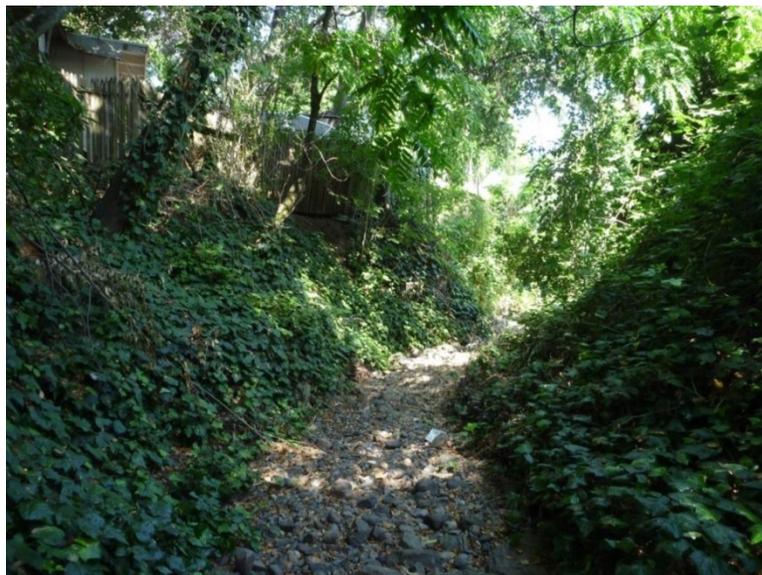
RCD considers the current condition of the channel to be stable and in a quasi-equilibrium state, and analysis reveals that the most-confined portion of the reach will convey the Q100 under the current roughness conditions. Therefore, the current roughness conditions should be maintained to ensure continued conveyance of the Q100, and the Channel Roughness Objective should be set at 0.05

**Photo 4-1:** Camille Creek looking downstream showing channel roughness. RCD selected an overall Manning's Roughness Coefficient of 0.05 for the reach.

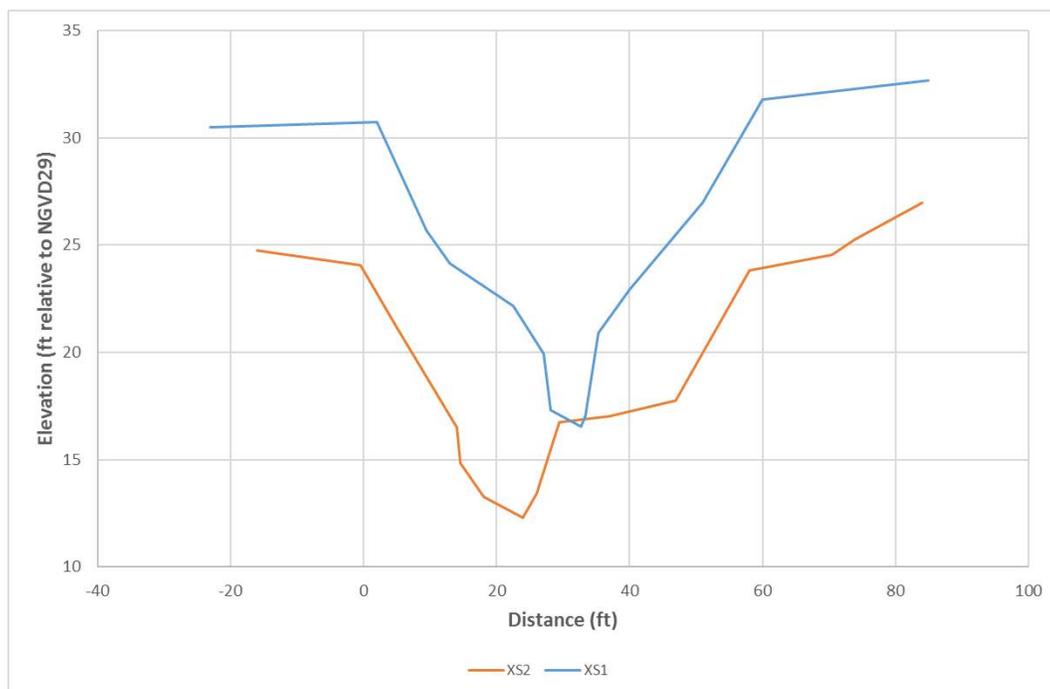
RCD visited the maintained reach of Fagan Creek in July 2016 and surveyed two channel cross sections (XS1 and XS2) at locations carefully selected to represent each respective subreach. The cross sections are shown in Figure 5-2. Surveying was performed with a theodolite and stadia rod relative to NGVD29 (Napa County benchmark A-C). Lateral distance was measured with a tape. RCD surveyed the configurations of stream crossings and other structures in the reach. Structures included the Airport Road bridge, a concrete grade-control weir, and the 1,300-foot runway culvert. RCD also performed a visual assessment of the bed and banks and collected data for an assessment of roughness conditions in the channel.

**Figure 5-2** Fagan Creek channel cross sections XS1 and XS2, shown looking downstream.

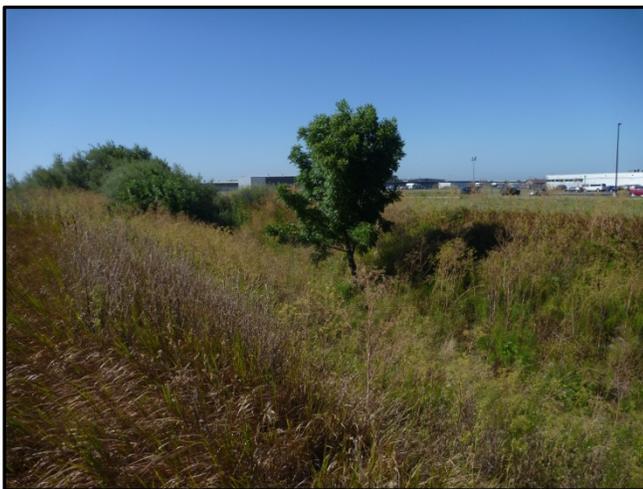
**Photo 5-1:** The upstream portion of the Fagan Creek maintenance reach, looking obliquely upstream from the right bank, showing channel roughness.

RCD estimates roughness by visually assessing and photographing channel conditions, and then employing the procedure outlined in *Guide for Selecting Manning's Roughness Coefficients for Natural Channels and Flood Plains* (USGS 1989). For the maintained reach of Fagan Creek, RCD noted firm soil substrate, low irregularity, gradual variation in cross section, negligible obstructions, low degree of meandering, and medium to large amounts of vegetation. Figures 5-1 through 5-3 depict roughness conditions in the reach.

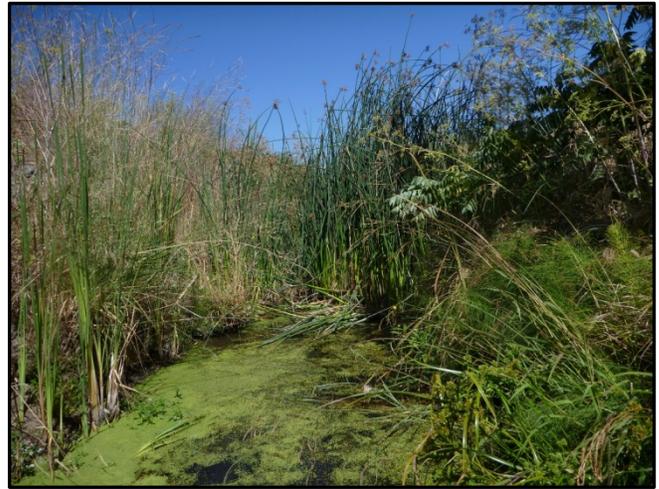
**Photo 5-2:** The upstream portion of the Fagan Creek maintenance reach, looking obliquely upstream from the right bank, showing channel roughness.

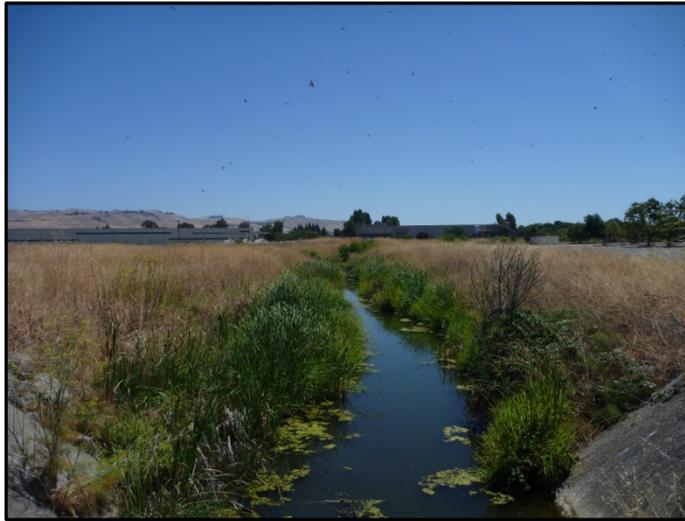
**Photo 5-3:** Fagan Creek maintenance reach, looking upstream from the inlet of the runway culvert, showing channel roughness.

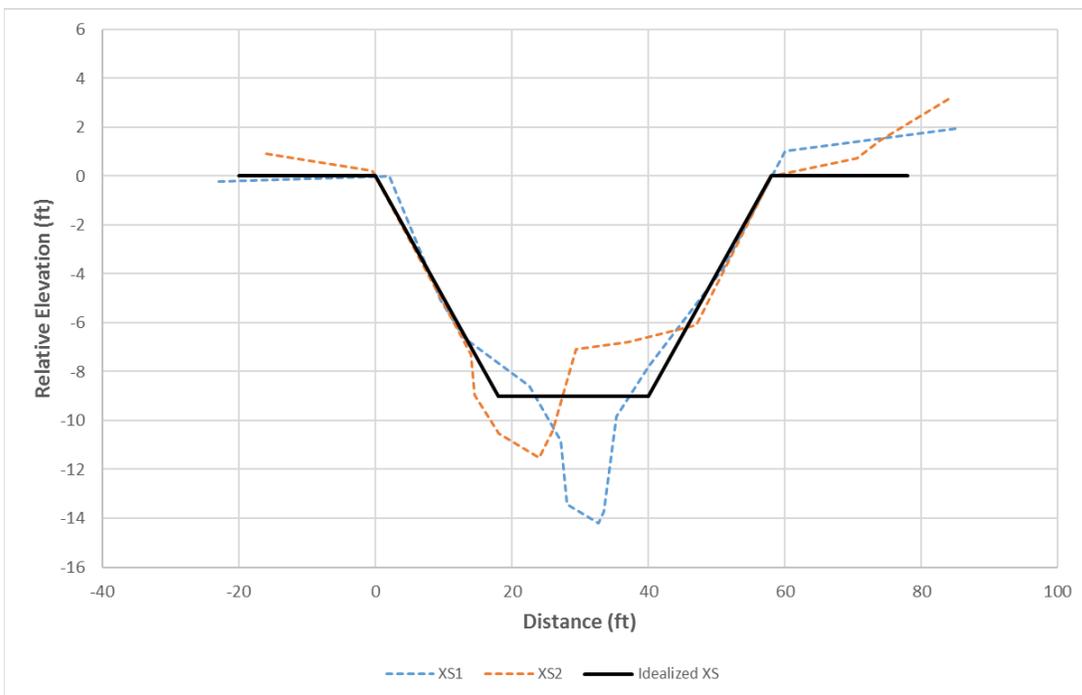
The channel assessment identified a low-flow trench in the bottom of the channel of the maintained reach of Fagan Creek that appeared to have been created by erosion. The banks of the channel appeared to be well-vegetated and stable. A review of historical air photos indicated that the trench existed in similar condition in 2002, indicating that erosion of the streambed has stabilized since channel construction. Therefore, the current dimensions of the channel, and not the original dimensions, should be maintained. To determine objectives for channel dimensions, RCD used the approximate bank slopes from cross sections XS1 and XS2 and computed the required width and depth of an idealized trapezoidal channel that would convey the Q100 under current roughness conditions and channel slope (Figure 5-2). The dimensions of this idealized channel cross section were used to set the channel dimension objectives (Table 5-3).

**Figure 5-3:** Idealized trapezoidal channel cross section for the maintained reach of Fagan Creek, overlaid on cross sections XS1 and XS2, shown looking downstream.

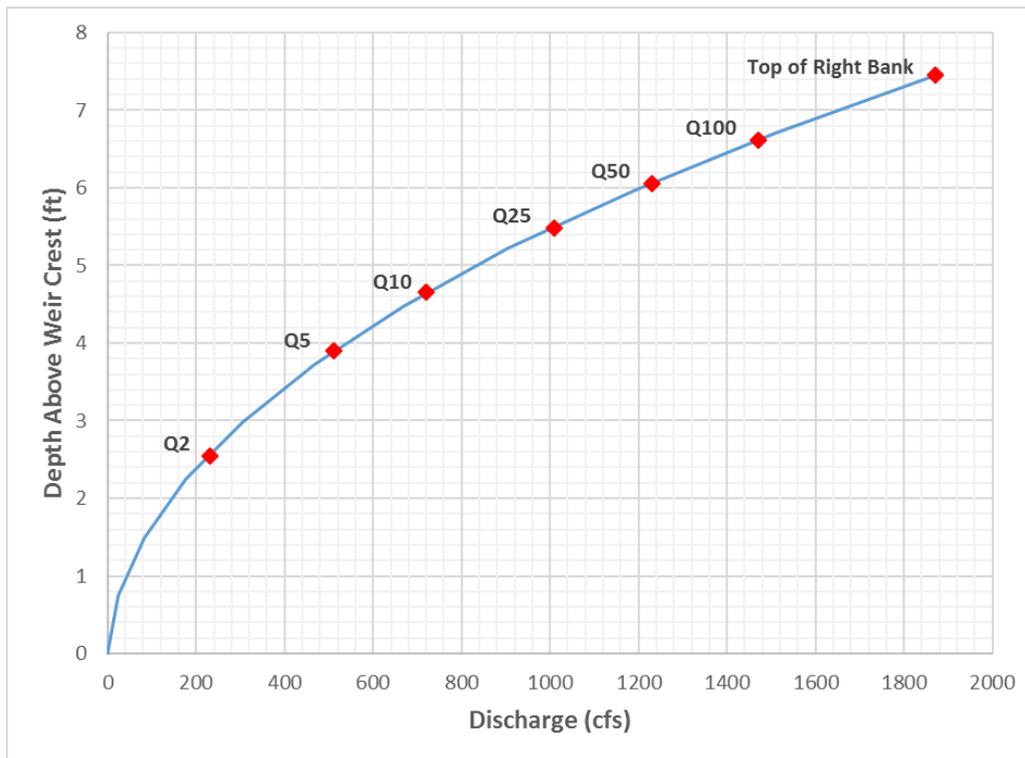
**Figure 5-4:** Stage-discharge rating for Fagan Creek concrete weir, obtained from Hydraulic Toolbox analysis. The red points show the water depth at the estimated recurrence interval peak flows.

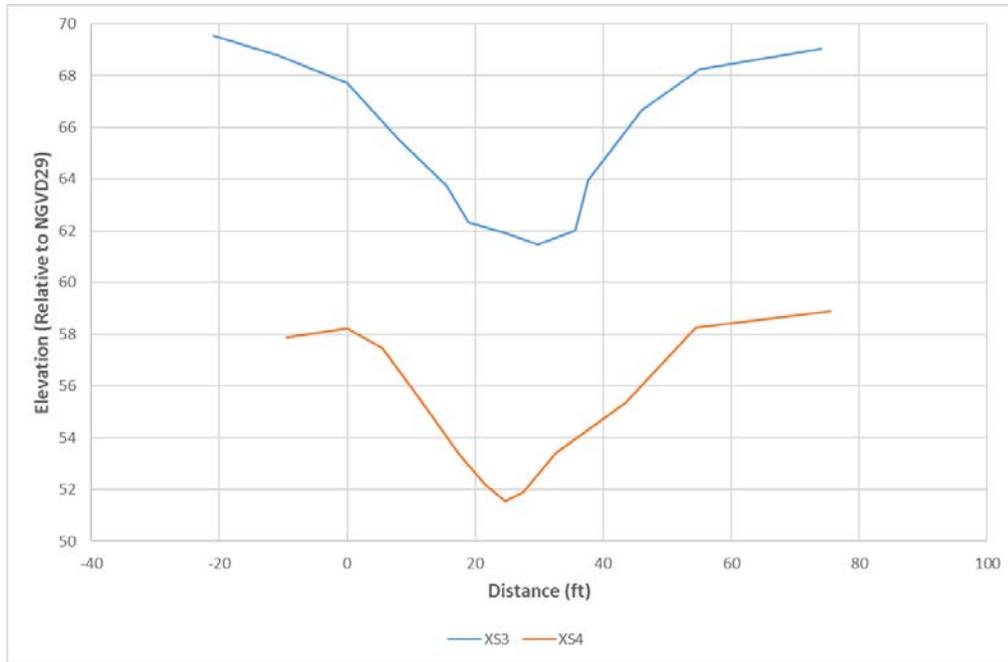
**Figure 6-2:** Sheehy Creek channel cross sections XS3 and XS4, shown looking downstream.
