## **Napa County Stream Maintenance Manual**

*Prepared for:*

Napa County Flood Control and Water Conservation District  
804 First Street  
Napa, CA 94559  
Contact: Michael Gordon, Watershed and Flood Control Resource Specialist  
707/259- 8684

January 2019

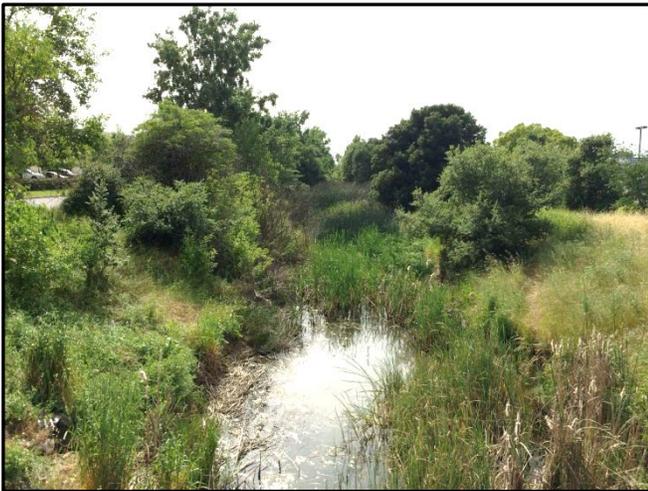
**Photo 6-1:** The maintained reach of Sheehy Creek looking downstream from the Kelly Road culvert, showing channel roughness.

As part of the roughness assessment, RCD noted firm soil substrate, low irregularity, gradual variation in cross section, negligible obstructions, low degree of meandering, and large amounts of vegetation. Figures 6-1 and 6-2 depict roughness conditions in the reach.

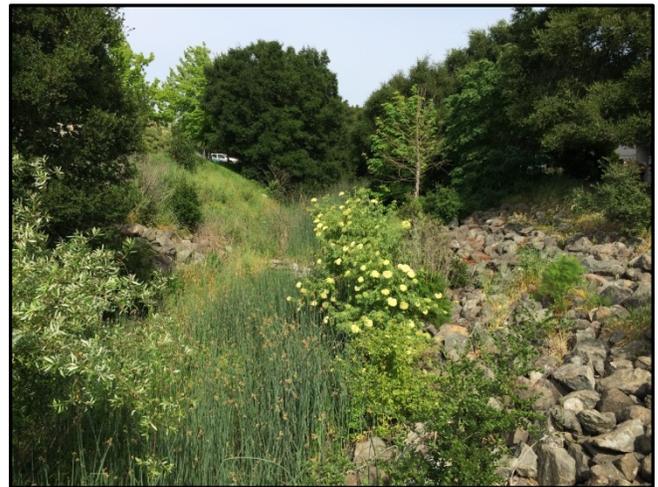
**Photo 6-2:** The maintained reach of Sheehy Creek looking upstream from the Hwy 29 culvert, showing channel roughness.

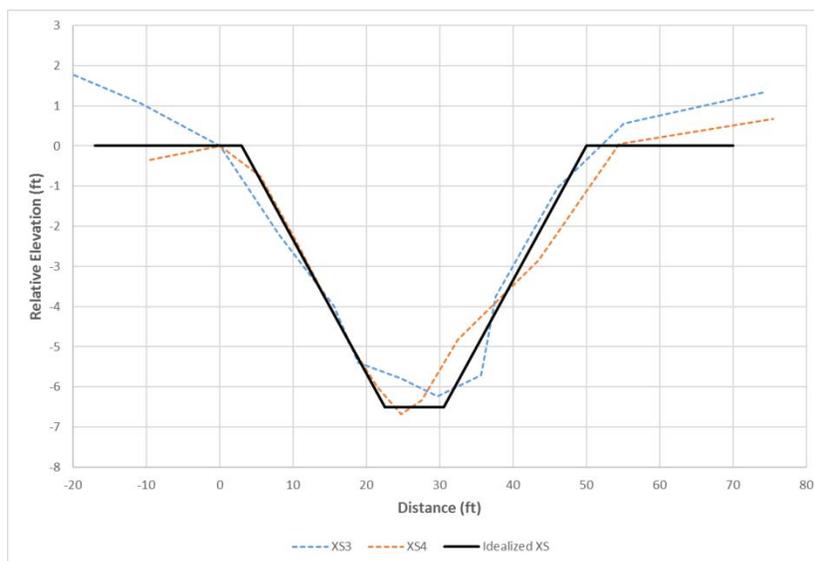
**Figure 6-3:** Idealized trapezoidal channel cross section for the maintained reach of Sheehy Creek, overlaid on cross sections XS3 and XS4, shown looking downstream.

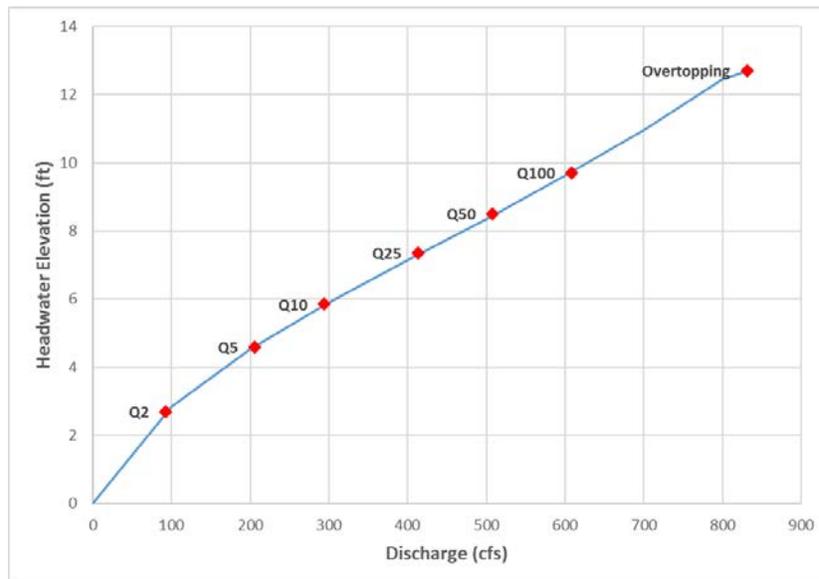
**Figure 6-4:** Stage-discharge rating for inlet of Sheehy Creek Hwy 29 culvert, obtained from HY-8 analysis. The red points show the water depth at the estimated recurrence interval peak flows.

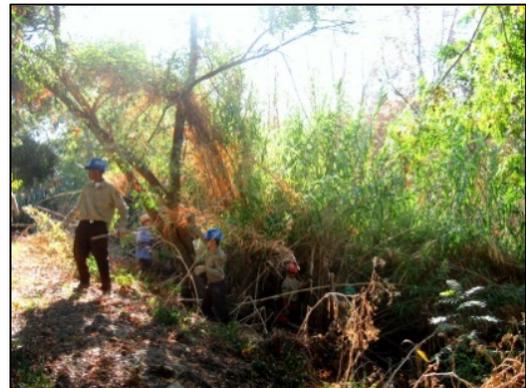
*Arundo donax* removal by California Conservation Corps team

*Arundo* is a bamboo-like plant targeted by the District as a priority weed. This species reproduces vegetatively and does not produce viable seed. When established within stream channels, *Arundo* can quickly reduce channel capacity, increase hydraulic roughness, and increase the flood risk. The plant's shallow roots encourage mobility in high flow events. Dislodged *Arundo* pieces move downstream, often plugging culverts or creating debris blockages at bridge crossings. Upon settling, *Arundo* will

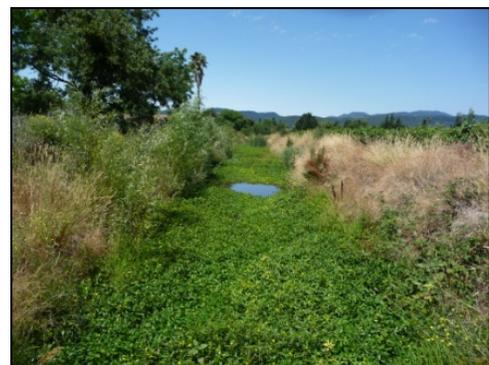
*Ludwigia* in Yountville Outfall

*Priority:* Moderate (on surface of water). *Ludwigia* is an invasive, exotic, aquatic weed found in apparently increasing occurrence on the west coast as well as nationally. The species occurs in tributaries to the Napa River, including Salvador Creek. Generally, winter streamflow rises above the *Ludwigia* patches or flushes the plants downstream. In most cases, *Ludwigia* patches are not problematic in conveying flood flows. However, accumulated *Ludwigia* is known to collect at downstream bridge piers where it can quickly grow, completely fill channels (as shown in the photo), and create flow blockages. *Ludwigia* also provides some beneficial functions similar to the native species (*Ludwigia peploides peploides*) including, bank toe stabilization, nutrient exchange and uptake, and cover for young fish and amphibians. While these functions may not be enough to support presence of *Ludwigia* in District flood control channels, it does provide sound reasoning for leaving it in a channel if there is no other emergent cover, or where the degree of *Ludwigia* present does not create a flow blockage.

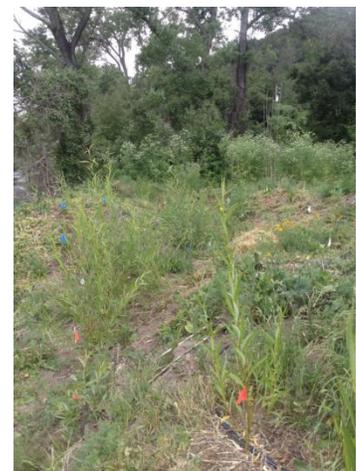
Photo 2: Example of revegetation site.

In treatment areas that have had impacts to non-target species the District is actively working on implementing riparian enhancement efforts. These efforts include a variety of strategies as described above and are dependent on site conditions. At revegetation sites the District will typically over plant with the understanding that about 10 percent of the installed plants may not survive due to site constraints, such as soil conditions, water, or other disturbances. As noted above, there were 43 impacted trees indicating 202 native riparian trees as mitigation; and the District has thus far implemented six revegetation projects within the reach that include 303 native trees (**Appendix A**). This high density planting will be continued at other revegetation sites to ensure that temporary impacts are fully mitigated and the riparian corridor is enhanced as planned.

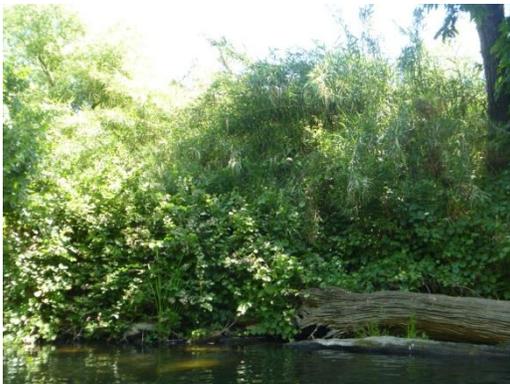
Photo 3: Example of large patch of Arundo along Streambank.

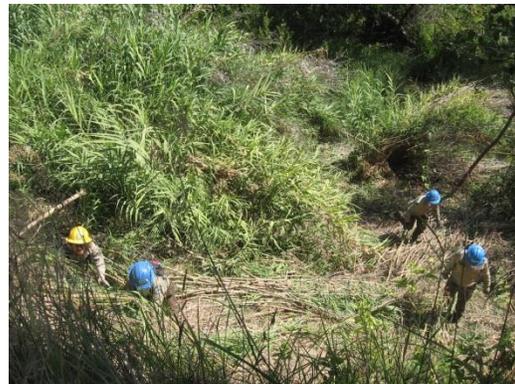
Photo 4: CCC crew removing Arundo Biomass.

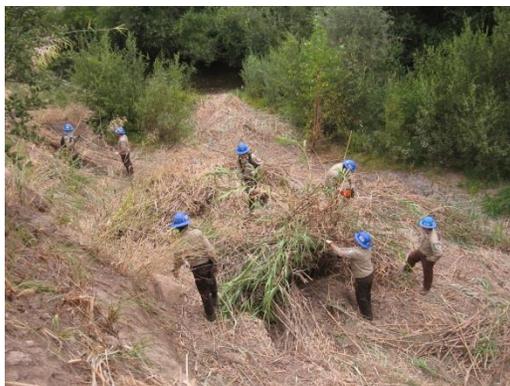
Photo 5: CCC crew completing Arundo biomass removal.

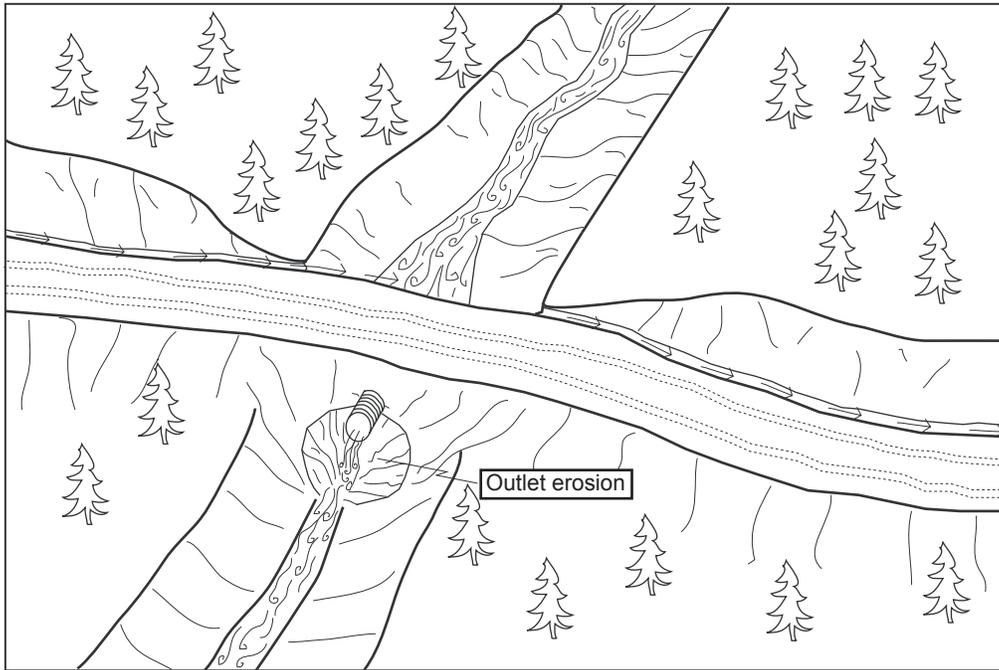
**Problem:** Culvert set high in outboard fill has resulted in scour of the outboard fill face and natural channel.

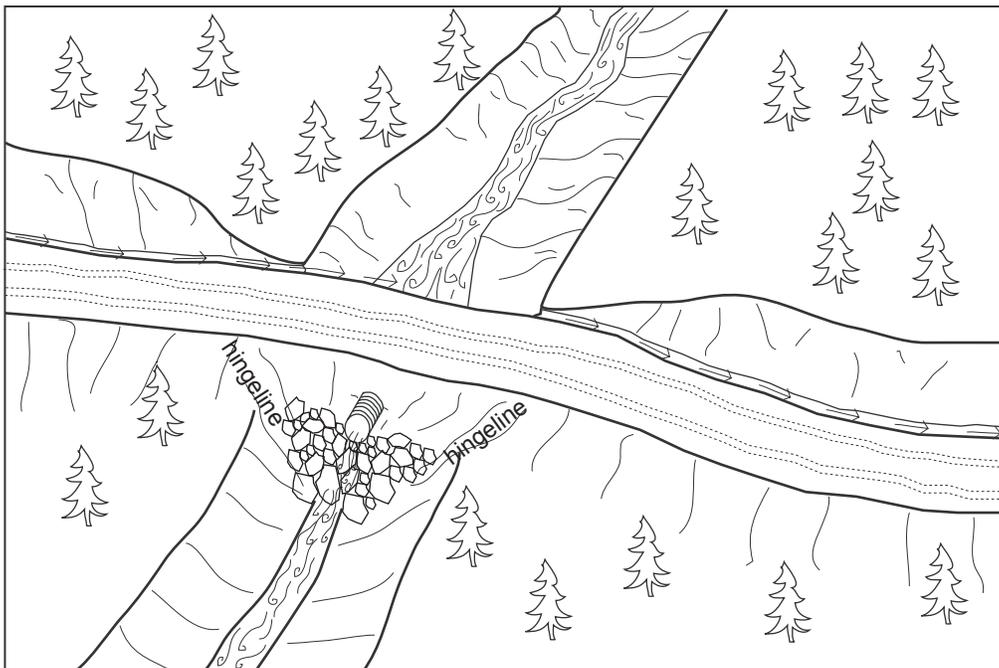
**Action:** The area of scour is backfilled with rip-rap to provide protection in the form of energy dissipation for the remaining fill face and channel.

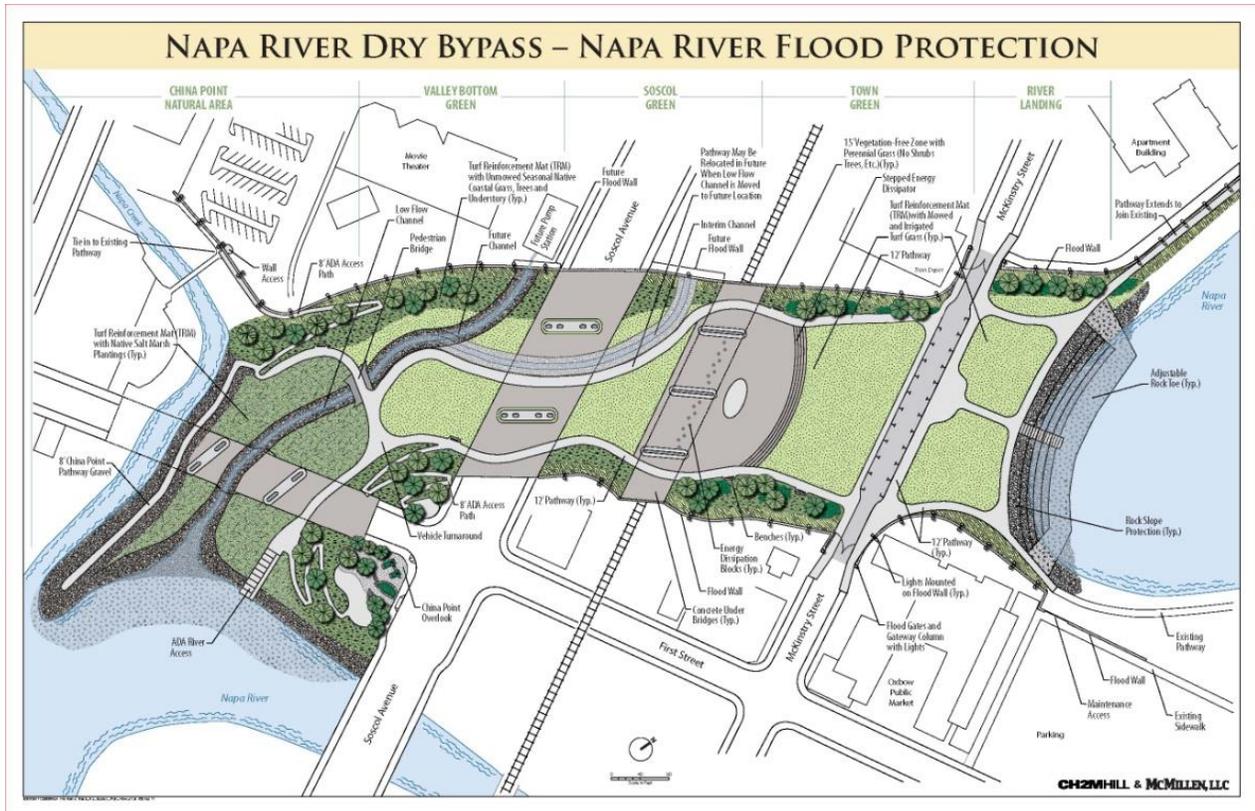
Figure 5-11: Site 3: Dry Bypass Project Features

The Napa Dry Bypass channel is comprised of a man-made channel which is planted with a varied plant community. Planting includes Brackish Emergent Marsh, Upland Native and Native grasses, and turf planted over high performance turf reinforcement matting (HPTRM) material. In addition, various shrubs and trees are planted to stabilize the channel. The channel bottom will be protected by HPTRM and concrete sidewalks. Rock is placed at the inlet and outlet of the channel which are also protected by permanent, capped, sheet piling at both toes. Due to high velocities anticipated within the bypass channel, concrete energy dissipaters are included below the Napa Valley Wine Train (NVWT) Dry Bypass bridge see Figure 5-10 and Figure 5-11.

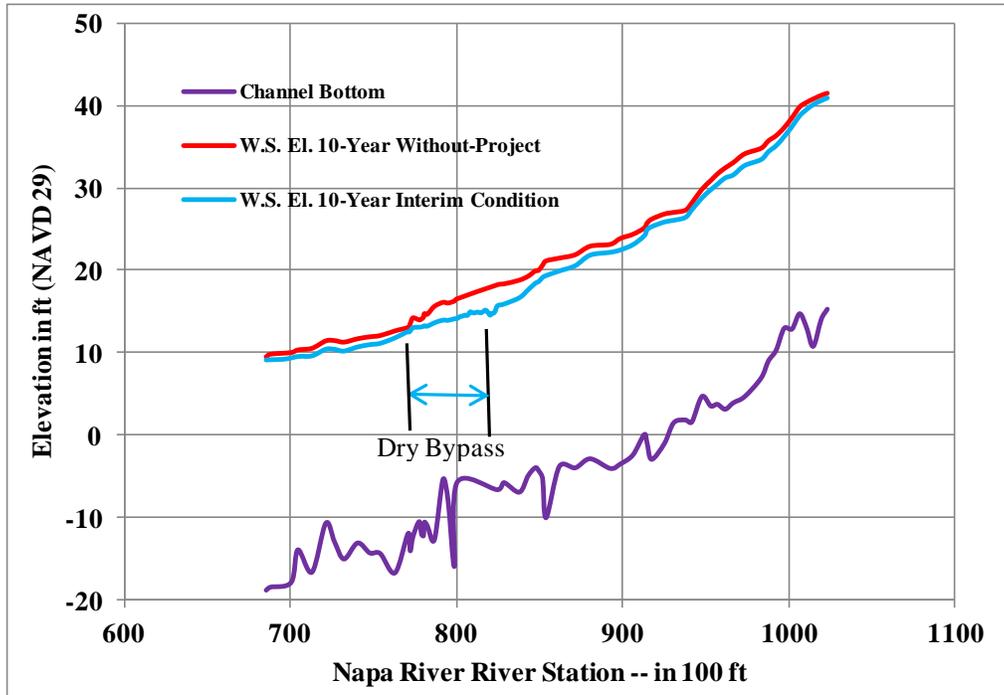
Figure 6-1: Napa River Water Surface Profile Comparison of Without-Project & Interim-Conditions for 1/10 ACE Flood Event

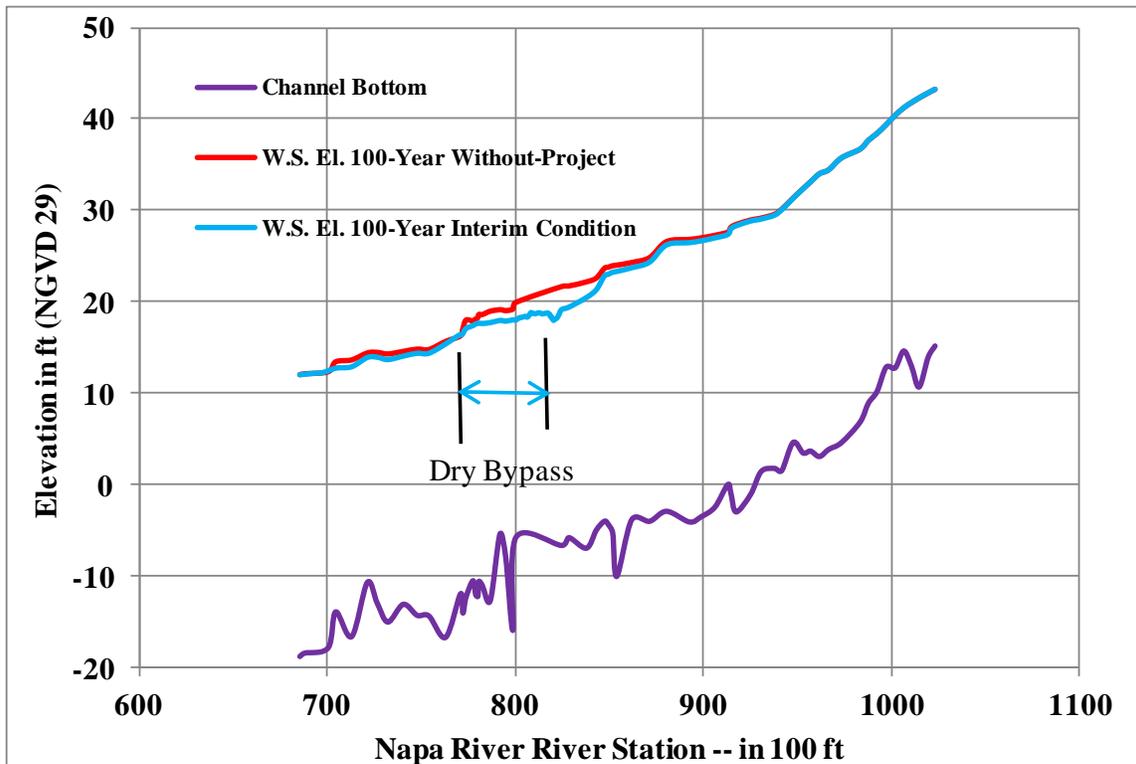
Figure 6-2: Napa River Water Surface Profile Comparison of Without-Project & Interim-Conditions for 1/100 ACE Flood Event

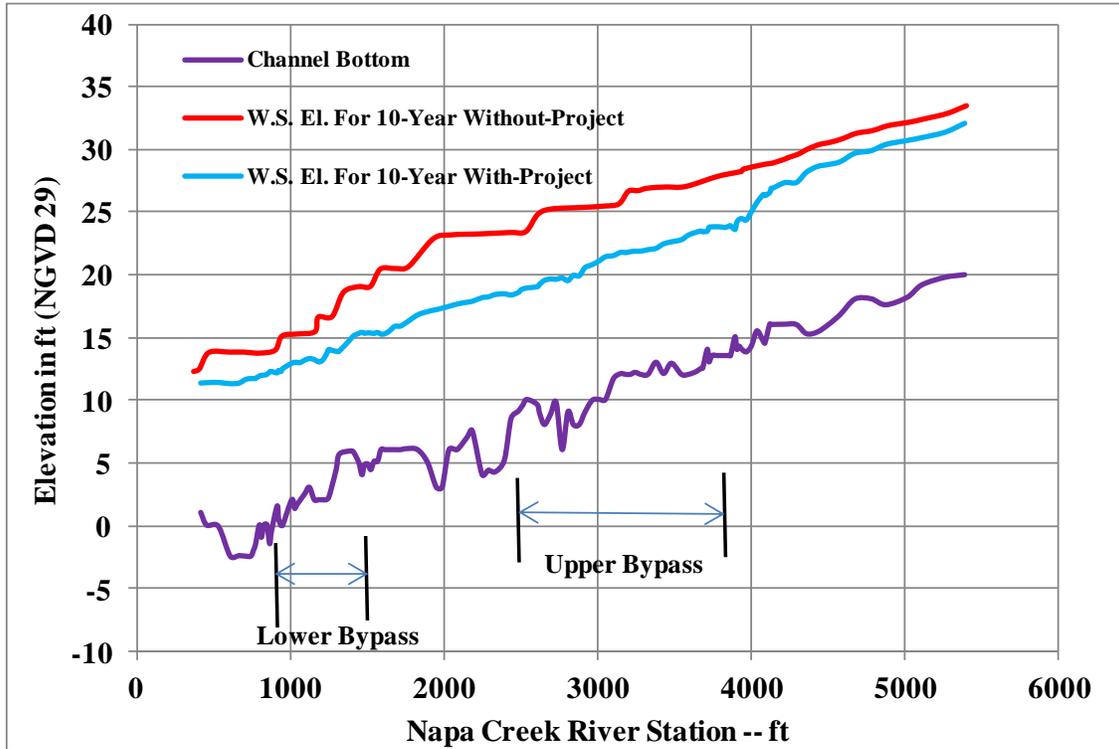
**Figure 6-3: Napa Creek Water Surface Profile Comparison of Without-Project & With-Project Conditions for 1/10 ACE Flood Event**

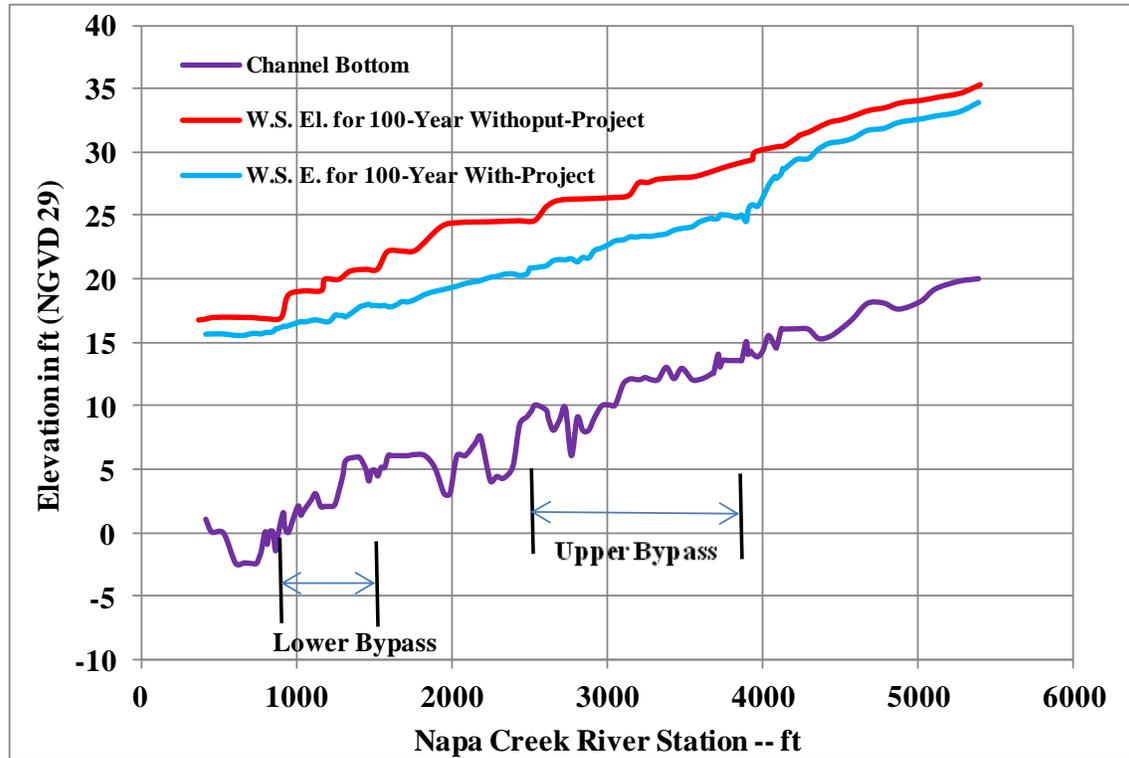
**Figure 6-4: Napa Creek Water Surface Profile Comparison of Without-Project & With-Project Conditions for 1/100 ACE Flood Event**

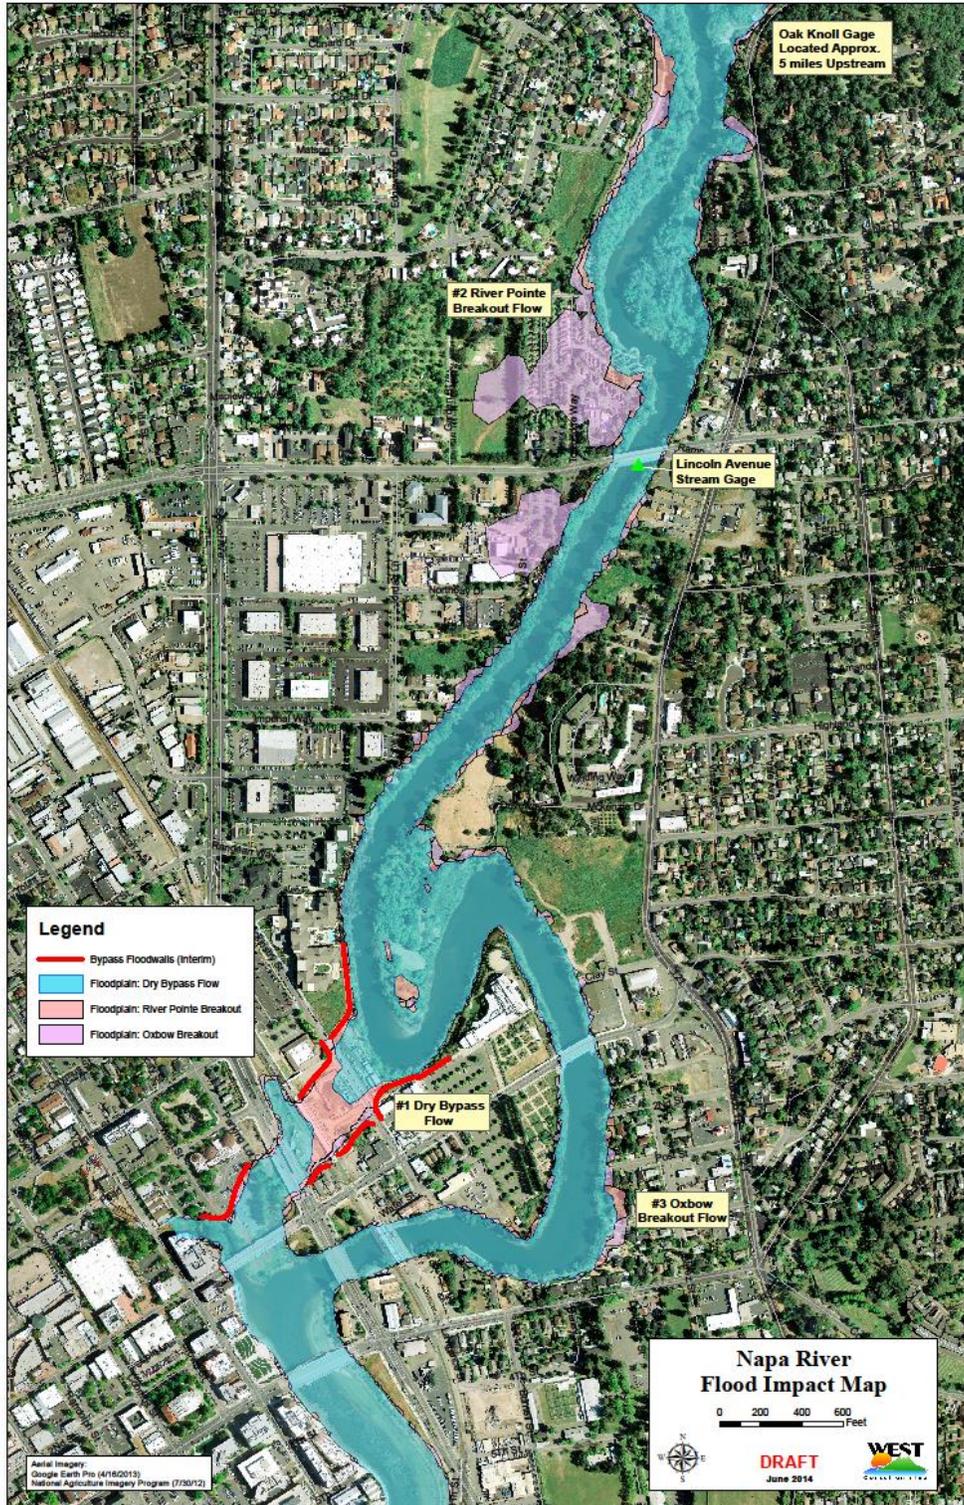
Figure 6-5: Anticipated Breakout Points when the Flood Events Exceed the Interim Condition for Napa River

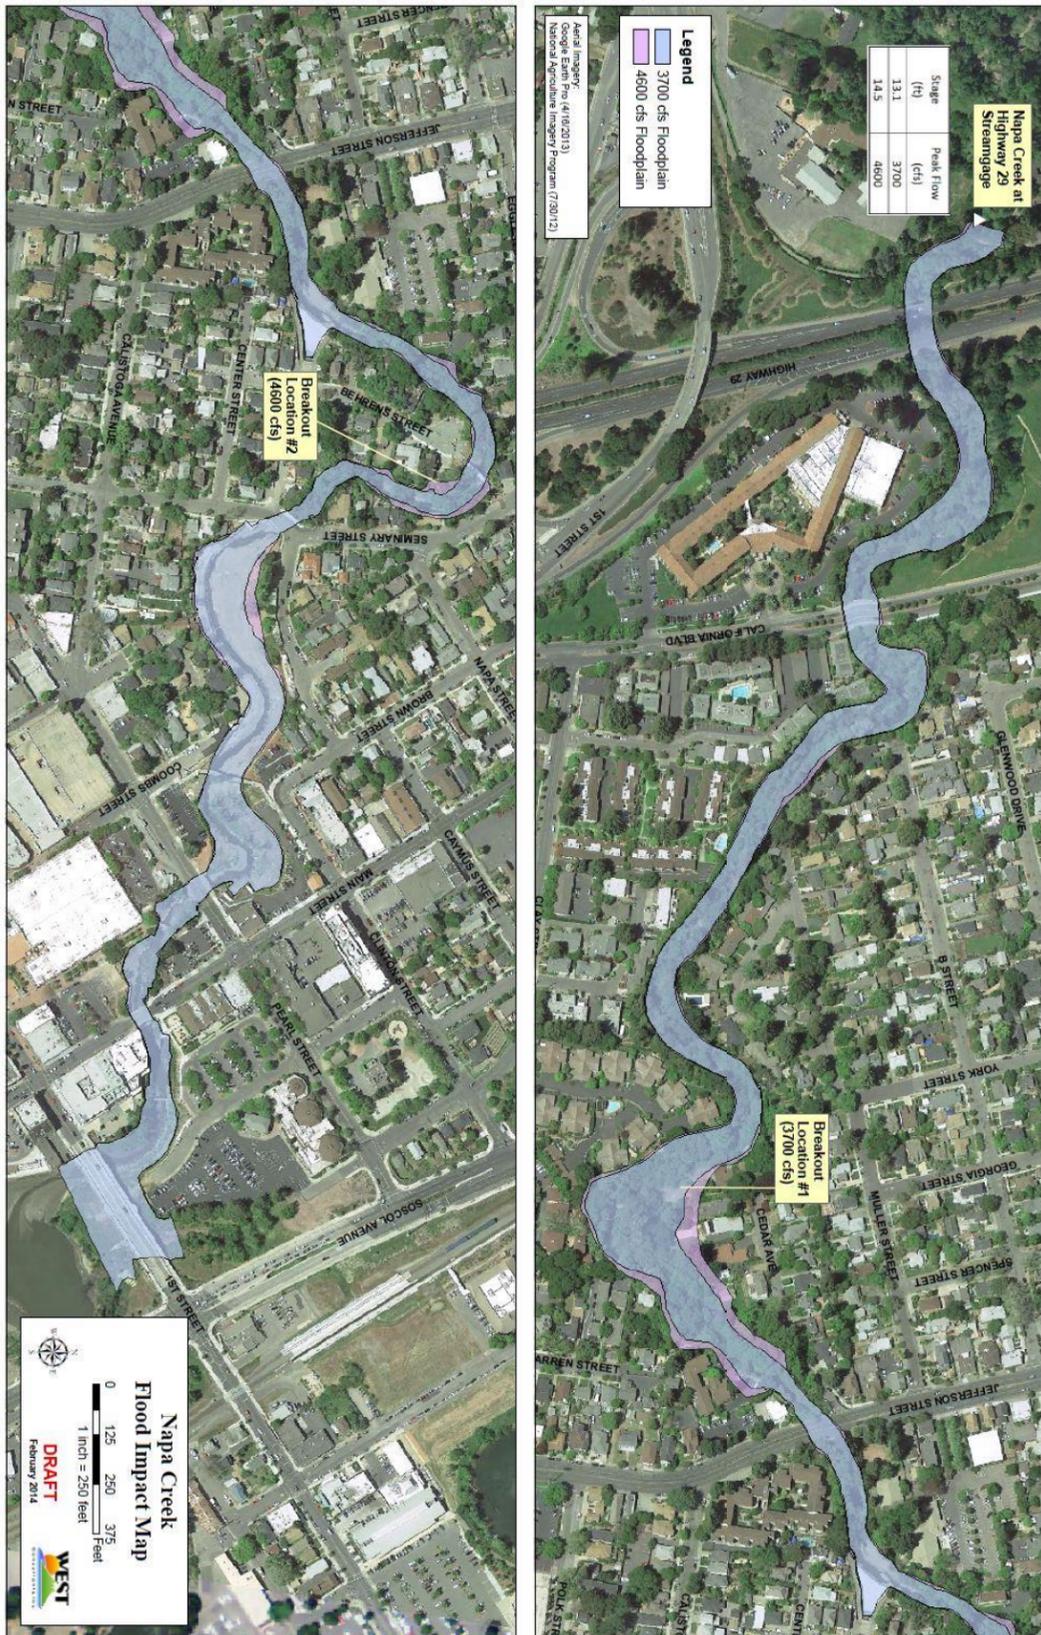
Figure 6-6: Anticipated Breakout Points when the Flood Events Exceed the 1/100 ACE Event for Napa Creek

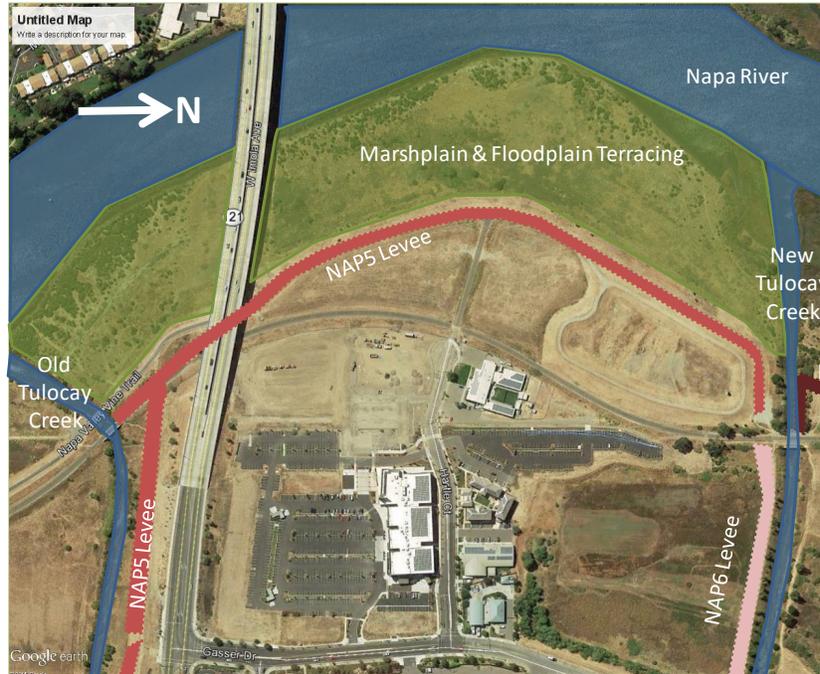
Figure 6-7: Old Tulocay Creek to New Tulocay Creek FRM Features

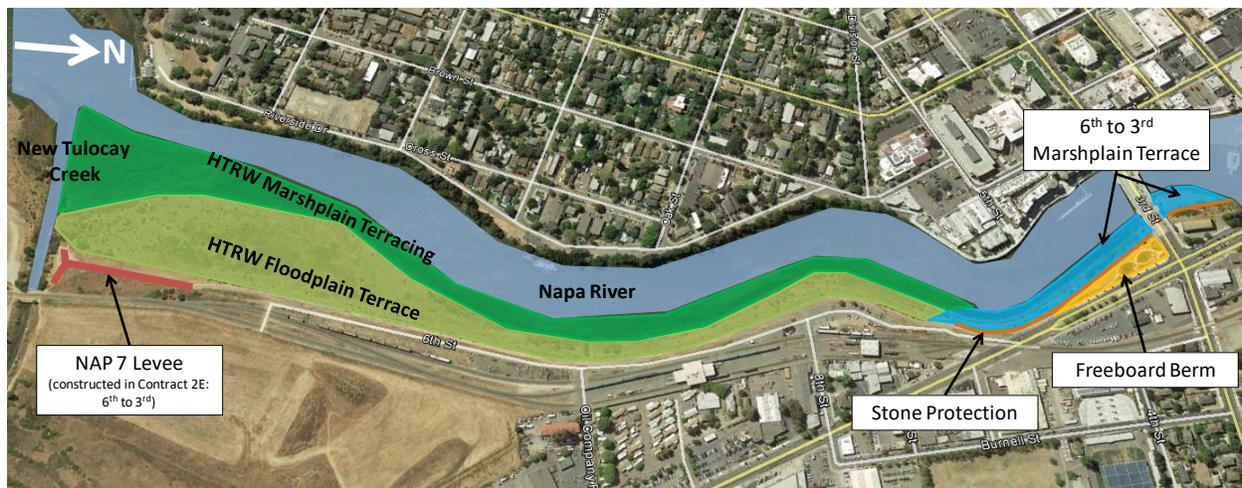
Figure 6-8: New Tulocay Creek to Soscol Avenue FRM Features

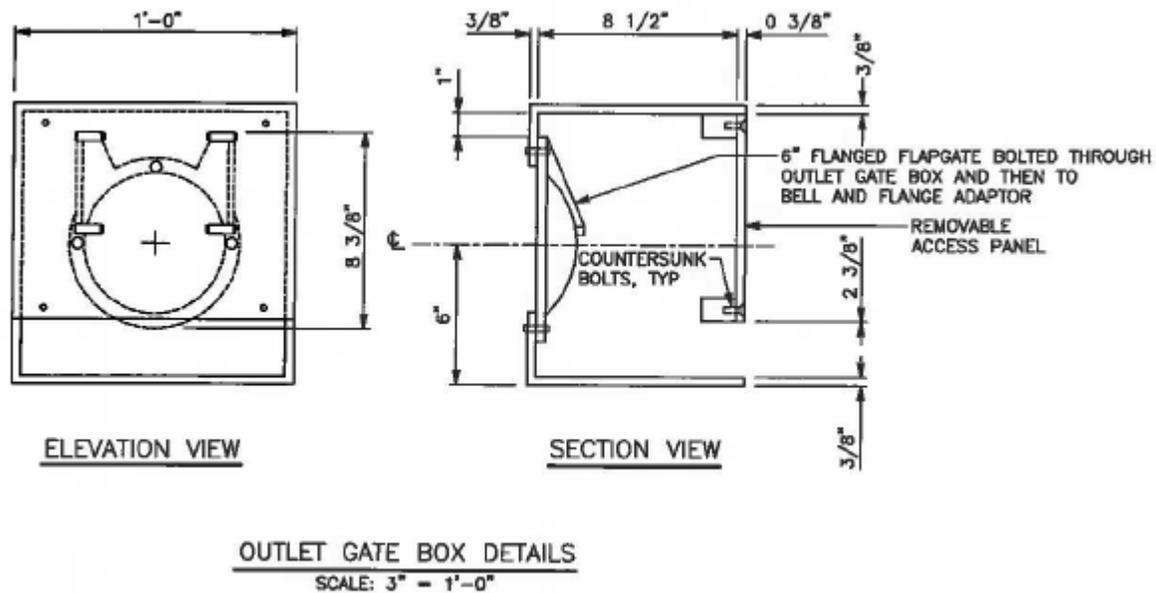
**Figure 8-1: Outlet Gate Box Detail**

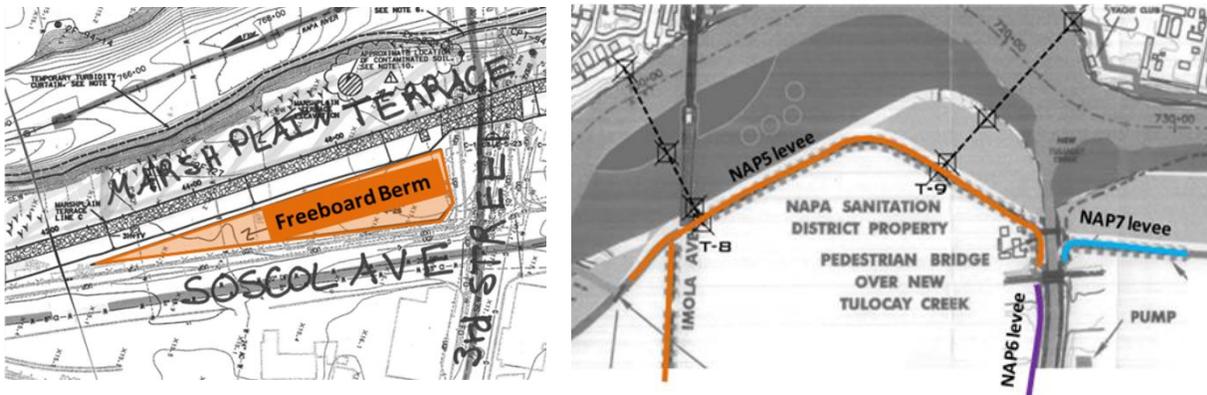
**Figure 10-2: (left) Freeboard Berm Location, (right) Levee Location**

Prior to performing maintenance and inspection on levees and berms, Section 10.6 shall be reviewed for important environmental features, specifically the BO exception granted for maintenance to Site 1 dikes. Measures shall be taken to promote the growth of sod, exterminate burrowing animals, and to provide routine mowing of the grass and weeds, removal of wild growth and drift deposits, and repair of damage caused by erosion and other forces unless otherwise noted. Vineyard Dike, Training Dike, Planting Berm and Dredge Disposal Dike shall follow the requirements described below except if it conflicts with the Special Instruction given in Section 10.7.3.1, 10.7.3.2, and 10.7.3.3, respectively.

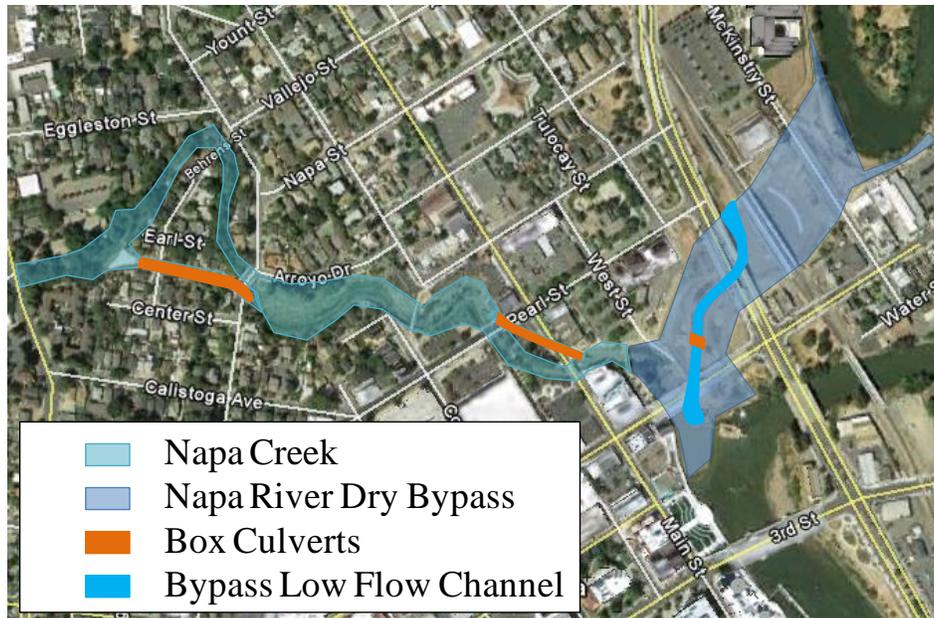
**Figure 10-4: Box Culvert Location Map**

There are two underground dual box culvert bypasses along Napa Creek. The downstream box culvert bypass is located between Main Street and Pearl Street and the upstream box culvert bypass is located between Seminary Street and Behrens Street. The dry bypass box culvert forms a "bridge" over the low flow channel in the dry bypass along a recreation trail. The box culvert locations are shown on Figure 10-4.

- Drainage channels were constructed in Site 1B at Napa River Station 647+00 and the Site 2E area in the vicinity of Imola Bridge.
- Dry Bypass:
  - The open channel north of the Soscol Avenue Bridge will be retained and will discharge into the new low flow channel. This channel extends south to discharge into Napa River.
  - The gabion wall is located at the most upstream location of the Bypass Low Flow Channel shown in Figure 10-4.

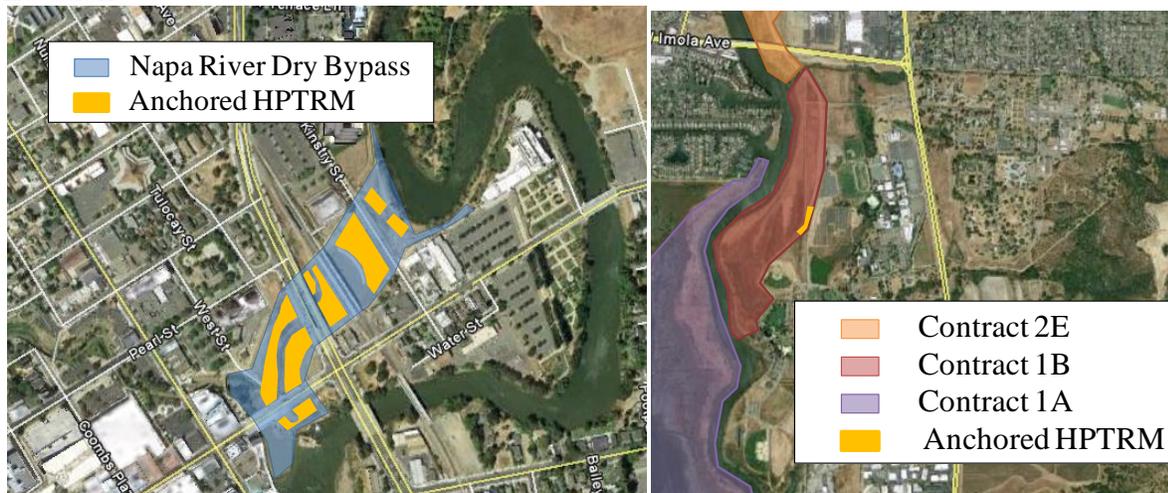
Figure 10-9: Locations of Anchored High Performance Turf Reinforced Matt

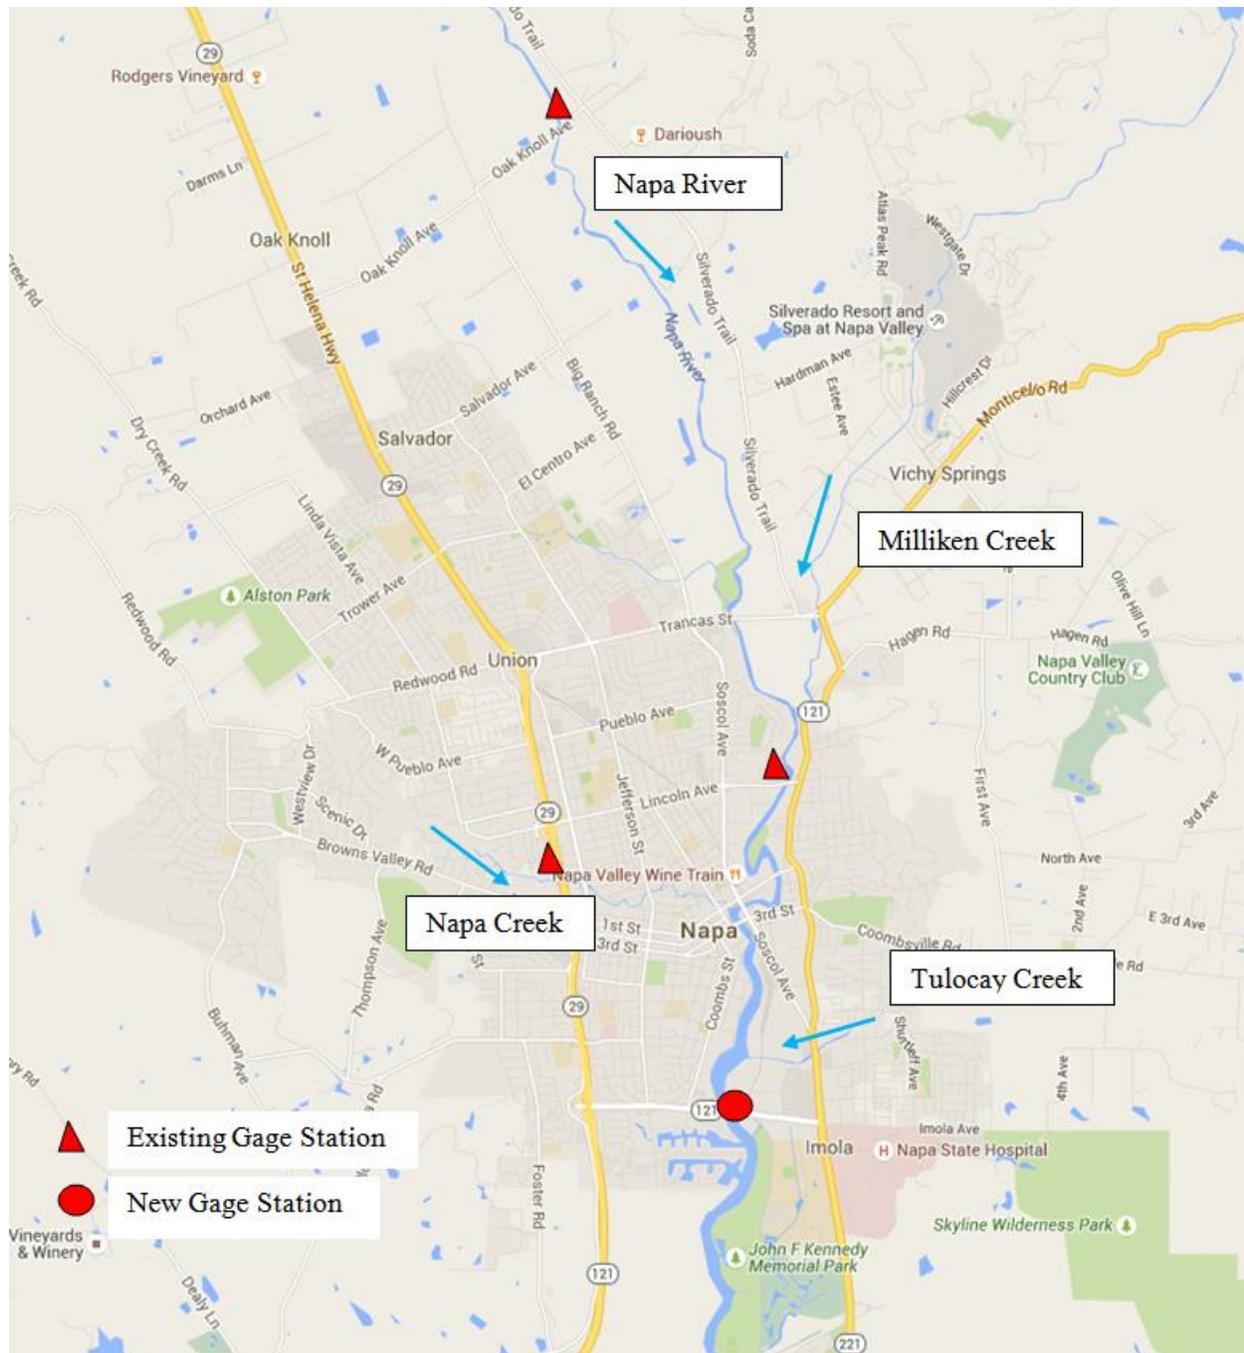
**Figure 11-2: Existing and Proposed Gage Stations**
