**GEOTECHNICAL INVESTIGATION**

STEELE CANYON ROAD AT P.M. 2.00  
NAPA COUNTY, CALIFORNIA

Prepared by:  
Blackburn Consulting

July 27, 2007

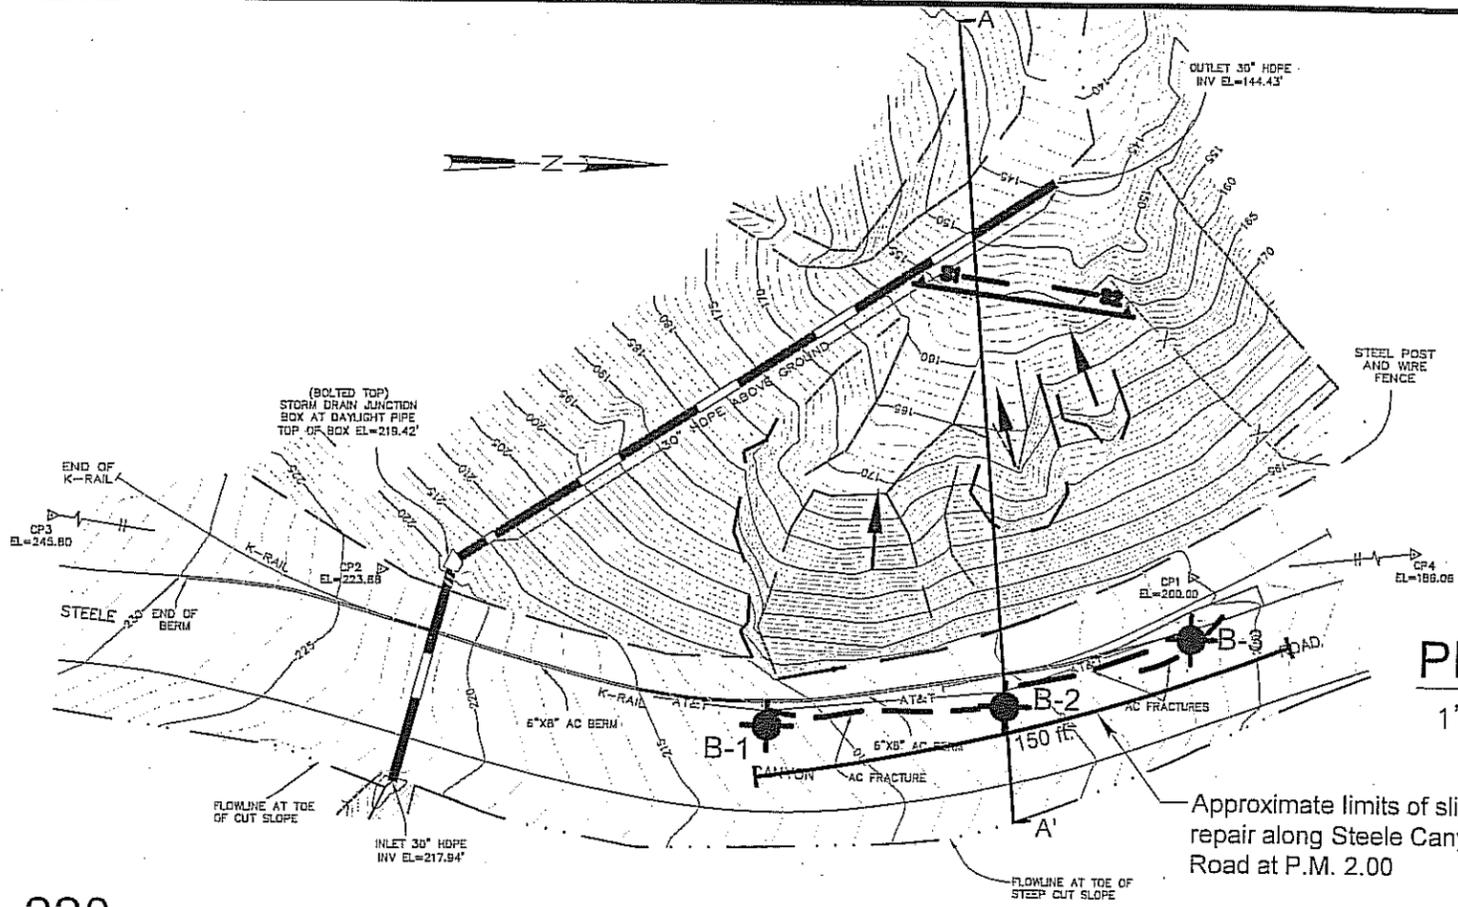
File No. 1216.1
July 2007
Figure 3

The slip-plane extends to the rock line in the central portion of the slipout. The Unit 1 fill materials are directly involved with the slipout event and we identified a 5 to 6 foot thick zone of weak Unit 2 soil that remains in-place along the flanks of the slipout. The lowermost Unit 3 rock appears "in-place" and not materially involved with the slipout event. Based on our boring data, the underlying rock is stable, but is intensely weathered, fractured and locally sheared (typical of rock weakened by fracturing, shearing and crushing along/near faults). We show the estimated slip-plane on Figure 3.

provide recommendations for a reconstructed embankment section with a 2:1 (horizontal: vertical) finished slope established from the restored original hinge-line (see Figure 3).

- We recommend that the excavation backslope extend at 1:1 from the heel of the toe to the top of Unit 3 rock materials, then follow the rock surface to where a 1:1 backslope can be constructed to maintain one-lane access through the site. Some trimming into the inboard slope may be necessary to maintain a single lane for traffic.

- Drain the buttress section with a 2-foot-thick “blanket” of ¾-inch crushed rock placed along the base of the toe bench and extended up the backslope to within 10 feet of road level to intercept/relieve subsurface water infiltration. Wrap the crushed rock with filter fabric (such as Mirafi 140N or equivalent) to prevent mobilization of fines into the drain.
